2018 Biennial Bridge and Culvert Inspection

Township of Johnson

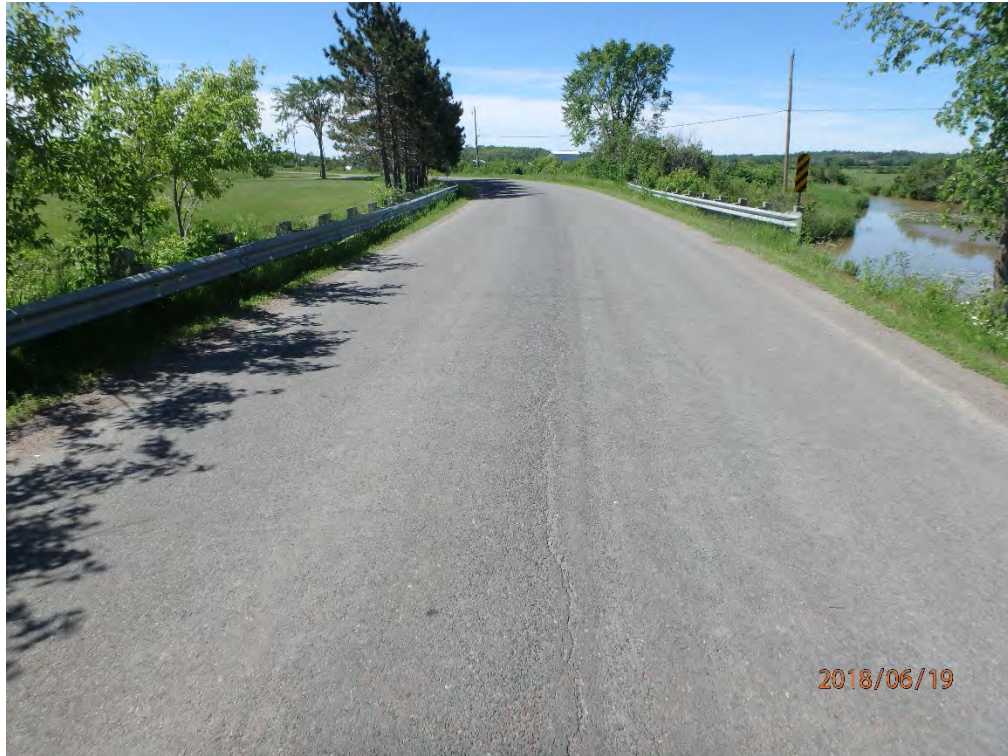
- Guard should be installed along the northwest approach
- All hazard markers should be cleared of vegetation and implemented as part of the regular maintenance.
- Repair to the settled shoulder of the road along the northwest gabion should be complete

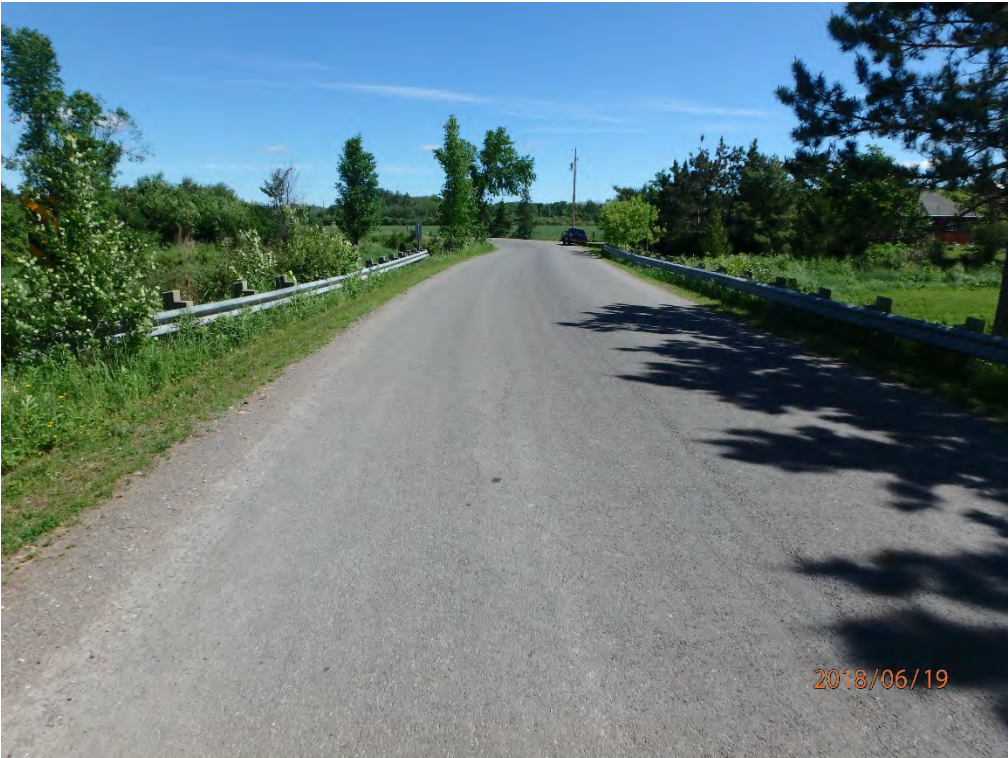
Hazard marker obstructed by vegetation

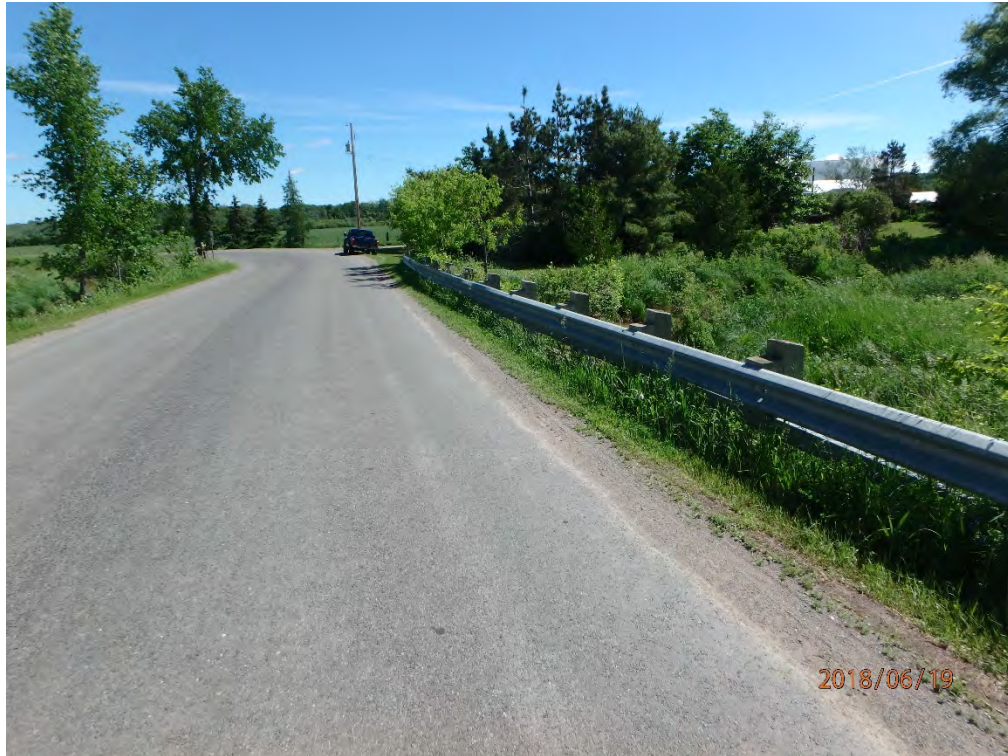
Scraped Guiderail along east side

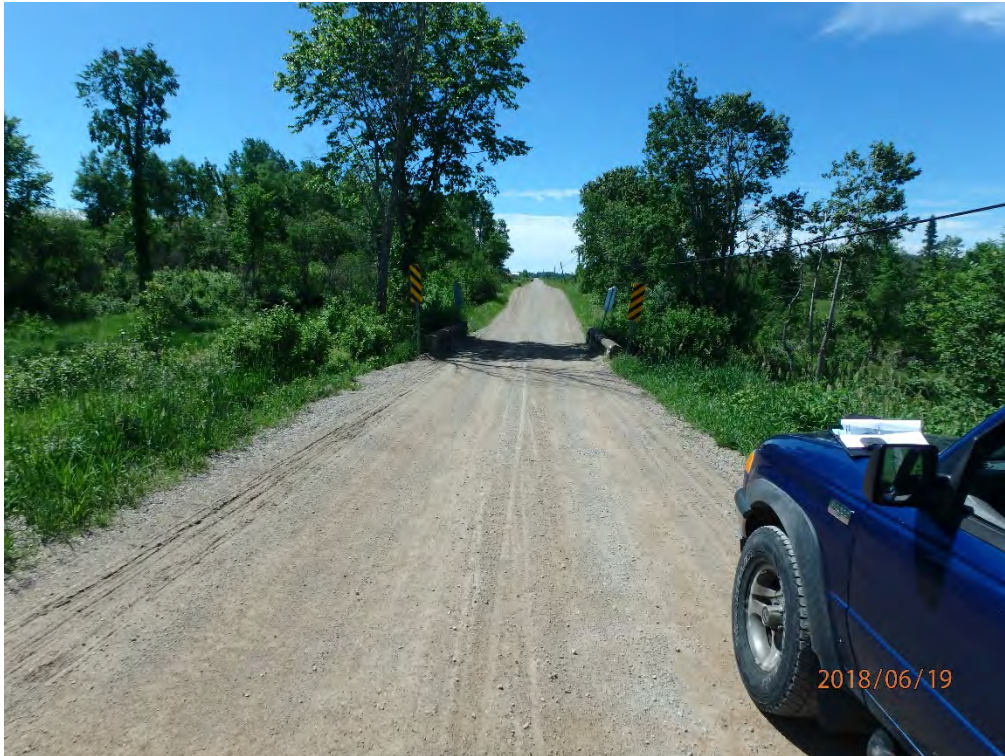
South across the bridge

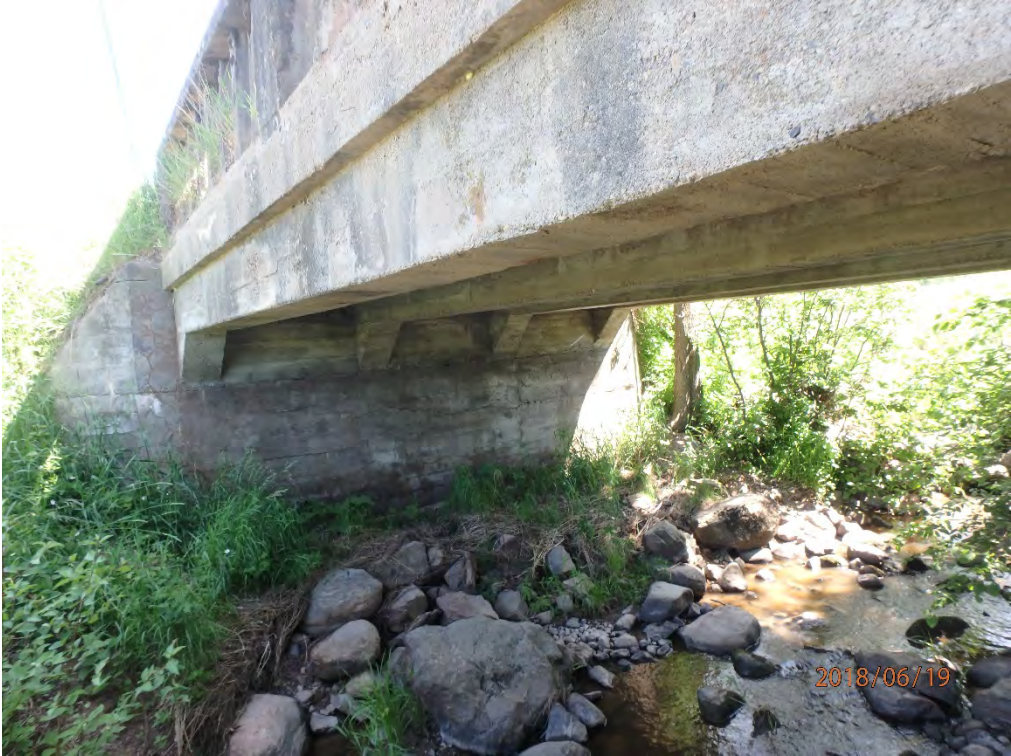
North abutment wall with narrow to wide horizontal cracks, map cracking and delamination.

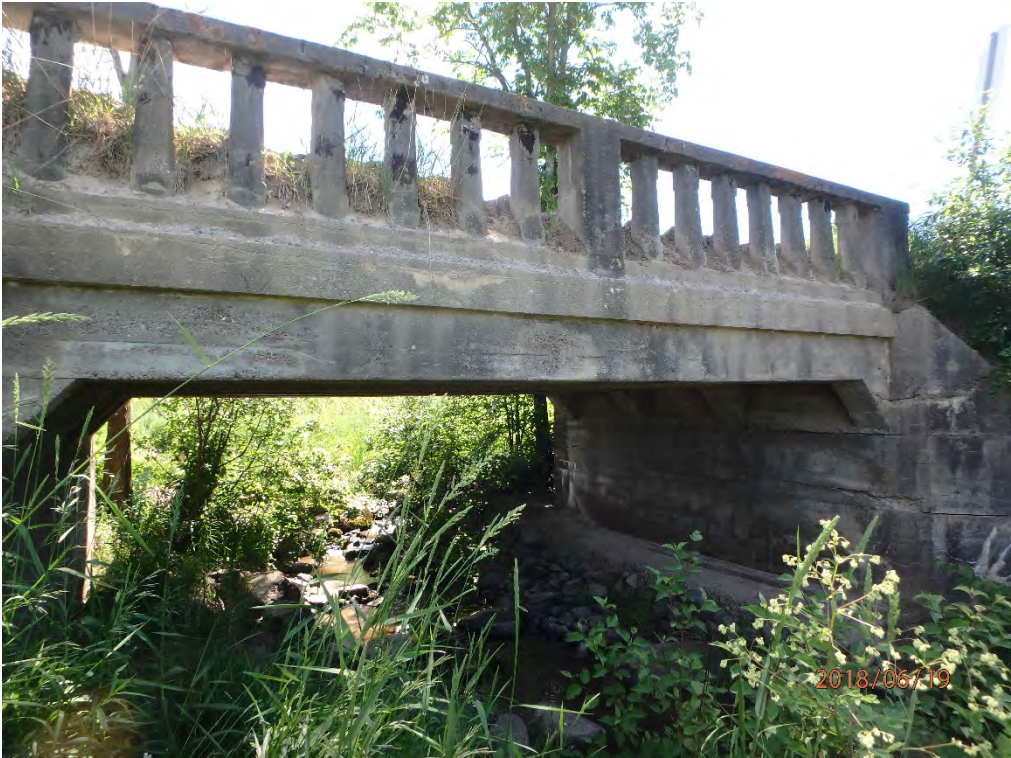
South abutment wall with narrow to wide horizontal cracks, map cracking and delamination.

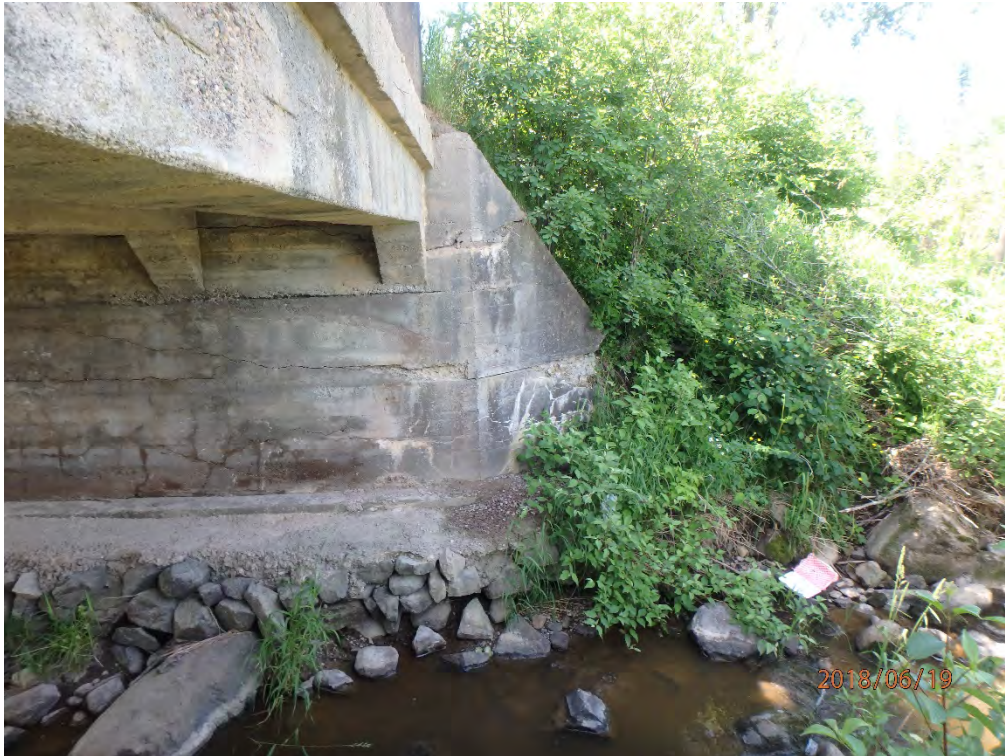
Southeast wingwall with narrow to medium cracking, wide horizontal cracks and delamination

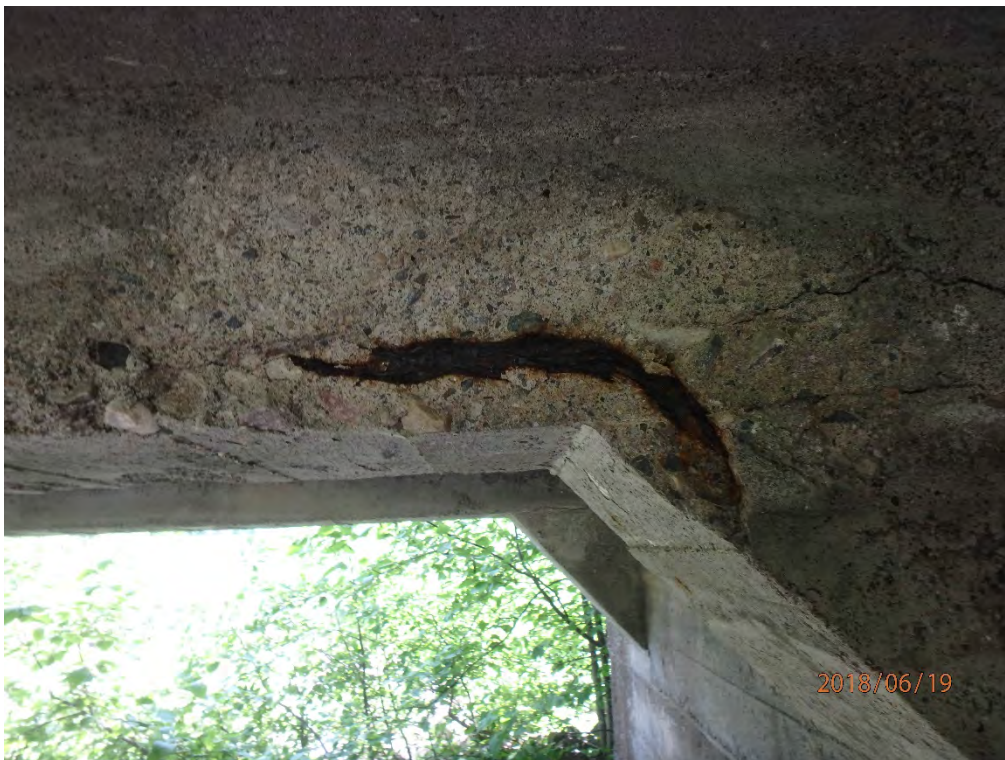
Southeast interior beam with exposed and corroded rebar.

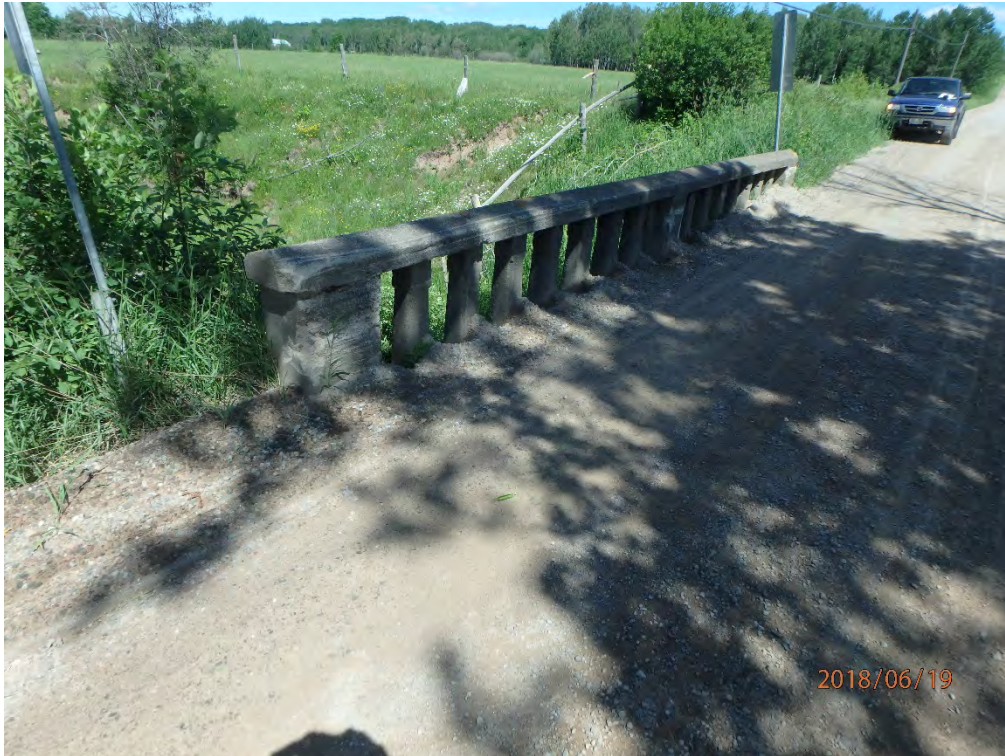
Damage to guard due to impact and buildup of gravel below guard

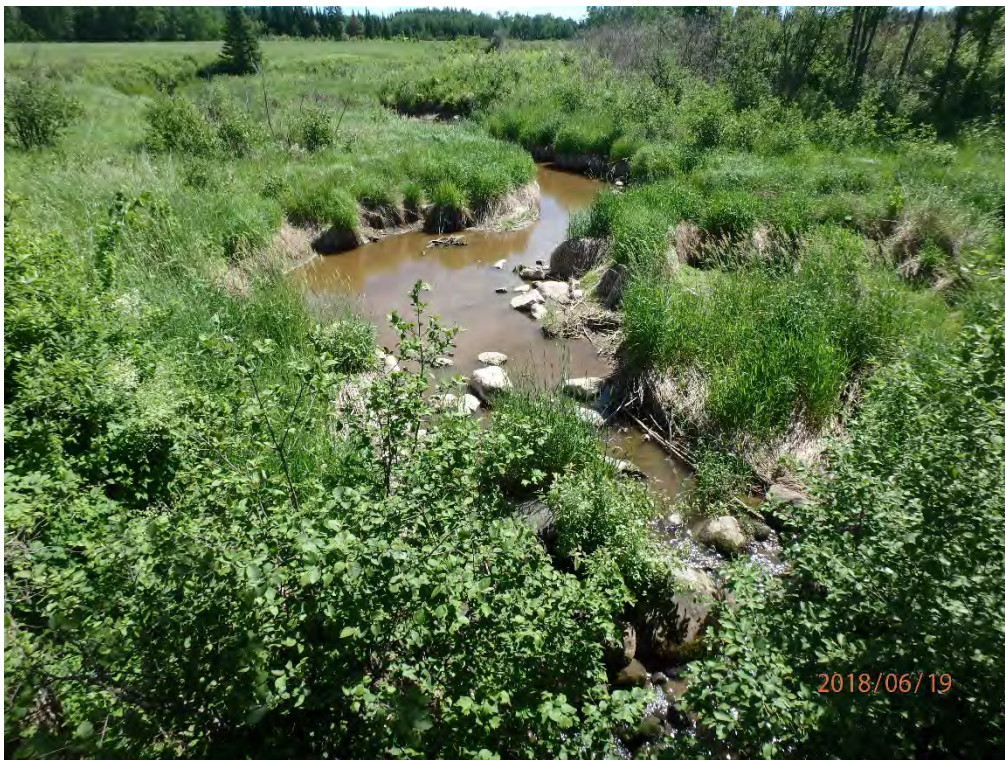
Unobstructed flow upstream

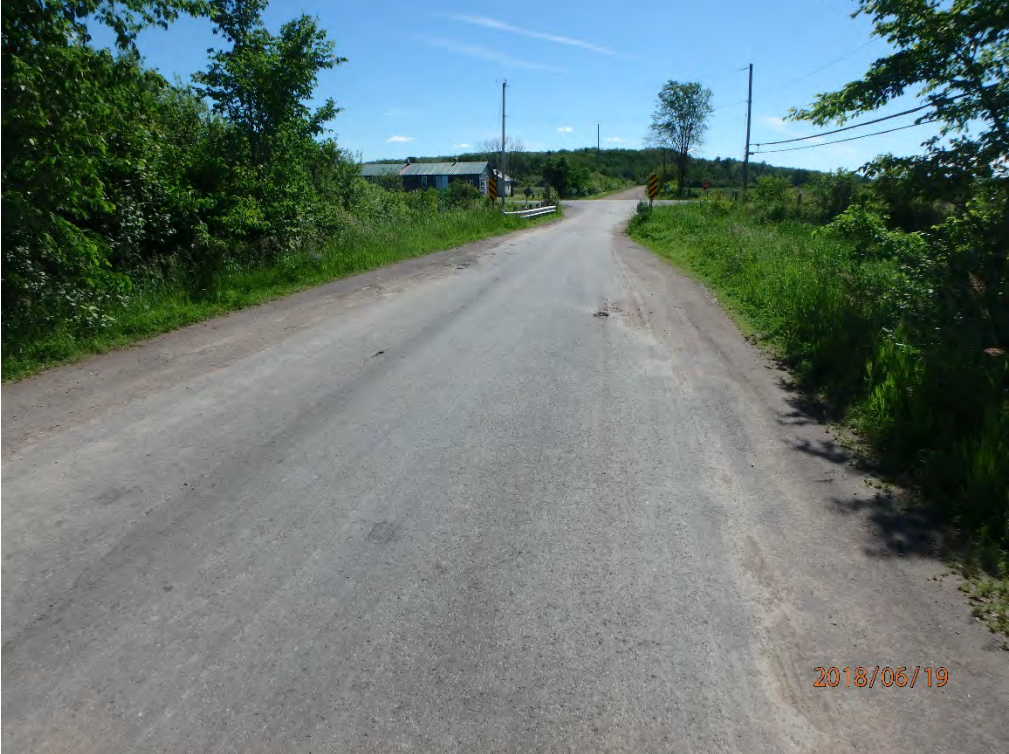
East across the bridge

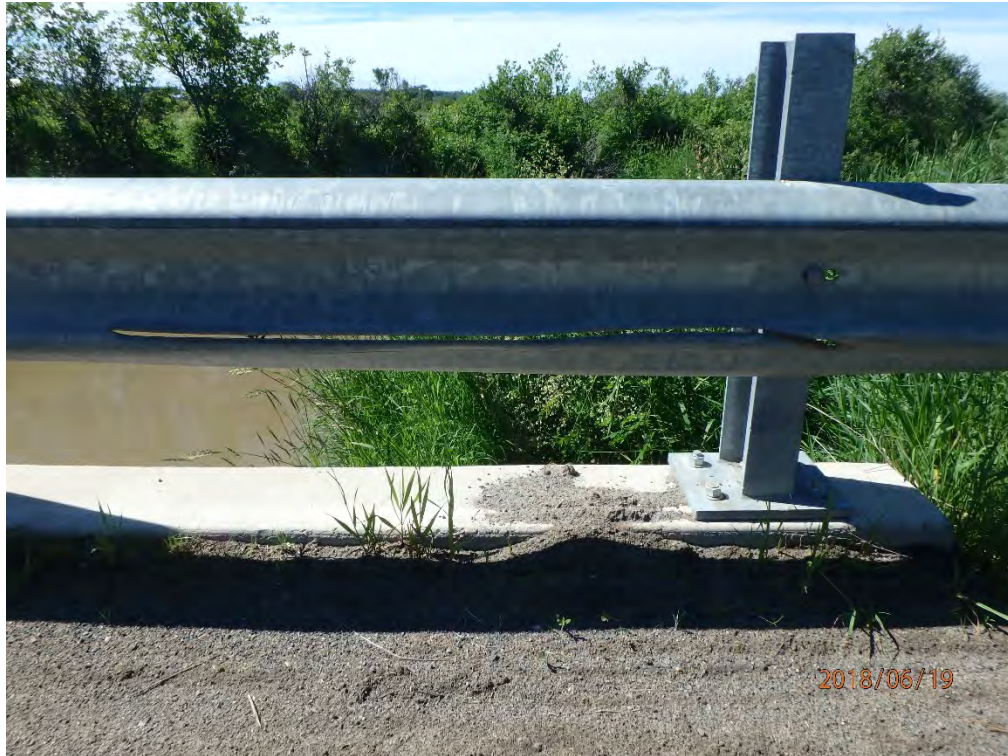
Damaged Guiderail along south side

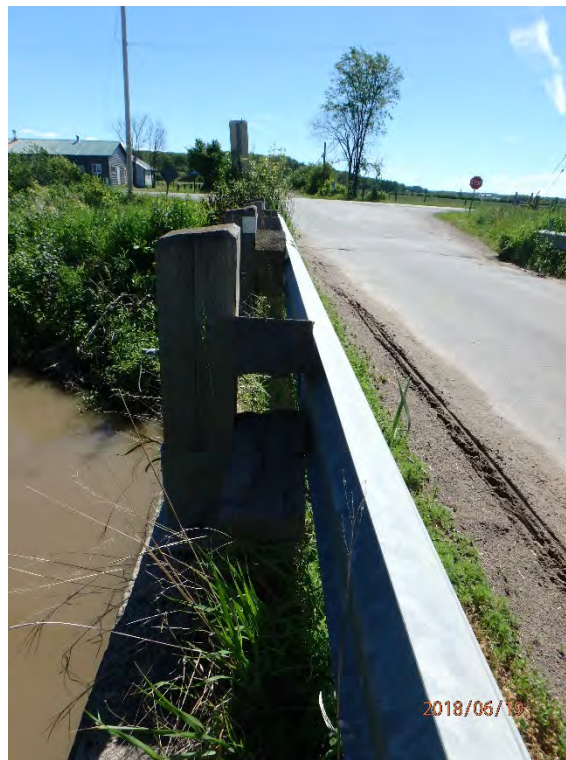
Broken and rotated offset block

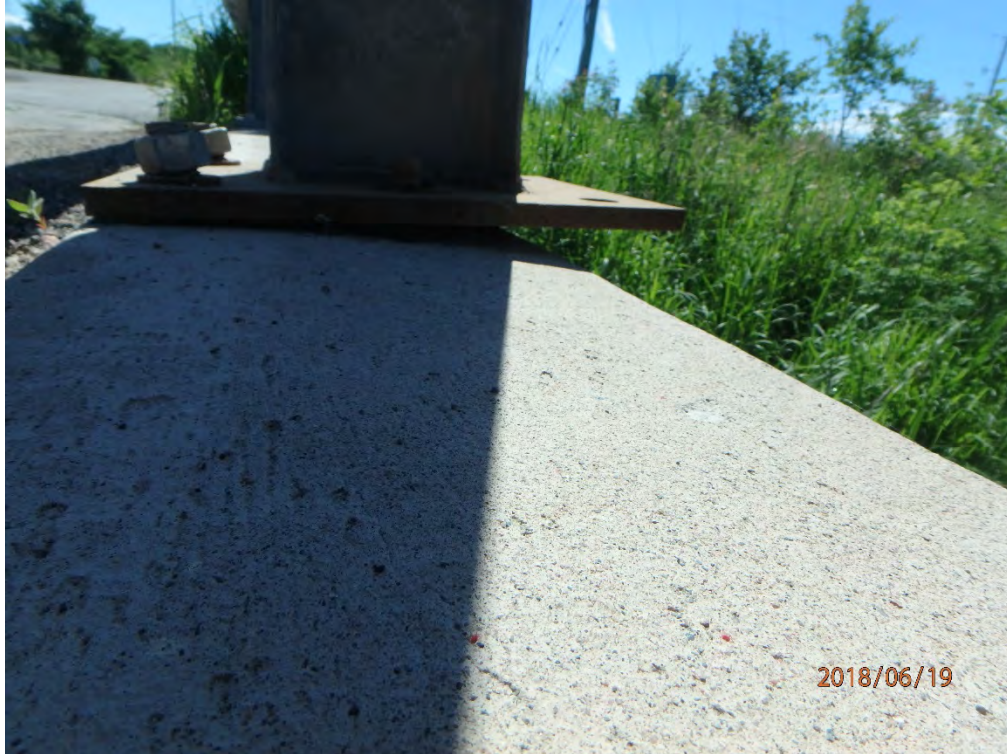
Gap under guiderail baseplate

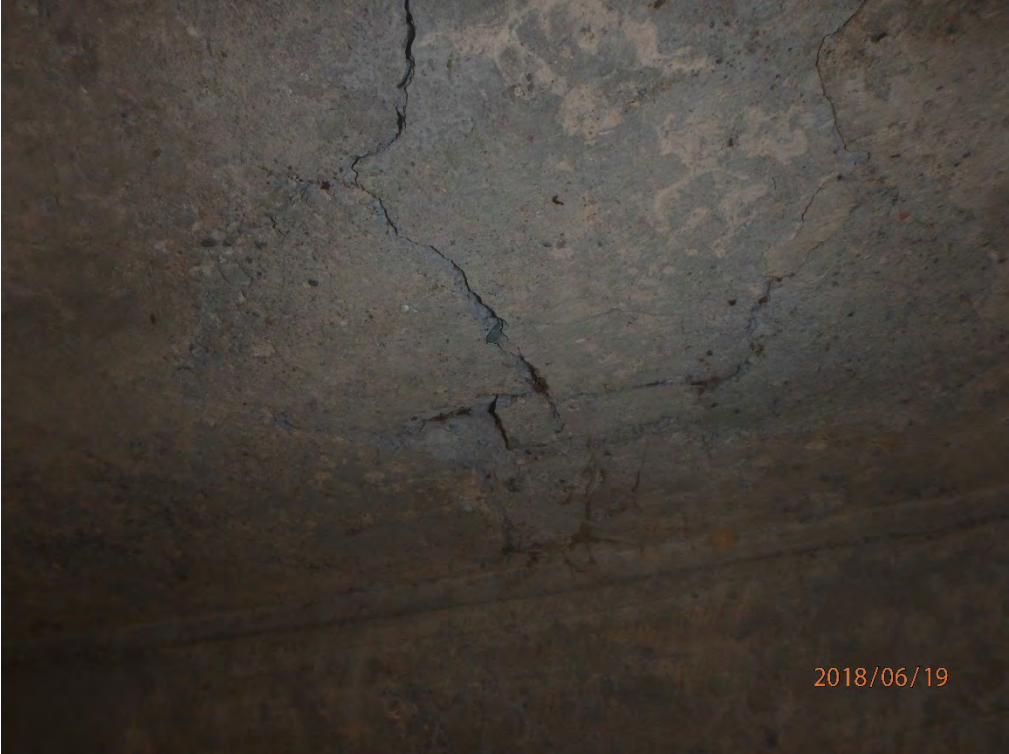
Medium to wide cracking of deck soffit at the east abutment

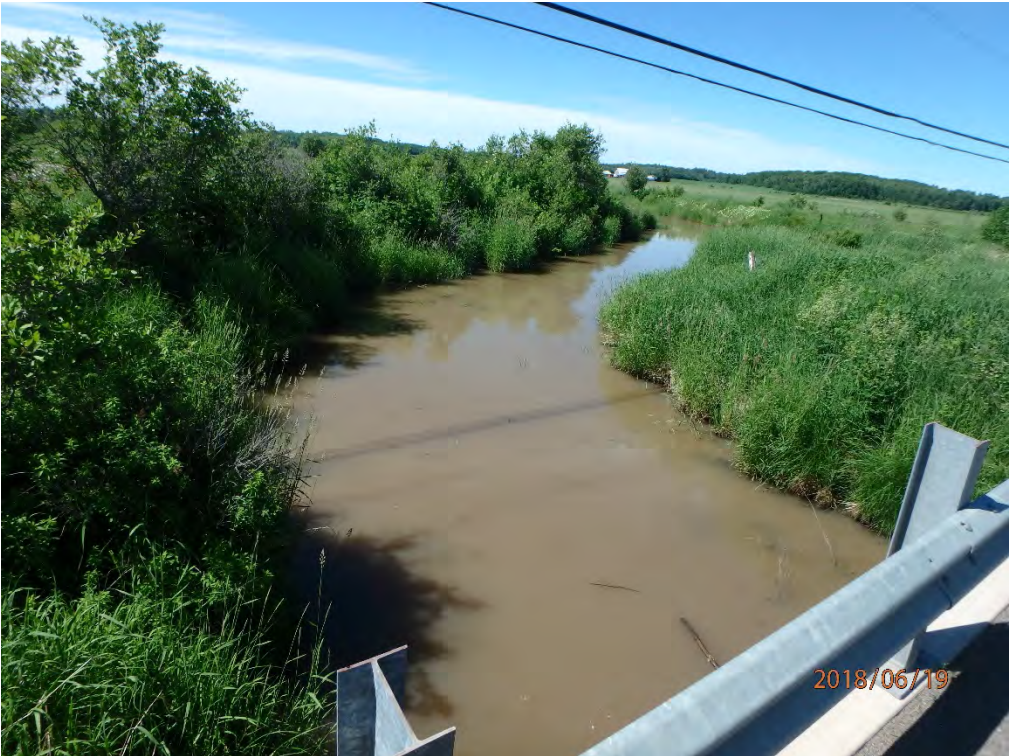
Downstream of bridge

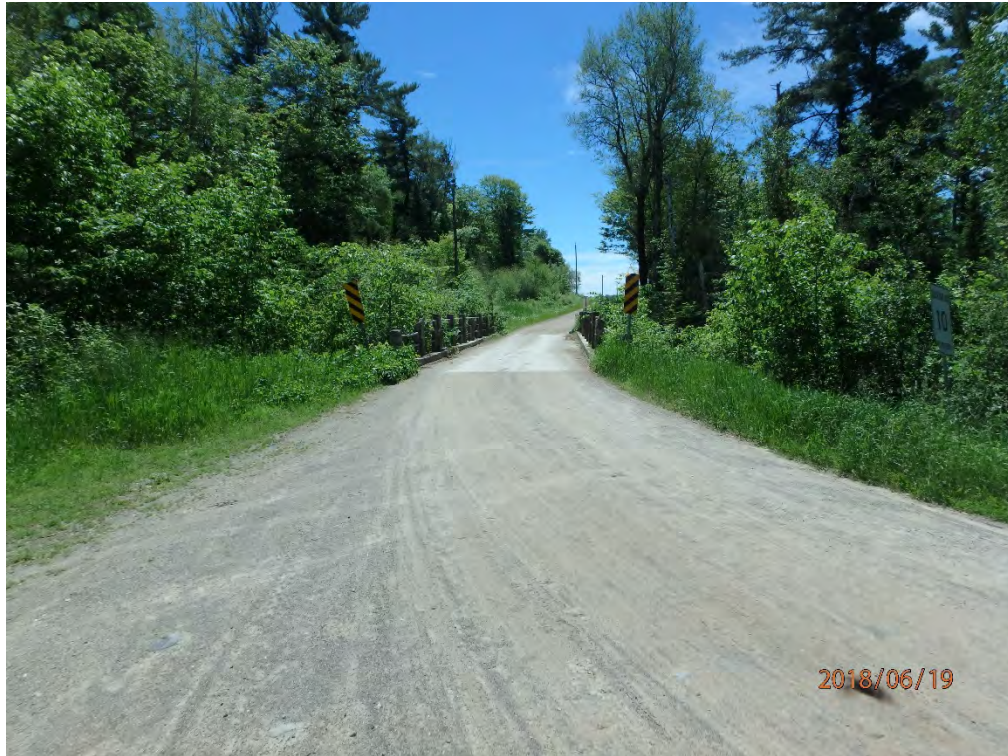
- If this bridge is intended to be subject to higher loads, a load evaluation should be carried out to confirm the rehabilitation/replacement recommendation and any further repair recommendations.

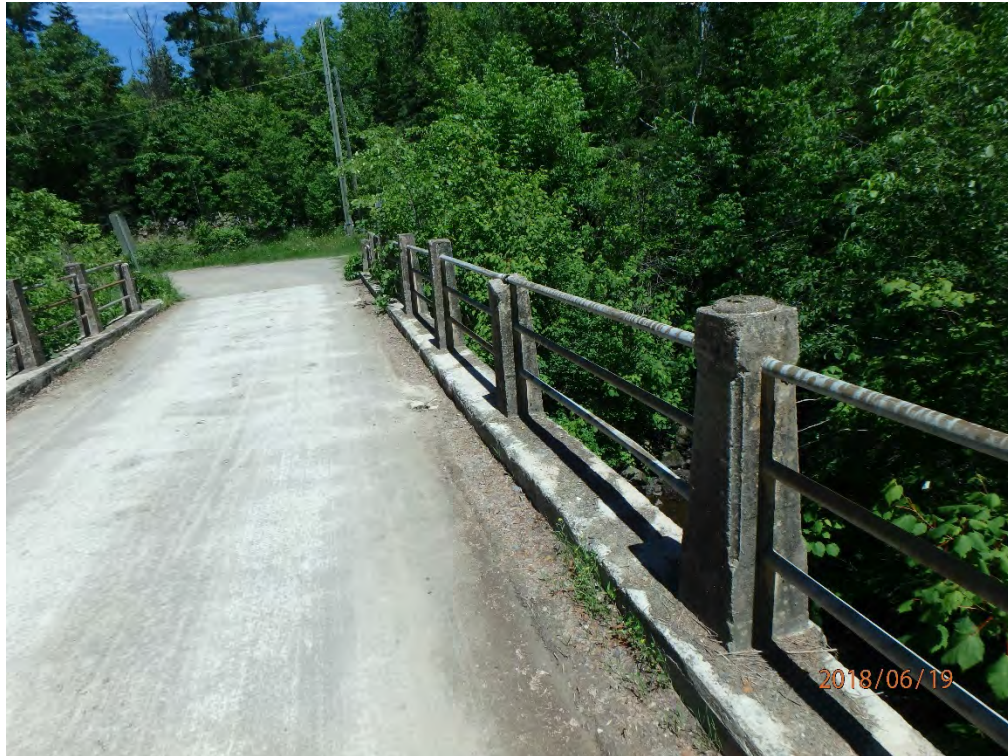
Concrete wear surface with light to moderate scaling. Broken railing post.

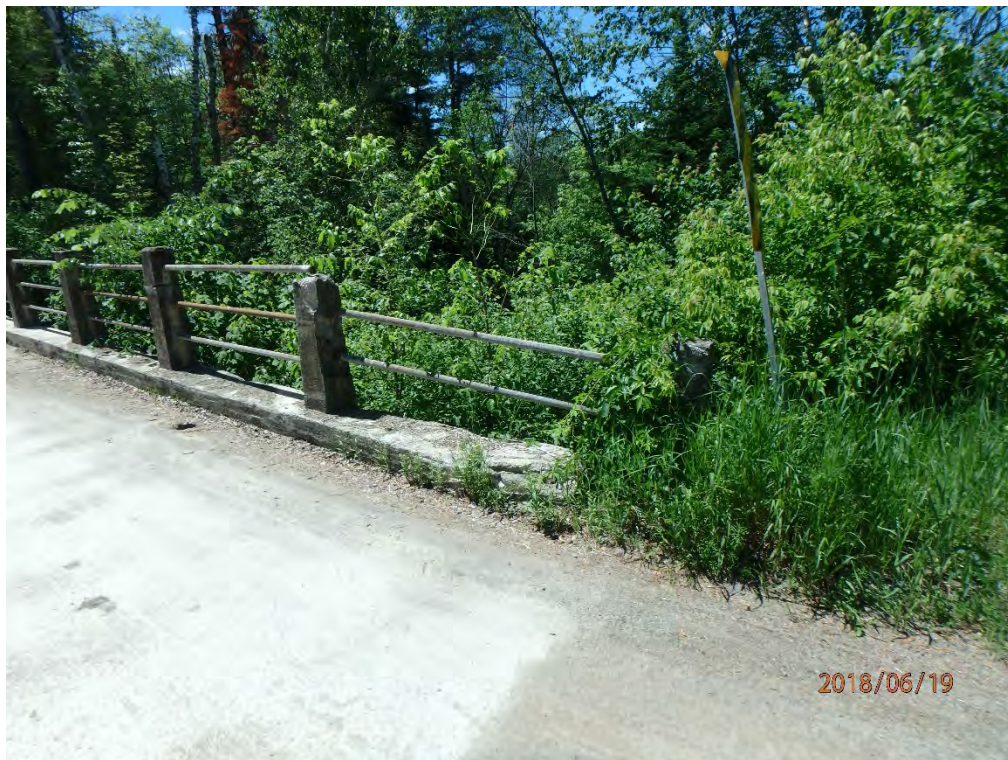
Broken missing railing post. Damaged pipe rails

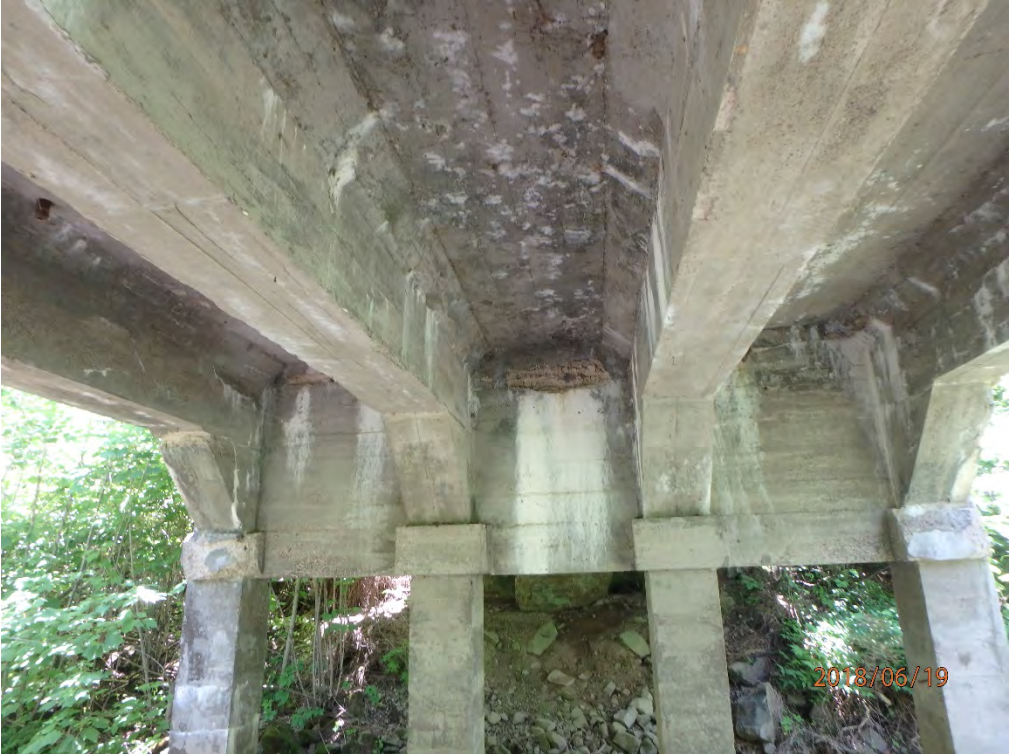
General arrangement of underside of bridge.

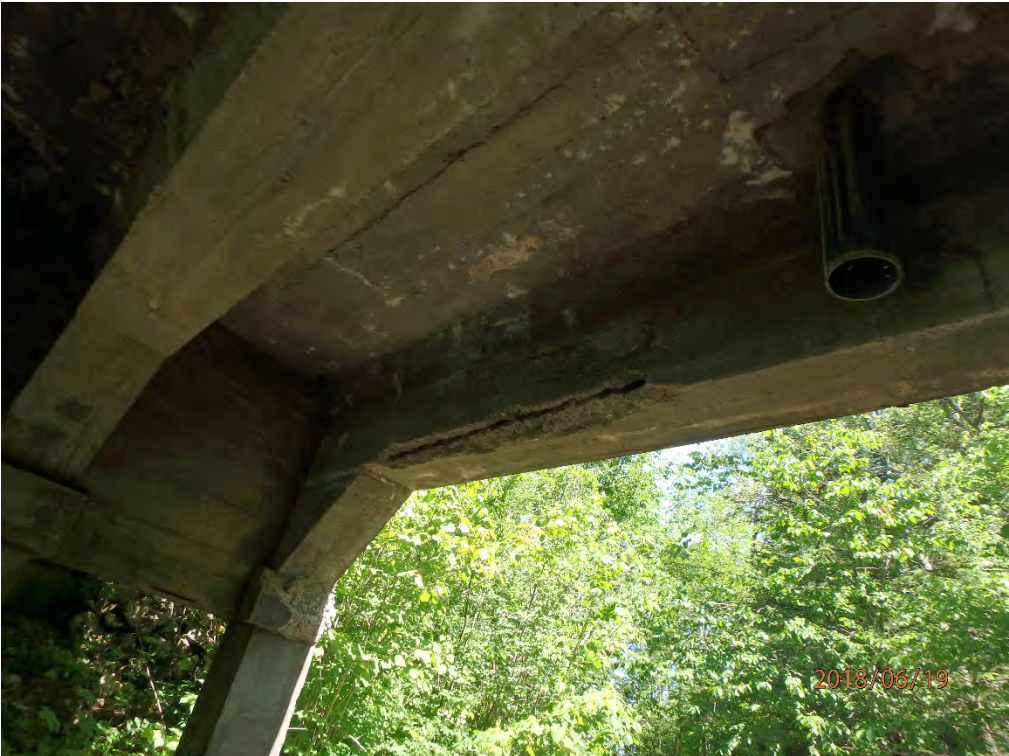
Exposed corroded rebar on east exterior beam.

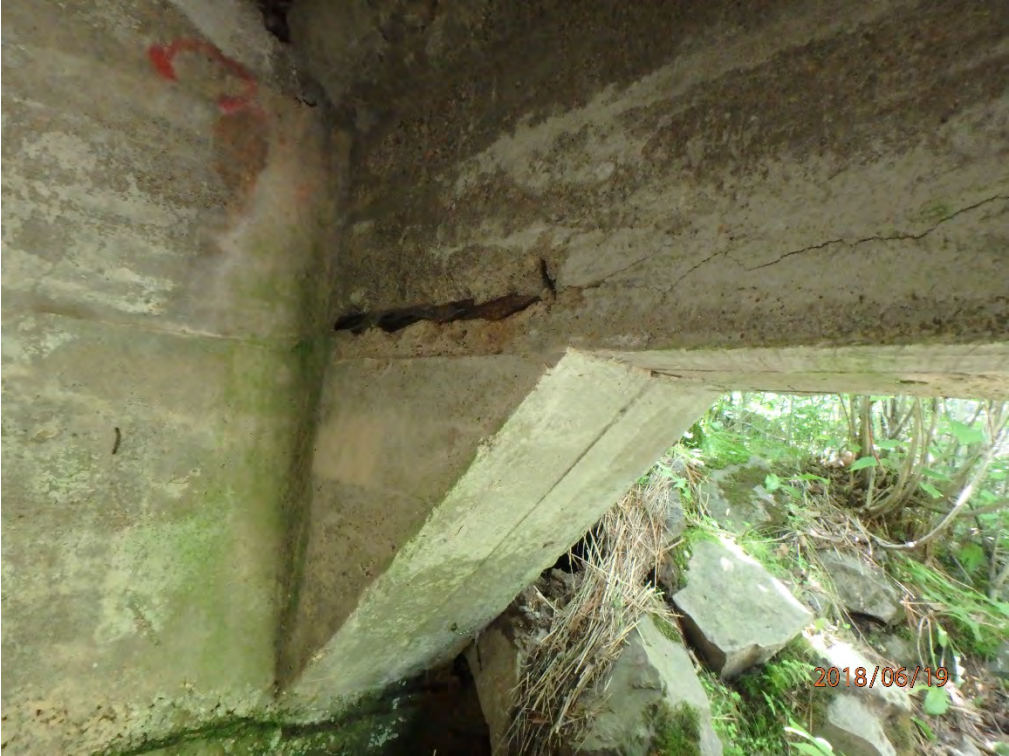
Exposed Rebar on east beam at abutment

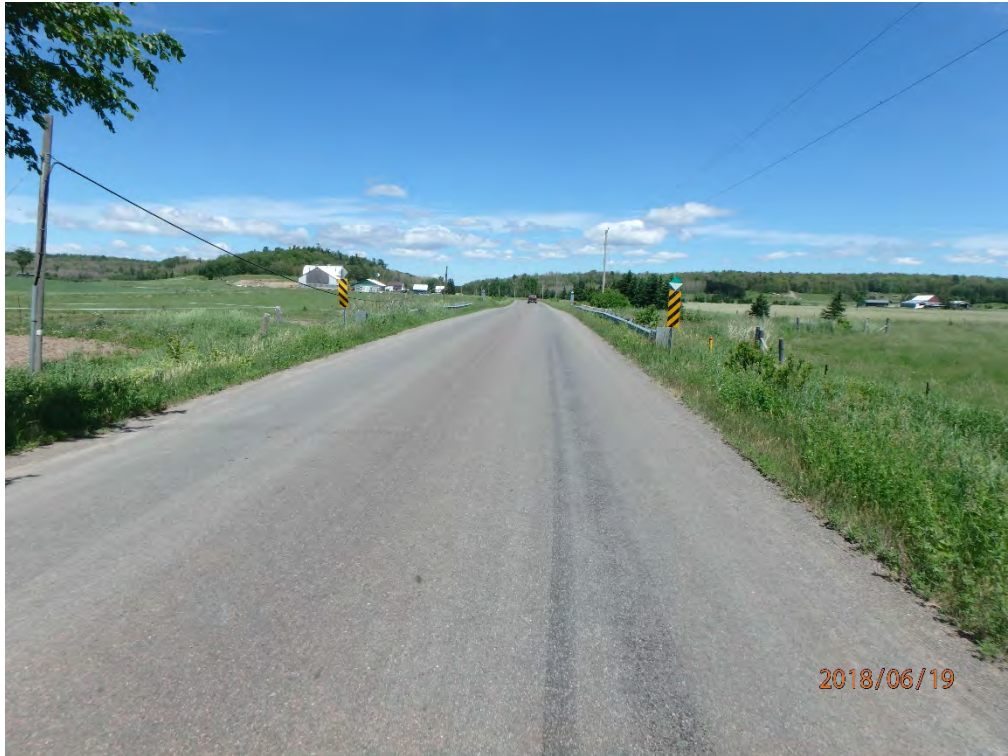
North across length of bridge

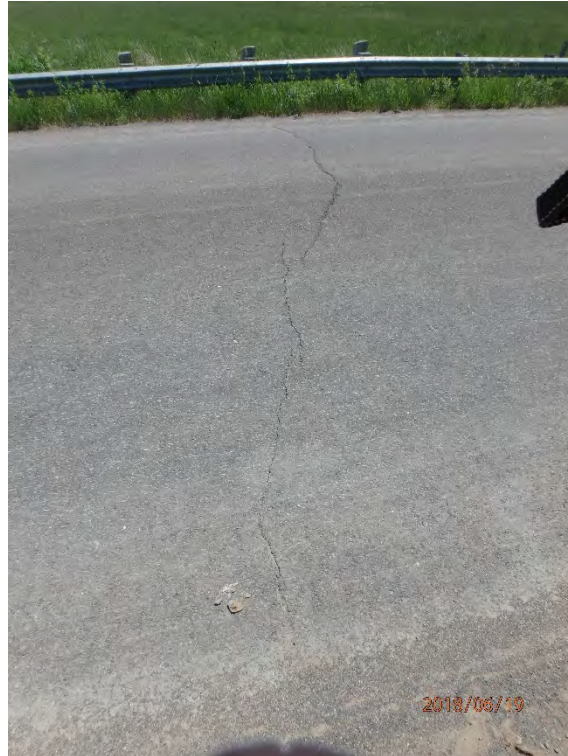
Transverse crack in the wearing surface

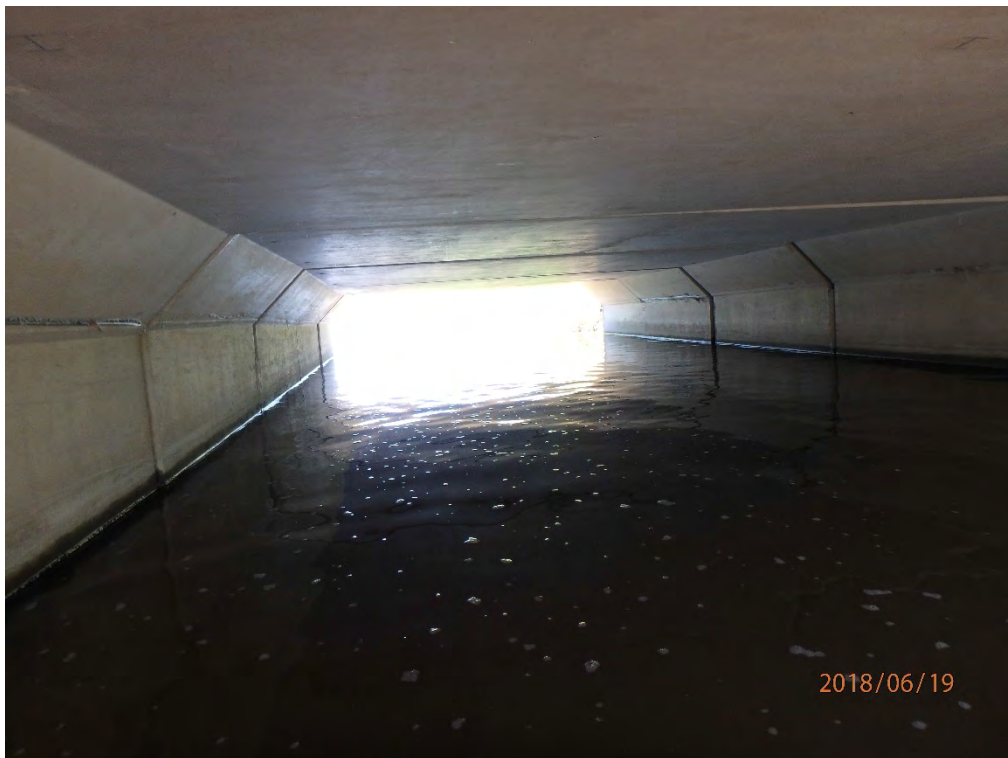
Looking west through barrel

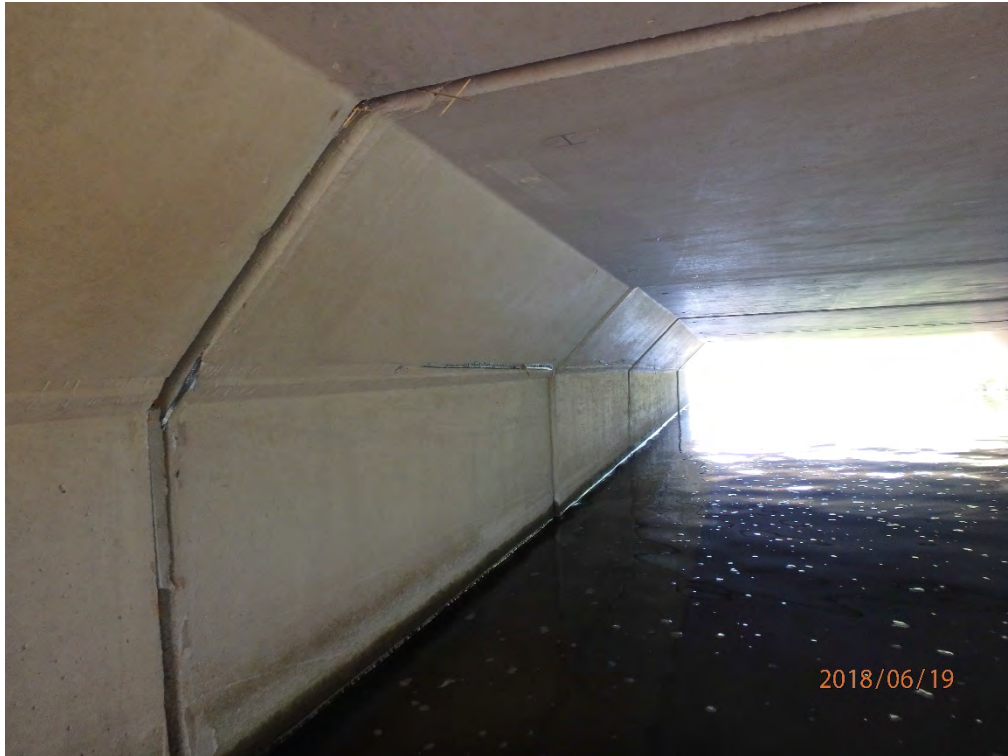
Missing parging at construction joints, typical at all joints.

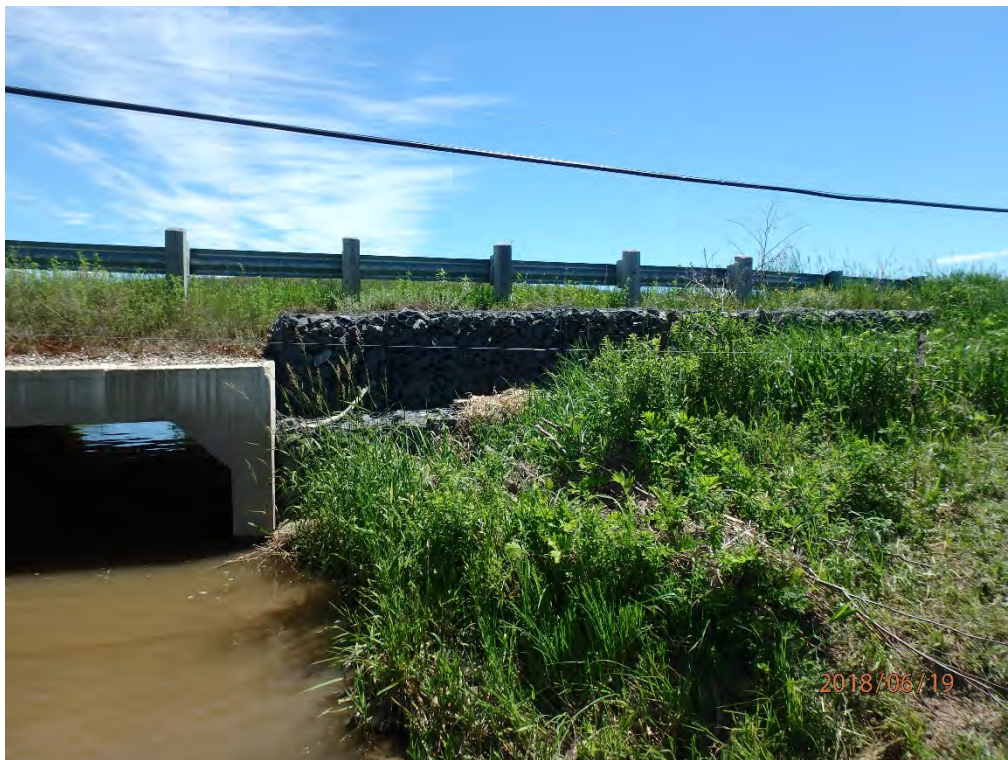
Gabions along west side of road

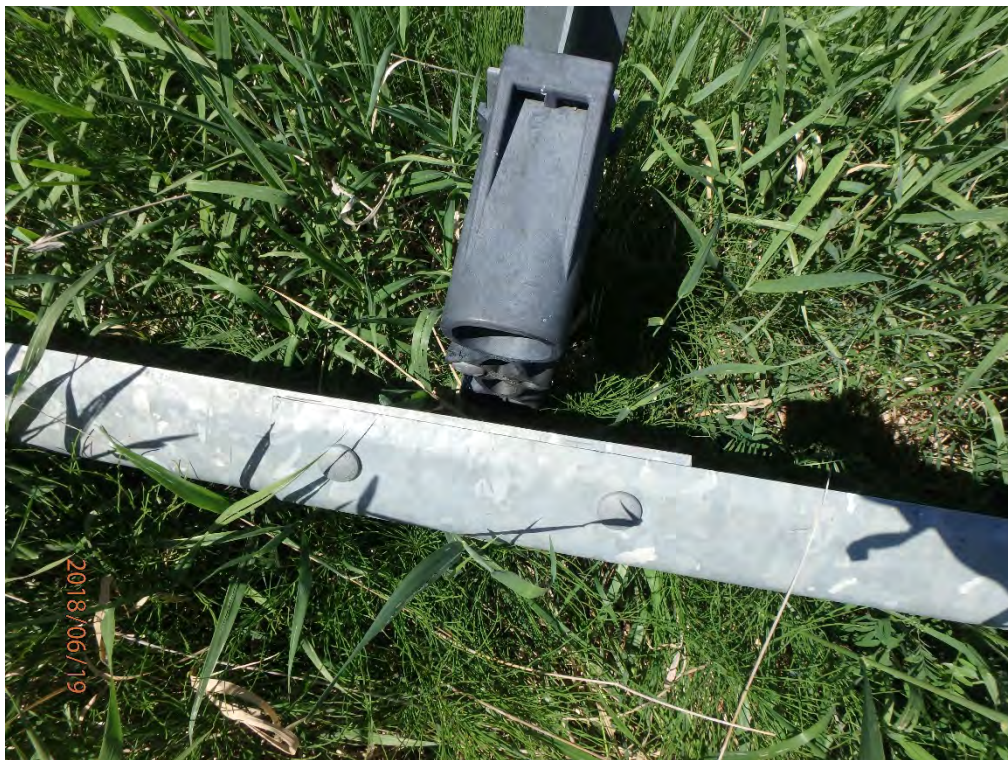
Guidrail support beam missing bolt to connect it to post

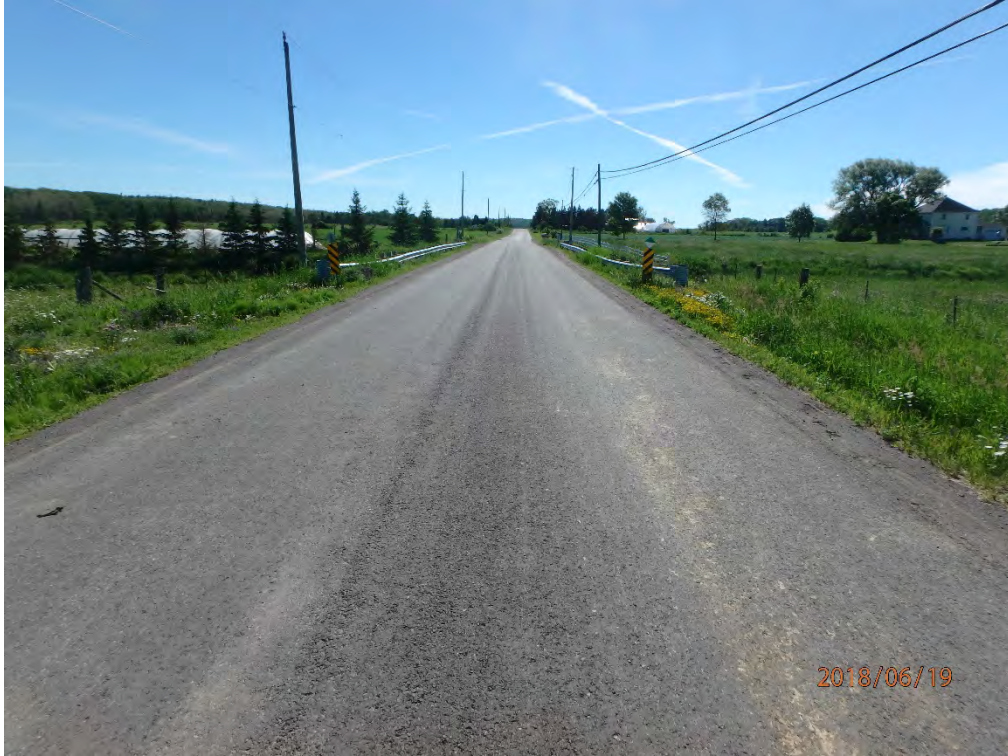
- Structure does not require posting with a load limit.

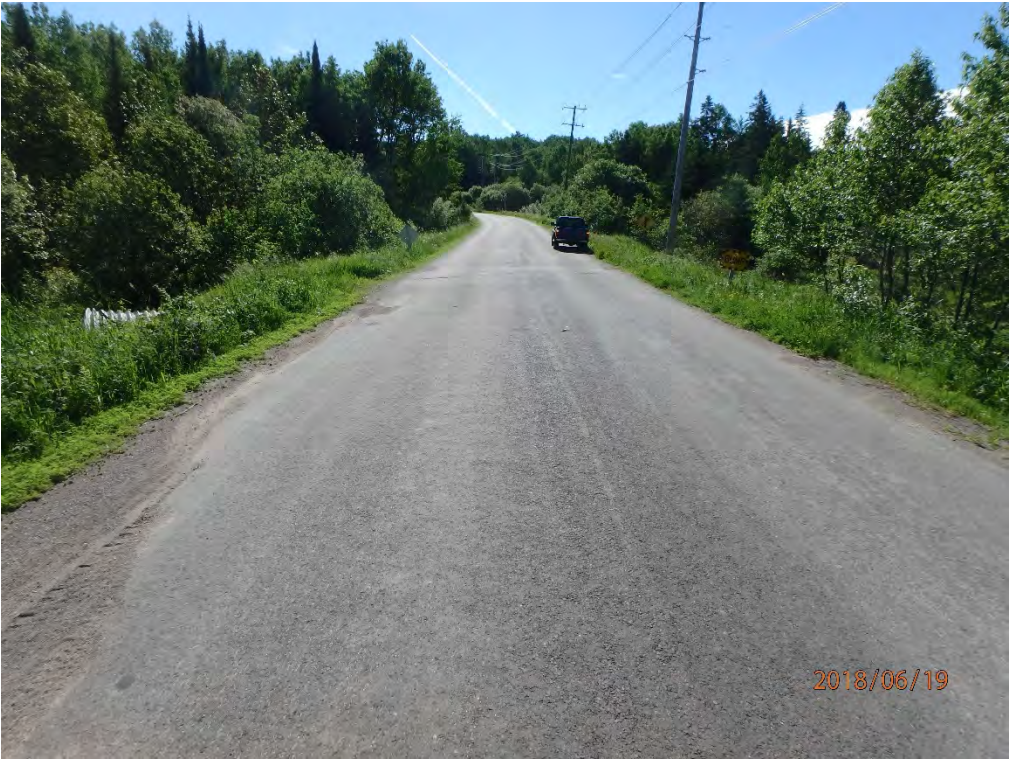
- Replacement of culvert should be budgeted in the next 5 years. Alternative option would be to install a liner in the culvert barrel. A culvert hydraulic study would be required to confirm suitability of installing a liner (this alternative was not costed).
