2018 Biennial Bridge and Culvert Inspection

Township of Johnson

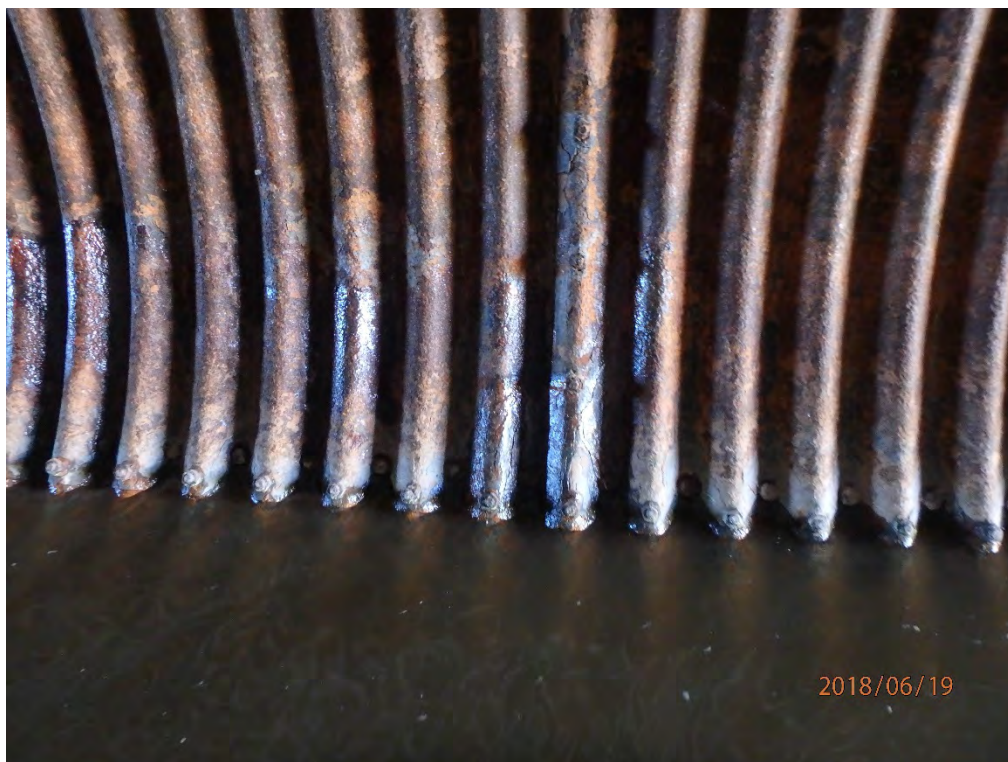
Culvert is rusting and flaking off. Water infiltrating through perforations in metal culvert.

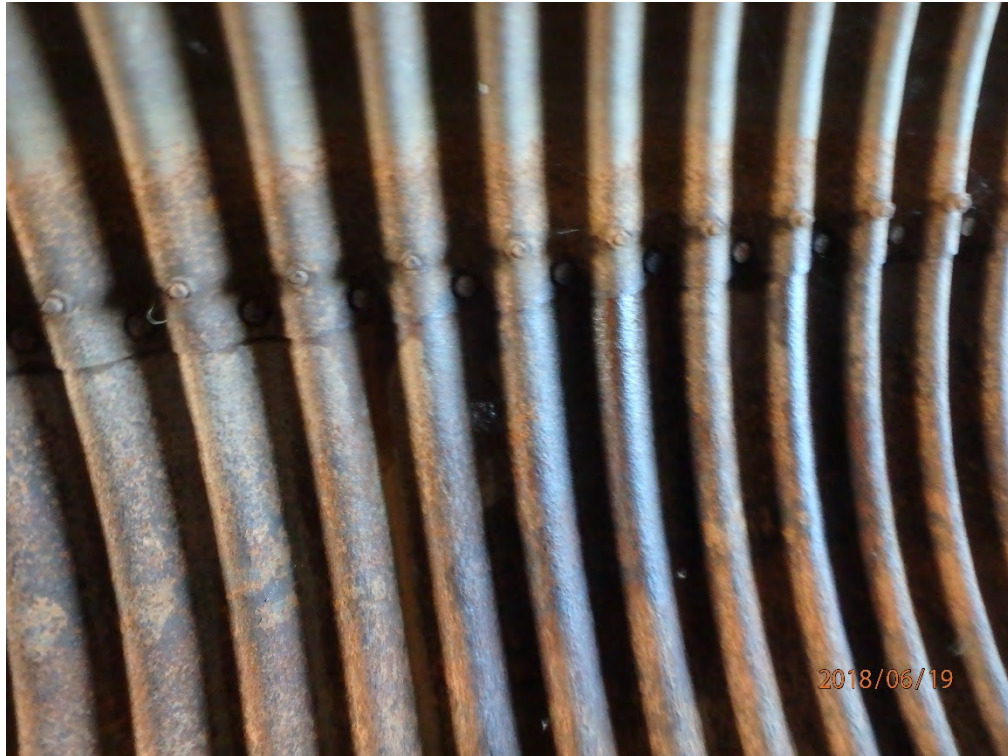
Joint in culvert leaking.

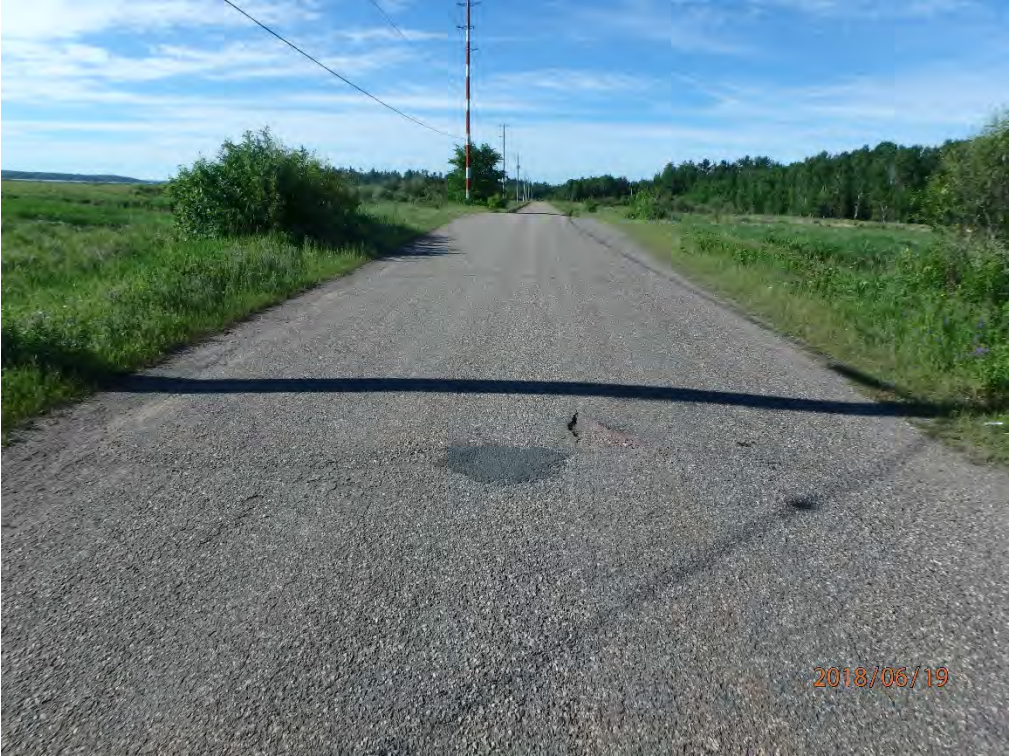
South across the culvert

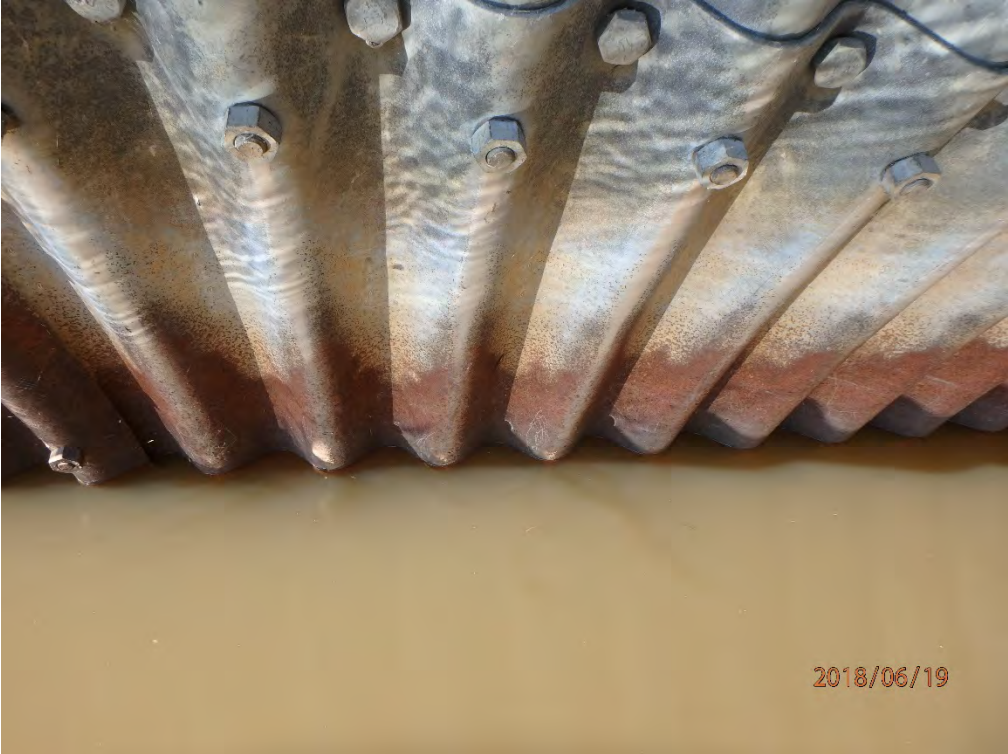
Light to moderate corrosion at waterline

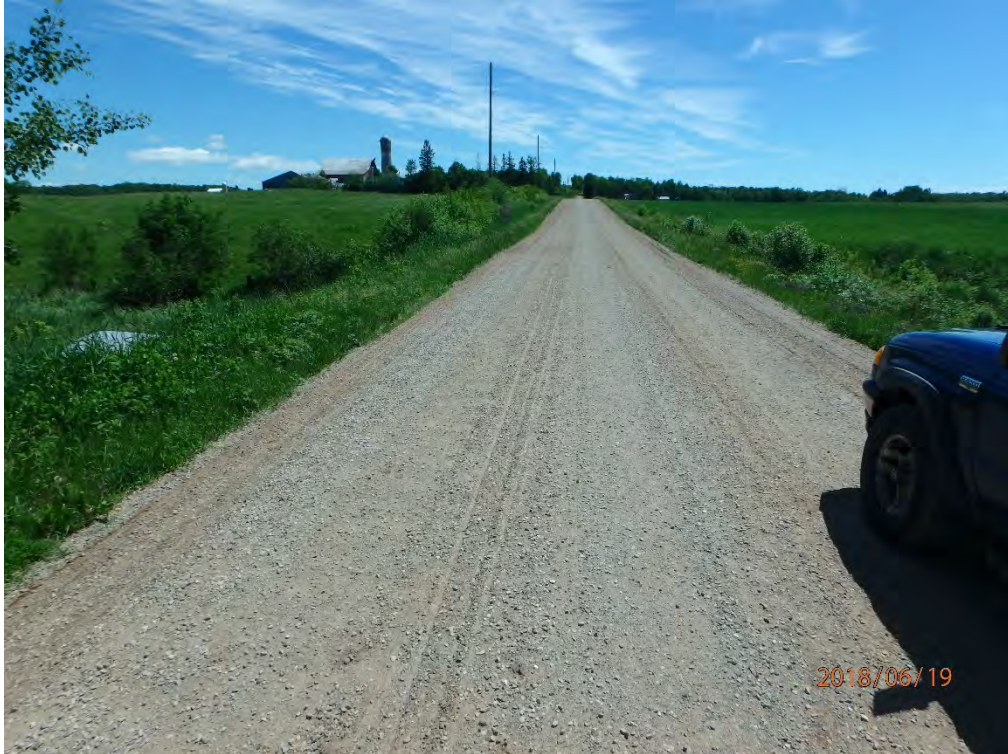
- Structure does not require posting with a load limit.
- Traffic protection should be installed at the approaches and across the structure
- The missing parging and opened seams should be repaired and maintained to prevent water from travelling under the culvert, including repairs at each end of the culvert.
- Monitor indentation of culvert barrel at centerline of roadway/culvert barrel.
- Expected replacement of culvert should be budgeted for the next 6-10 years. Alternative option would be to install a liner in the culvert barrel. A culvert hydraulic study would be required to confirm suitability of installing a liner.

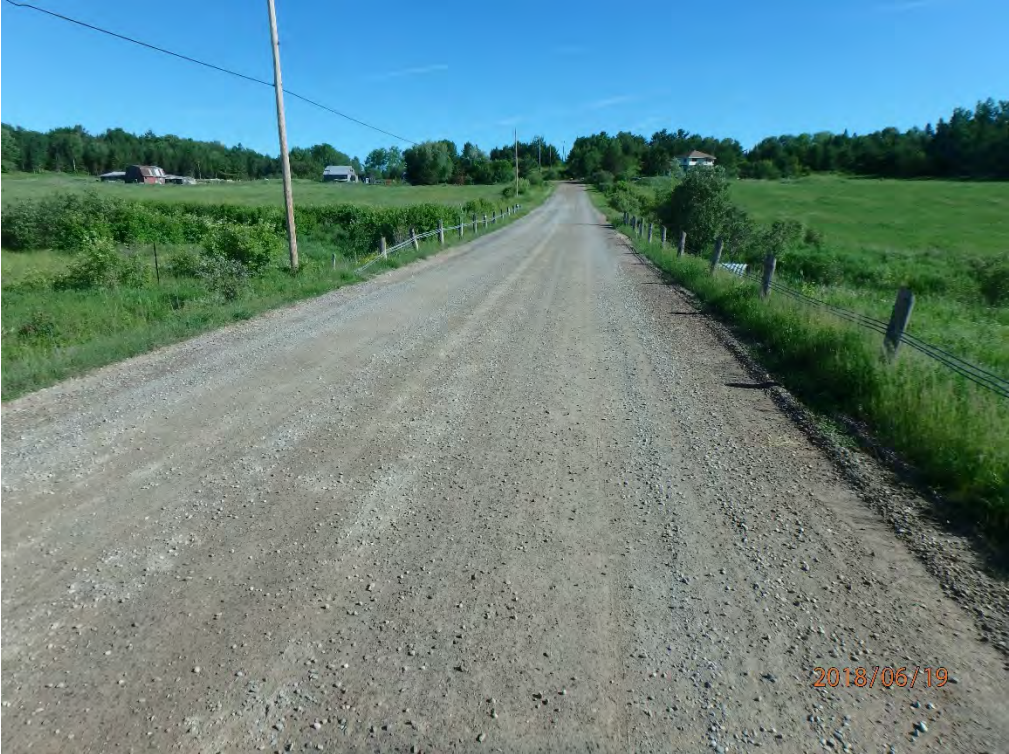
North across the culvert

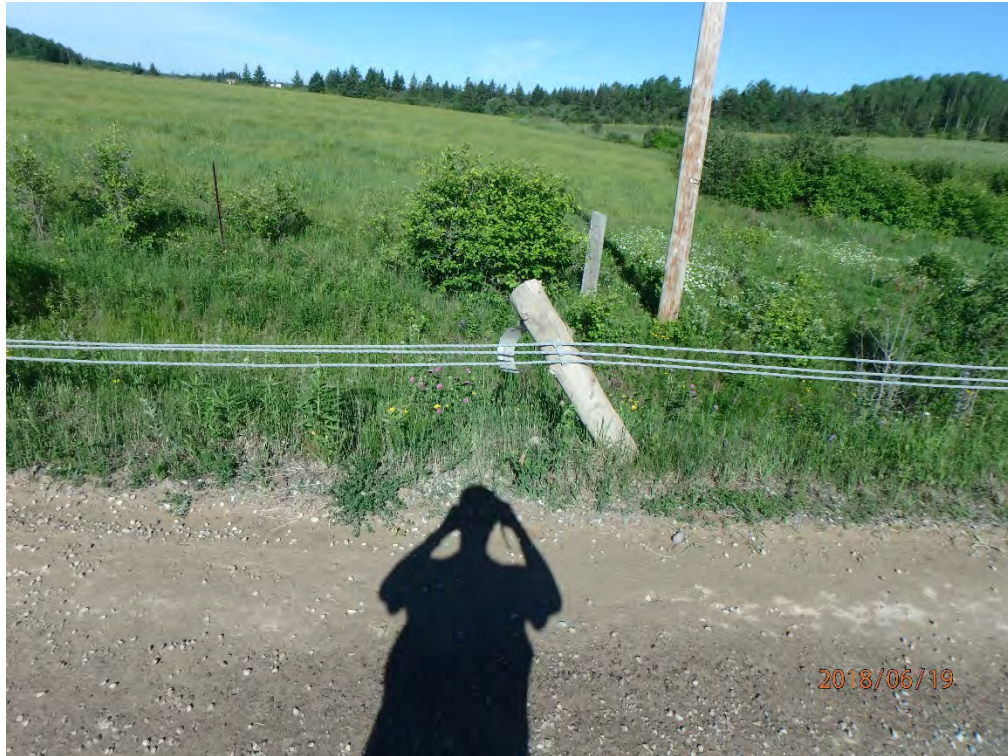
Broken post and slack in the steel guild cables

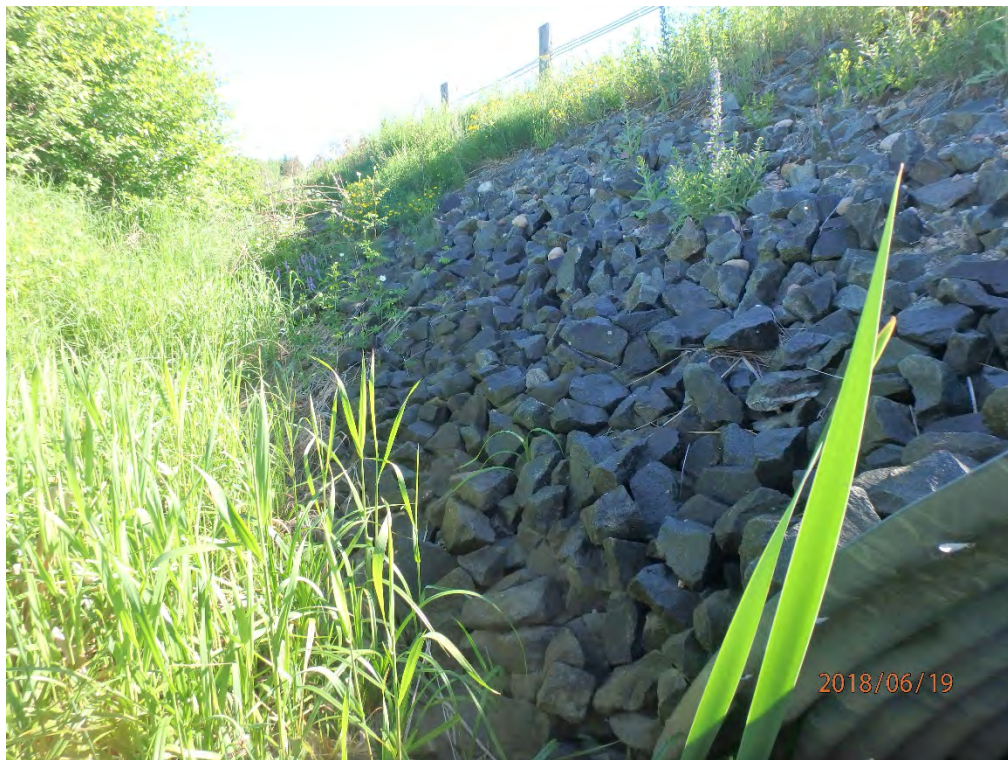
Protected embankment

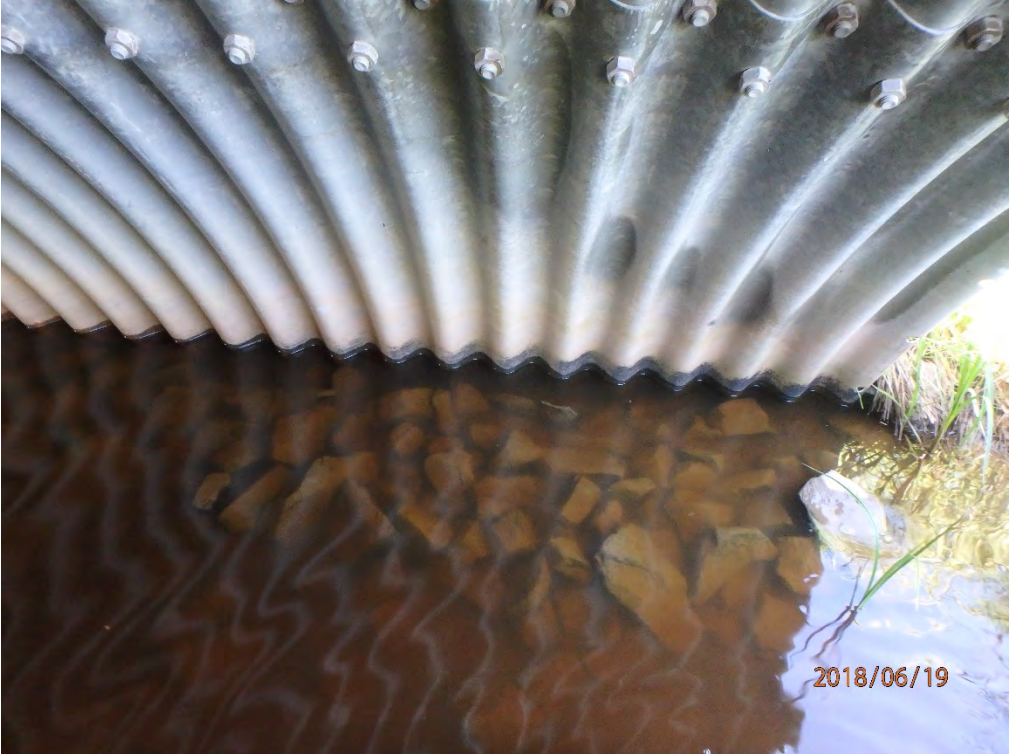
Light staining at waterline

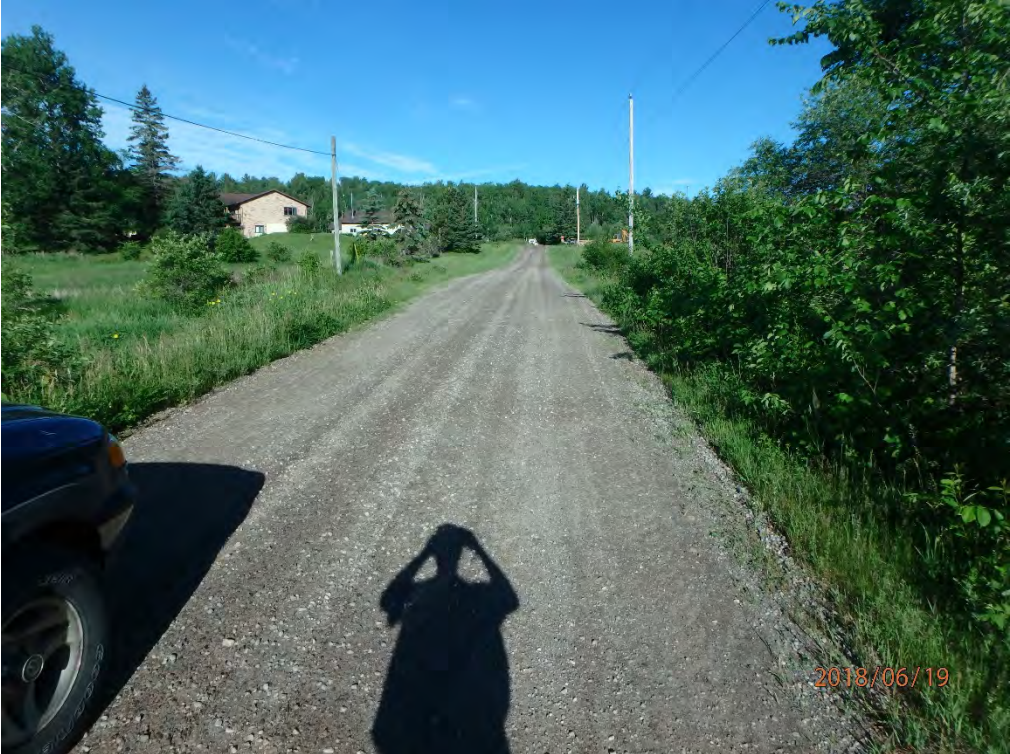
East across the culvert

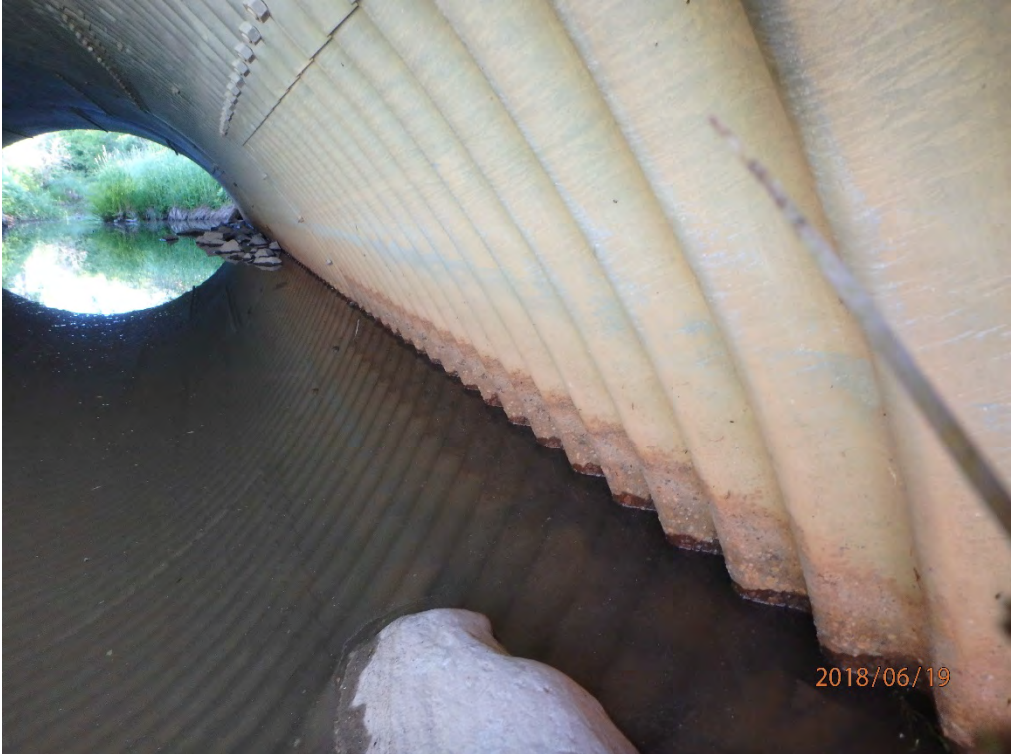
Upstream through the culvert. Minor staining and surface corrosion at just above waterline.
