2018 Biennial Bridge and Culvert Inspection

Township of Johnson

STEM Engineering Group Inc.
875 Queen Street E. Suite 2
Sault Ste. Marie, ON
P6A 2B3

July 27, 2018

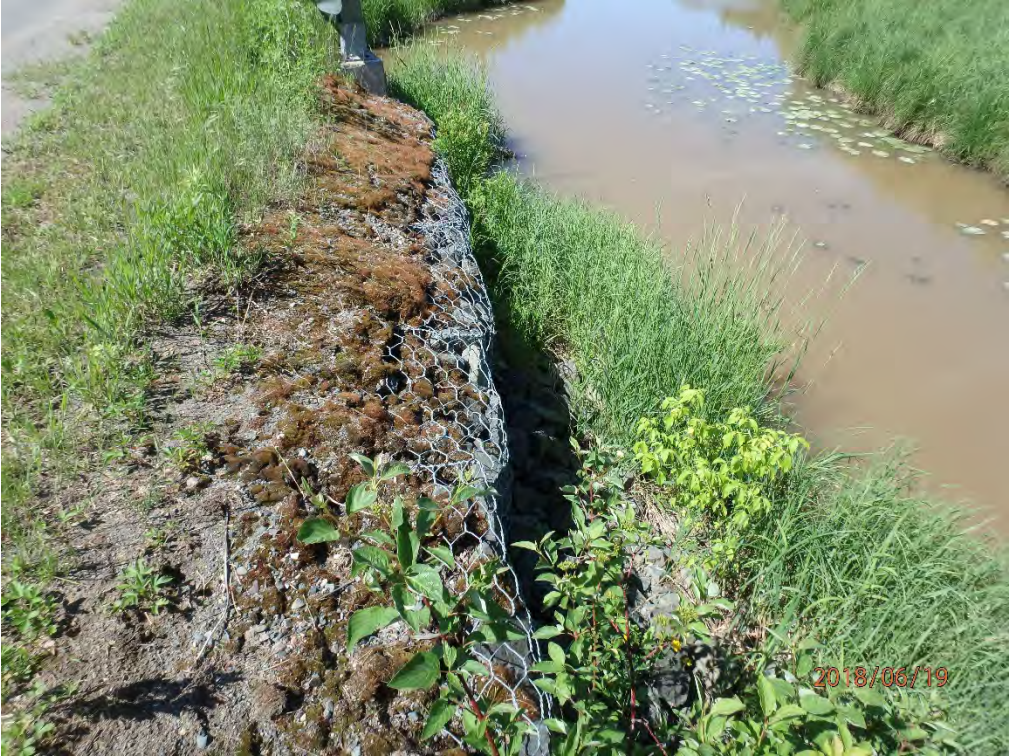
Gabion along the northwest approach

- Guard should be installed along the northwest approach
- All hazard markers should be cleared of vegetation and implemented as part of the regular maintenance.
- Repair to the settled shoulder of the road along the northwest gabion should be complete

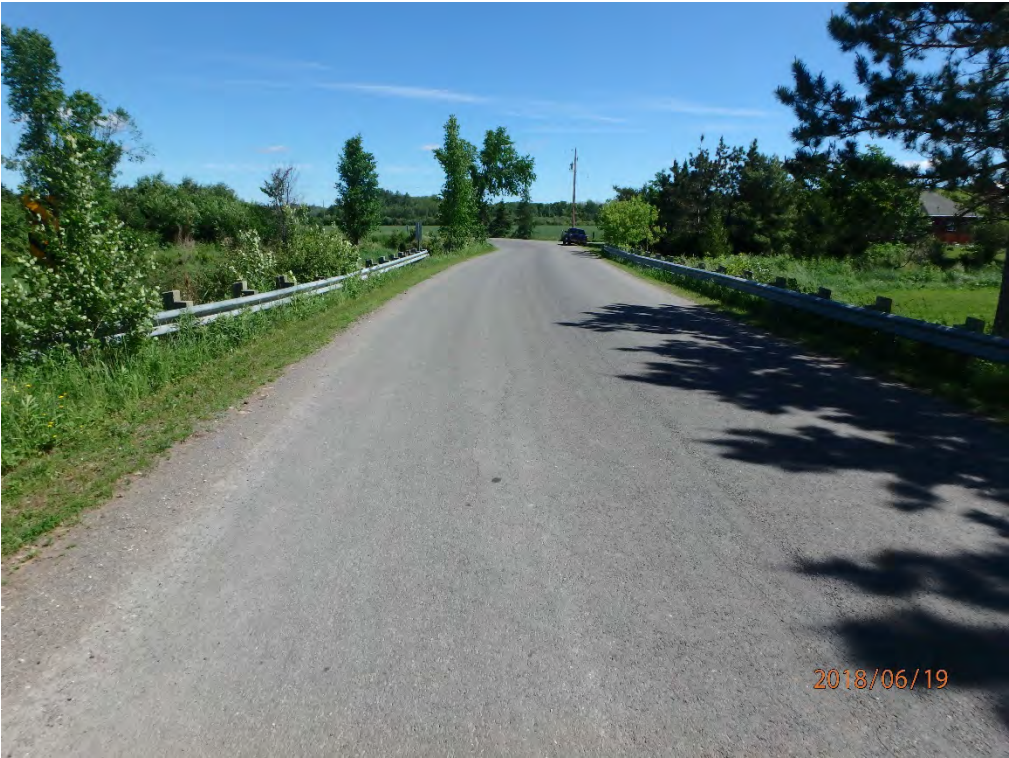
Hazard marker obstructed by vegetation

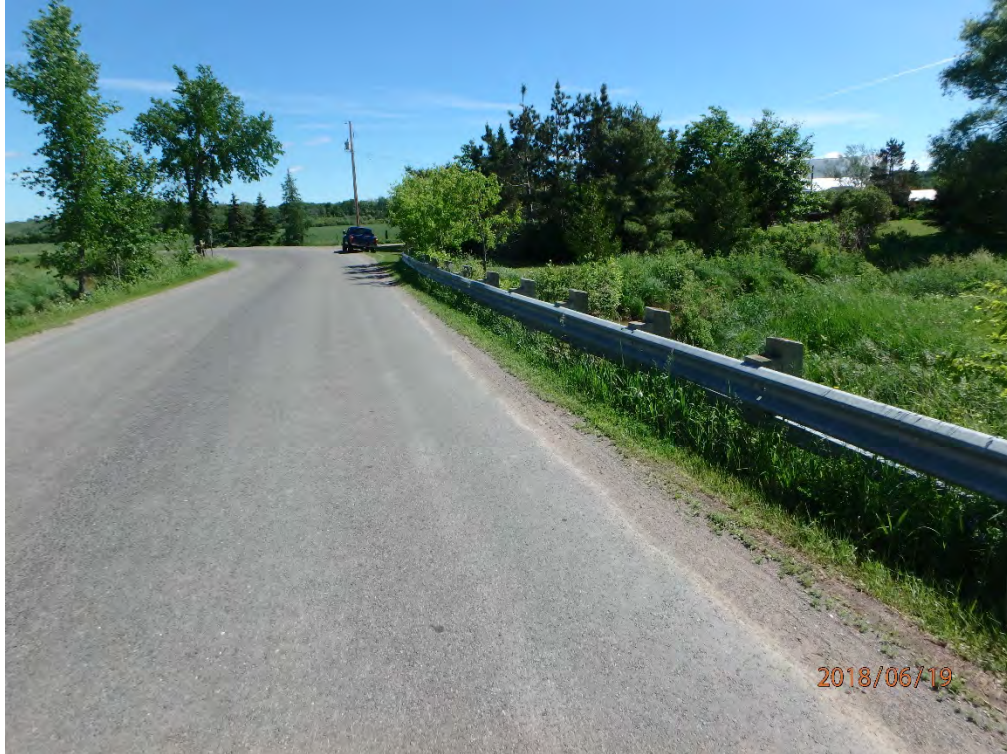
Scraped Guiderail along east side

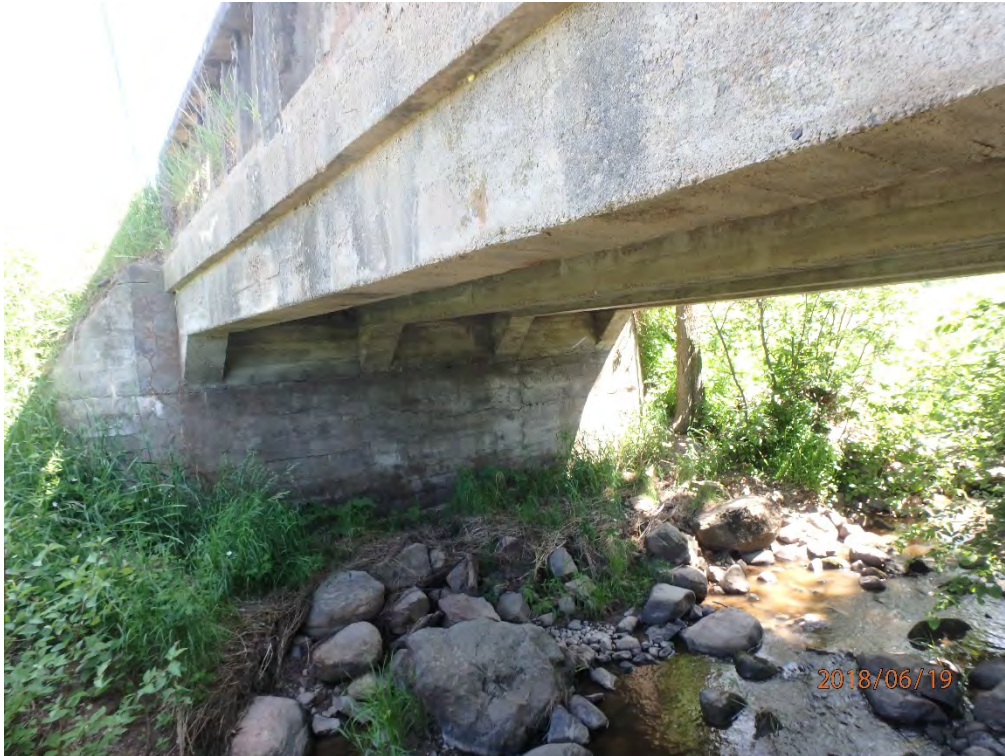
- Concrete abutment walls have moderate to wide horizontal cracks, scaling, and narrow to medium map cracking with efflorescent staining and delamination throughout. The north abutment wall has horizontal cracking at the cold joint and at the shear connection. It was noted that the north abutment wall was poured right at the edge of the abutment footing. The south abutment wall has horizontal cracks at the cold joints, the mid span and one at the beam elevation.

North abutment wall with narrow to wide horizontal cracks, map cracking and delamination.

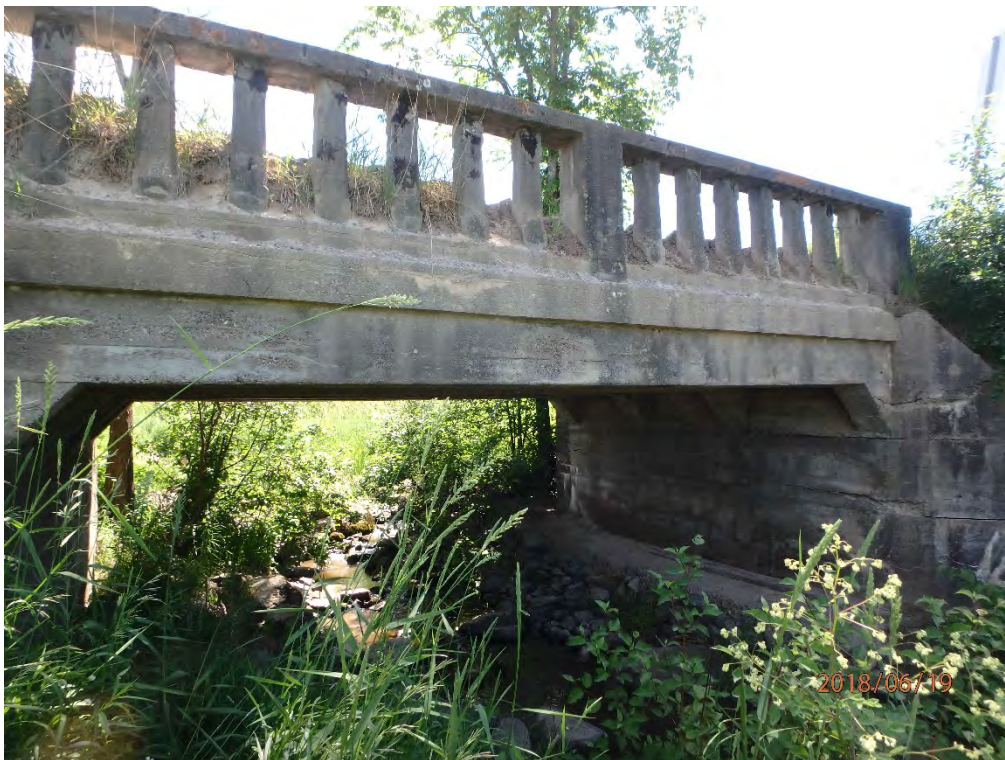
South abutment wall with narrow to wide horizontal cracks, map cracking and delamination.

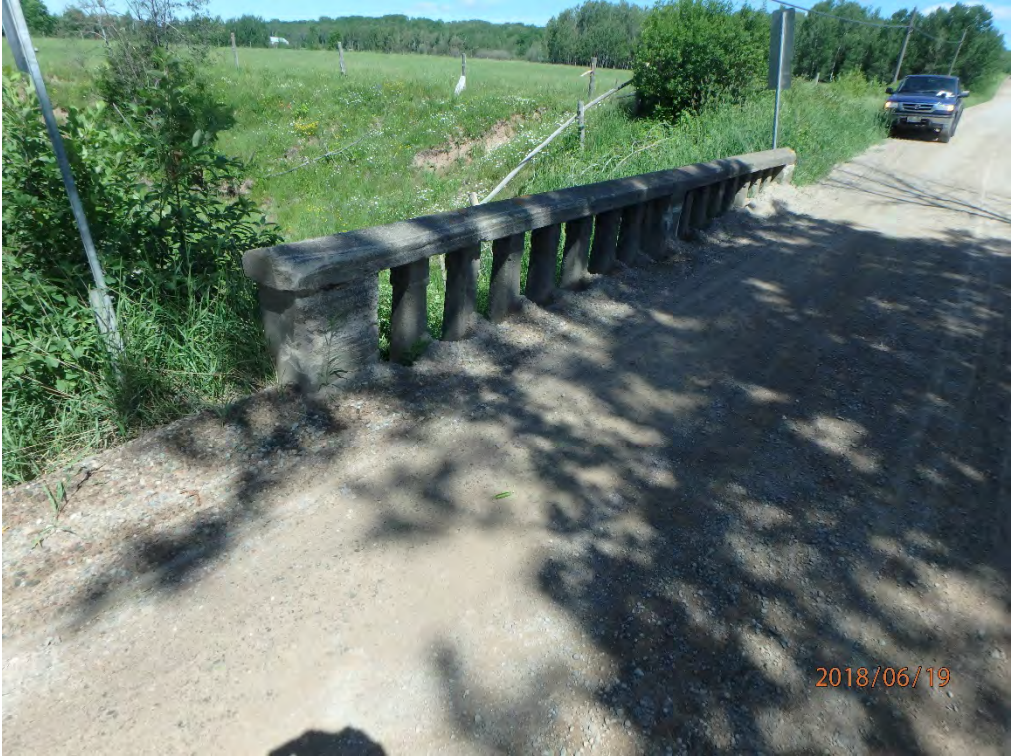
- Gravel approaches and deck wearing surface are generally in good condition.
- Buildup of gravel under the concrete railings along the bridge deck.
- Four cored holes in concrete deck are present for drainage but are covered by the buildup of gravel on the bridge deck.

Damage to guard due to impact and buildup of gravel below guard

- Structure does not require posting with a load limit.
- The excess gravel build up on the bridge deck should be removed and the deck drain holes should be unplugged as part of regular maintenance.
- Should rehabilitate deck soffit, T-beams, abutments and wingwalls.
- Should install traffic protection on the approaches.
- Any leaning or bent hazard signs should be straightened.

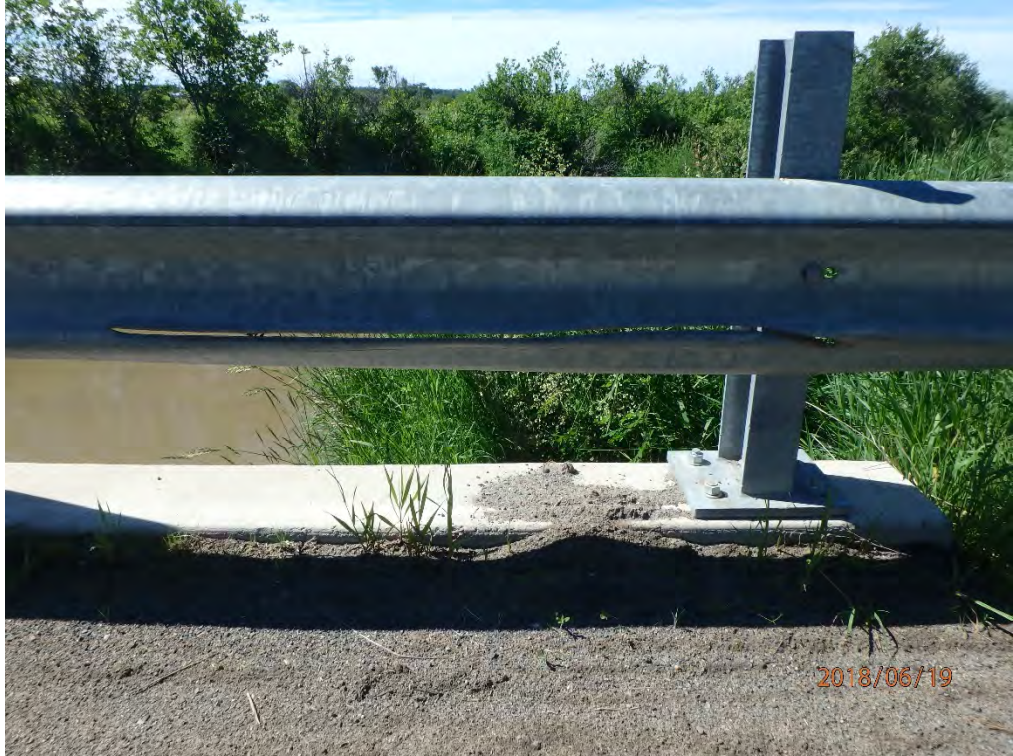
- Gravel and vegetation buildup along the bridge deck under the guiderails.
- Steel flex beam railings on deck are in generally good condition. No offset blocks were present on south guiderails. Offset blocks on the north guiderail, with some rotated and/or broken in half. The west end of the south guardrail has a large cut approximately 2.0 m long.

Damaged Guiderail along south side

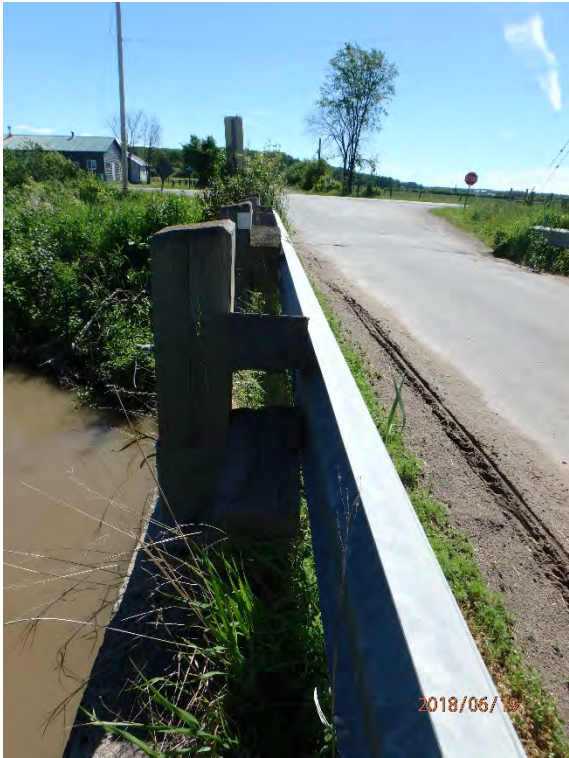
Broken and rotated offset block

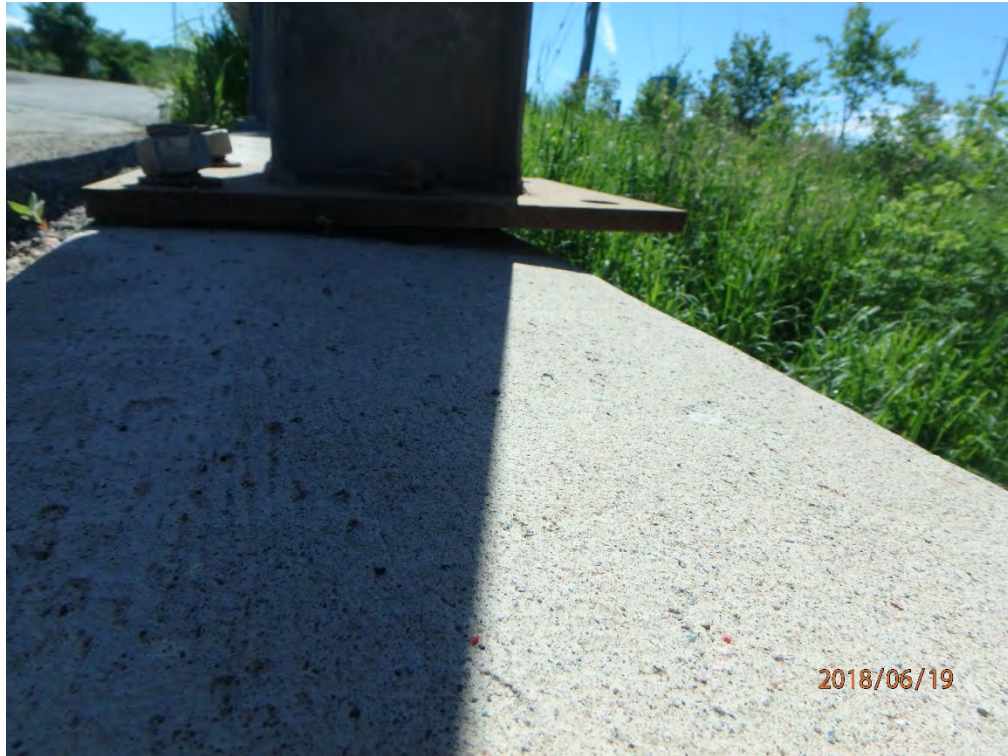
Gap under guiderrail baseplate

- Previous report stated that undermining of abutments was present. Due to the high water level at time of inspection, abutments and footings were not inspected. If not already completed, repairs should be completed.
- Repair offset blocks along north guiderail.
- Replace section of cut guiderail along south side.
- Seal Transverse crack on the east approach.
- Repair minor erosion at the southeast corner of the bridge
- Remove gravel and vegetation from under the guiderails along the bridge deck and around hazard signs.
- Repair guiderail baseplate, including new anchor bolts and shims.

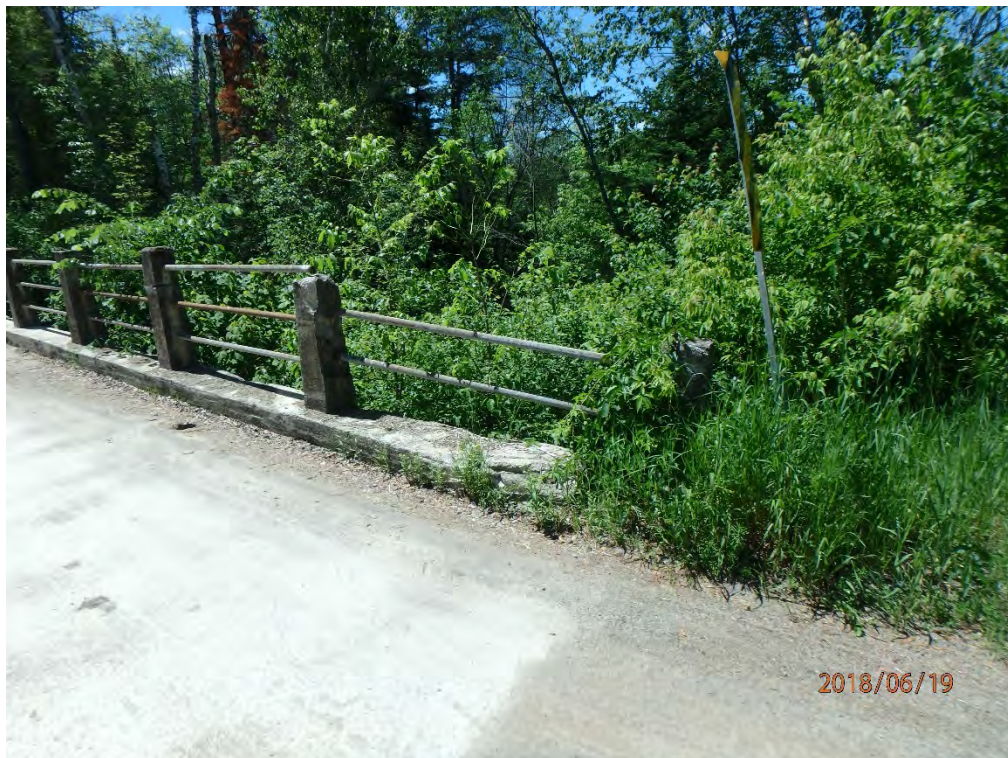
Broken missing railing post. Damaged pipe rails

- Subject to findings of deck condition survey, repairs to concrete beams, soffit, piers, abutments and curbs/railings should be completed and the deck should be rehabilitated with a waterproofing membrane and wearing surface. The rehabilitation of all the concrete components will not increase the load capacity (see below).

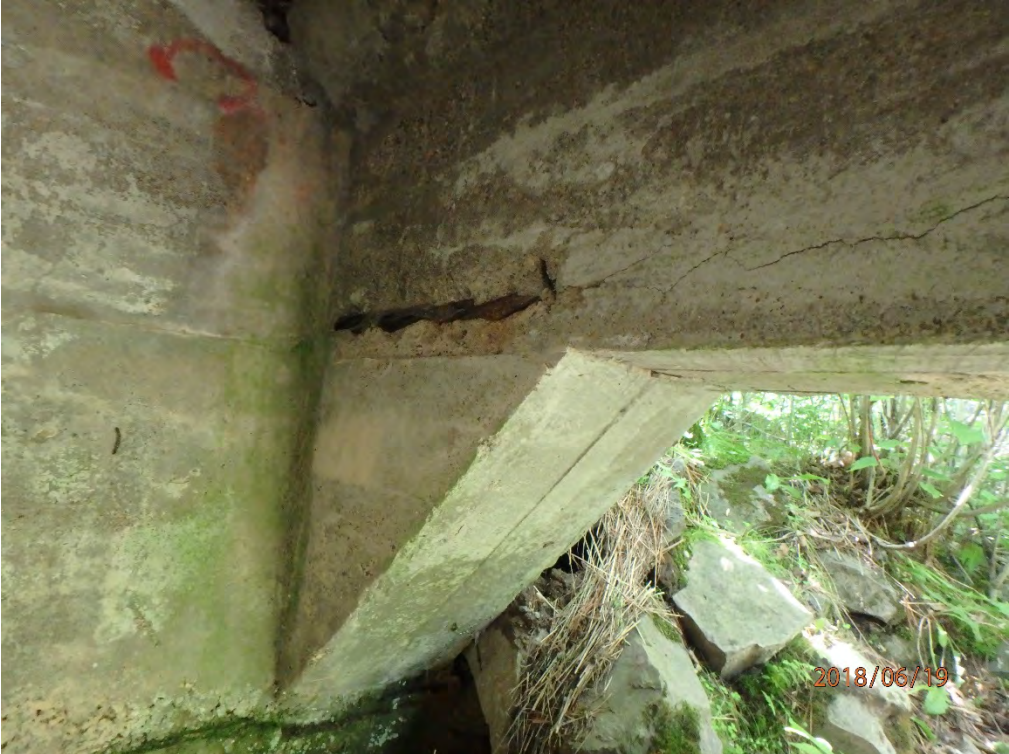
Exposed Rebar on east beam at abutment

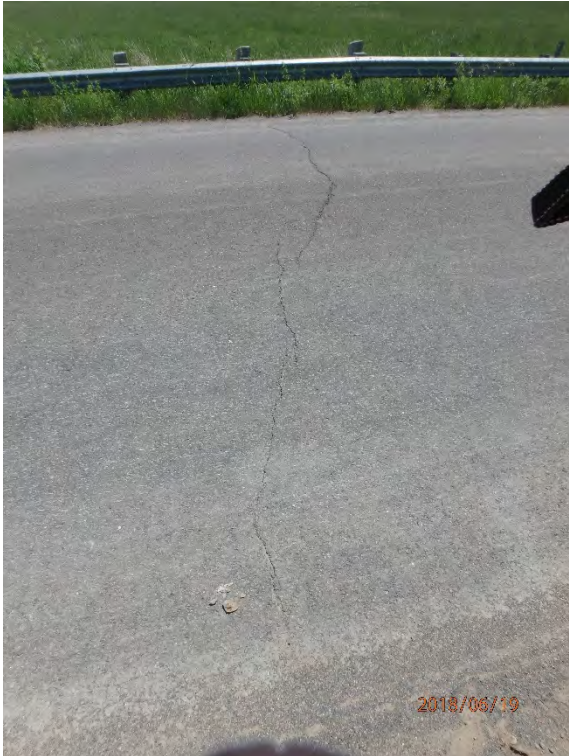
Transverse crack in the wearing surface

- Transverse cracks in the roadway should be monitored. Cracks should be sealed or patched to prevent further damage to wearing surface.
- Install bolts where missing in the guiderail to connect the flex beam to the post.

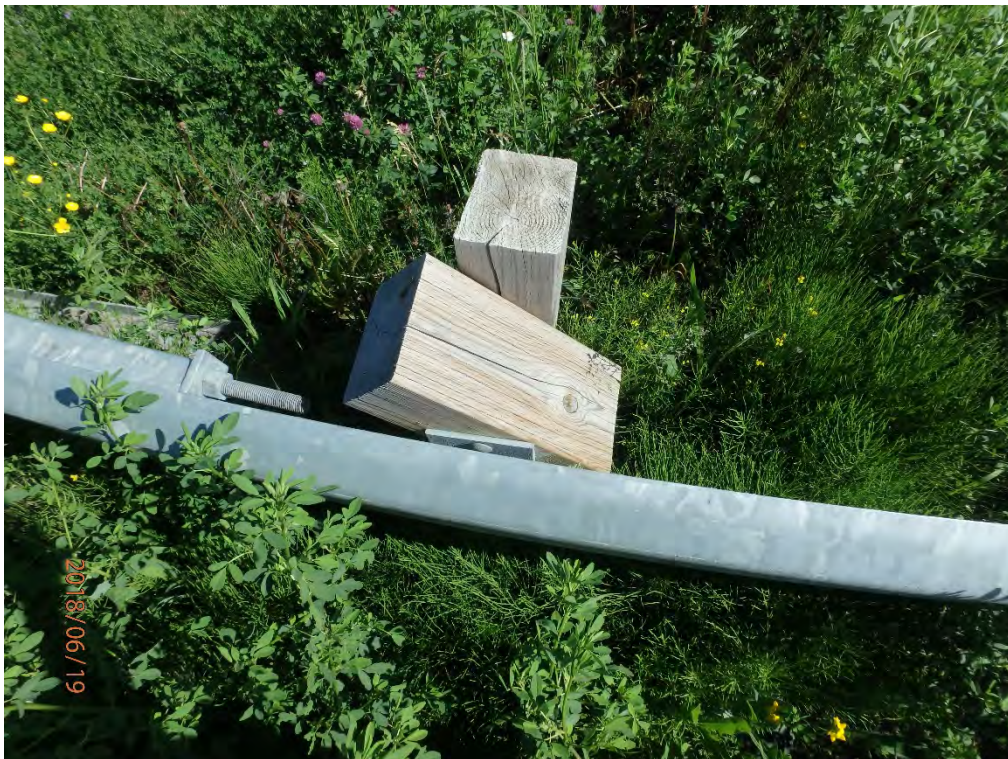
Rotated offset block

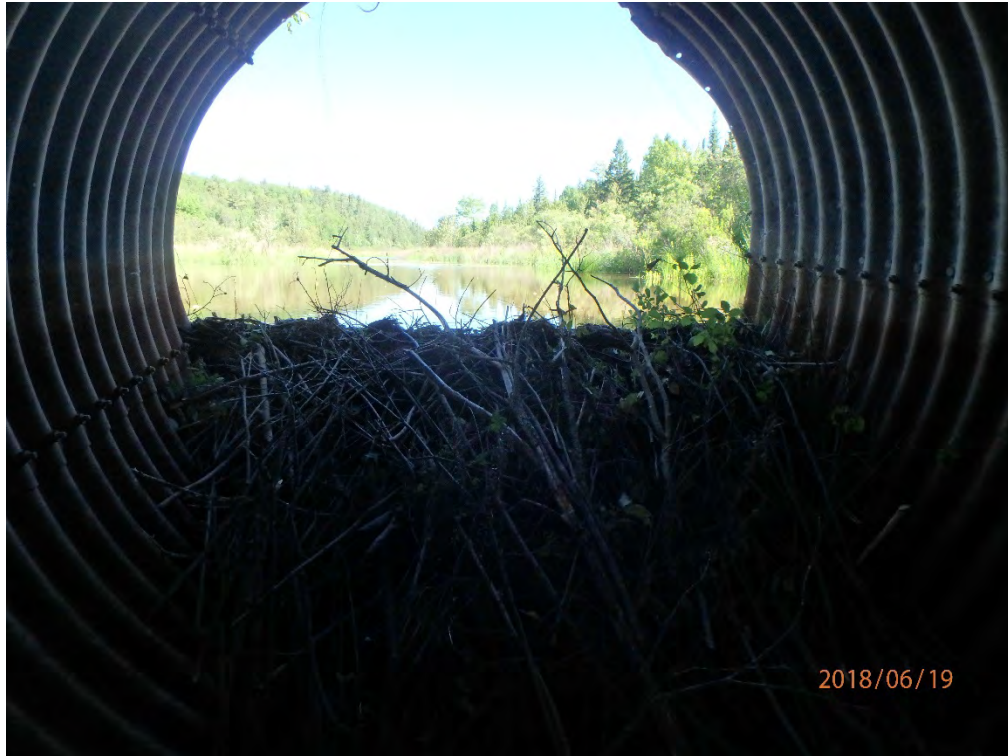
Beaver Dam at the inlet of the culvert

- Structure does not require posting with a load limit.
- Traffic protection should be installed on the approaches and over the structure.
- Beaver dam located at the culvert inlet should be removed
- Erosion on the north embankments and scour under the pipe inlet should be repaired and stabilized/protected to prevent re-occurrence.
- Cracks in surface treatment should be repaired to prevent damage to wearing surface at structure. Patching should also be placed on either side of the culvert to mitigate the depressions.

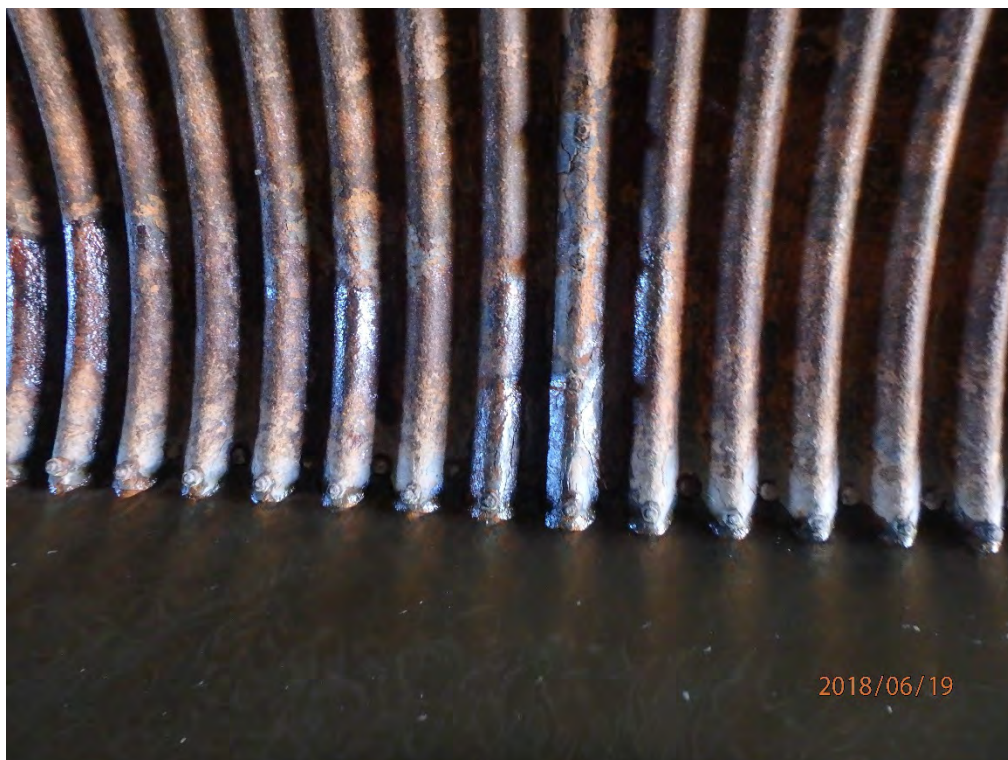
Culvert is rusting and flaking off. Water infiltrating through perforations in metal culvert.

- Replacement of culvert should be budgeted in the next 5 years. Alternative option would be to install a liner in the culvert barrel. A culvert hydraulic study would be required to confirm suitability of installing a liner (this alternative was not costed).

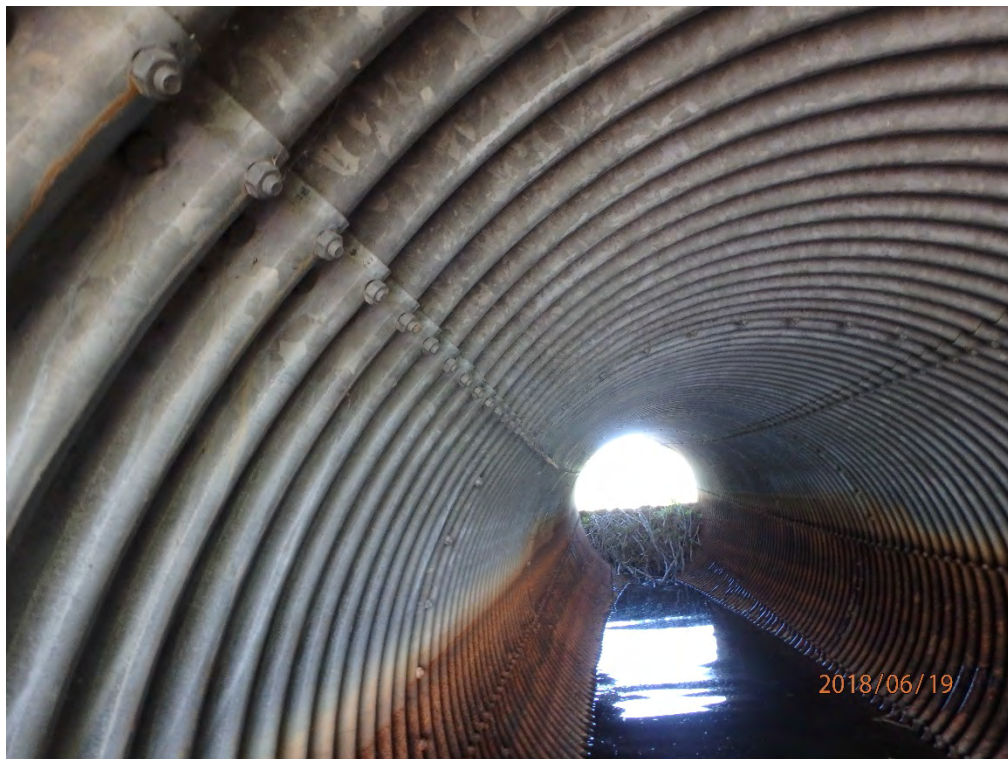
North through the culvert, sag along its length.

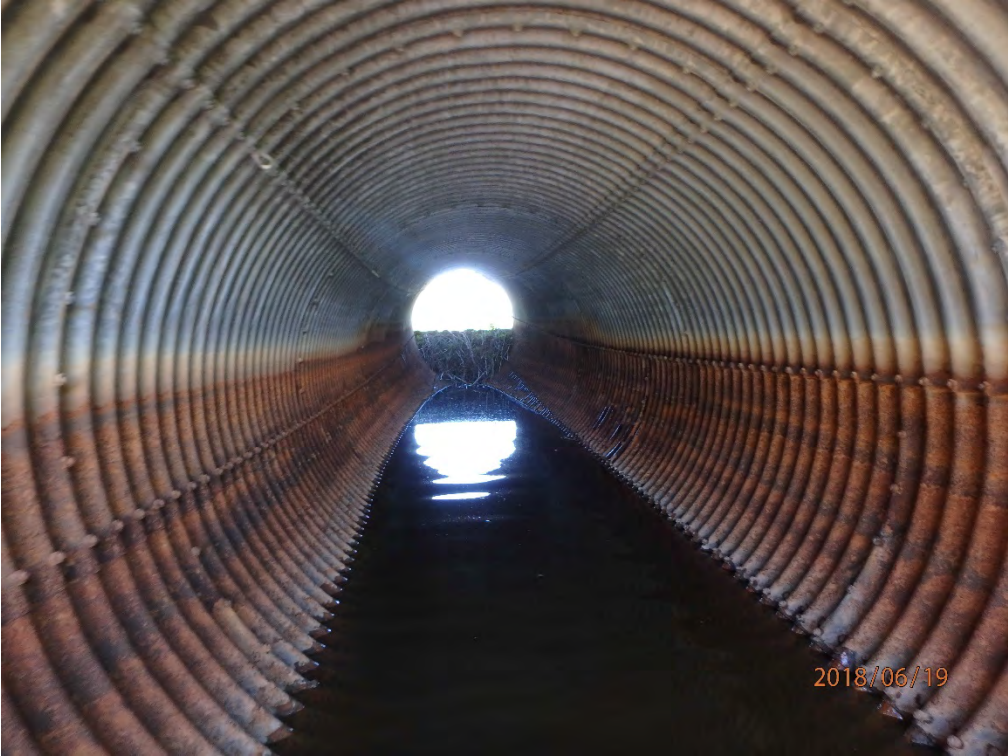
North through the culvert, sag along its length.

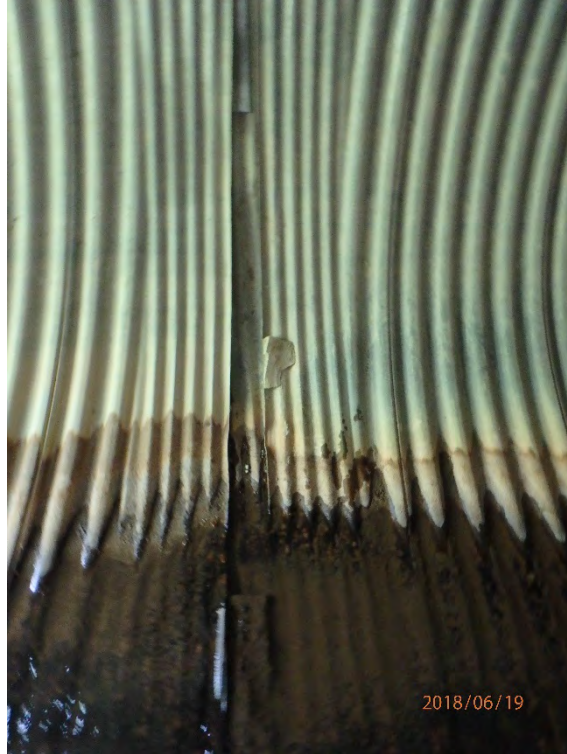
Parging missing at joint, typical.

- Structure does not require posting with a load limit.
- Traffic protection should be installed at the approaches and across the structure
- The missing parging and opened seams should be repaired and maintained to prevent water from travelling under the culvert, including repairs at each end of the culvert.
- Monitor indentation of culvert barrel at centerline of roadway/culvert barrel.
- Expected replacement of culvert should be budgeted for the next 6-10 years. Alternative option would be to install a liner in the culvert barrel. A culvert hydraulic study would be required to confirm suitability of installing a liner.

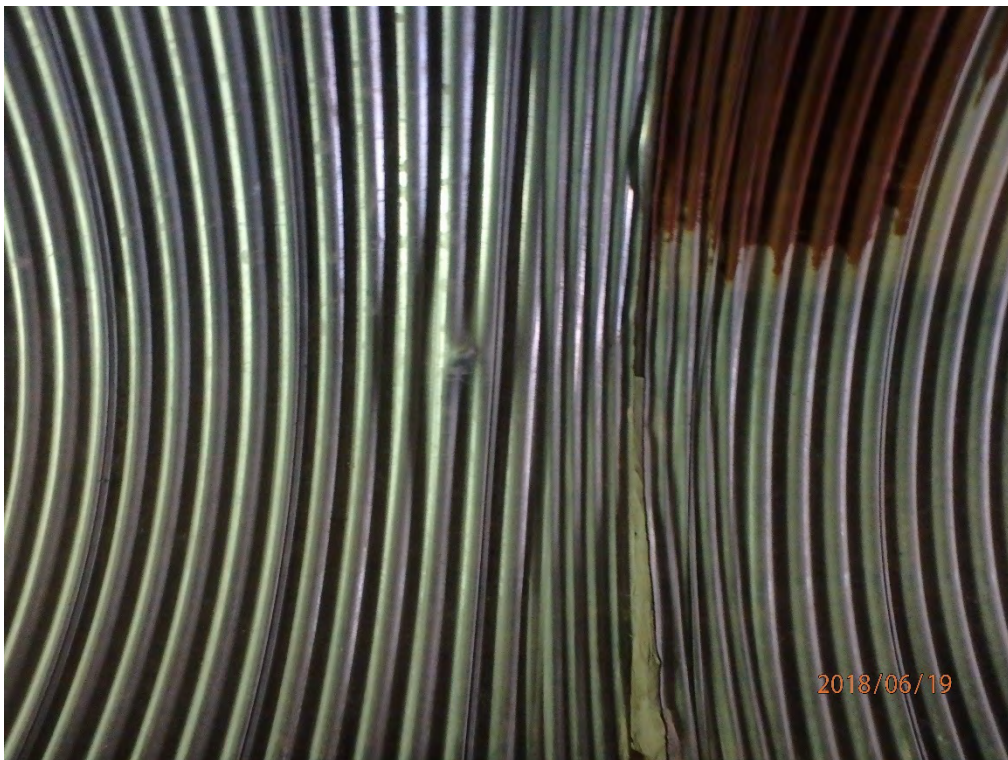
Indentation on the east wall of culvert

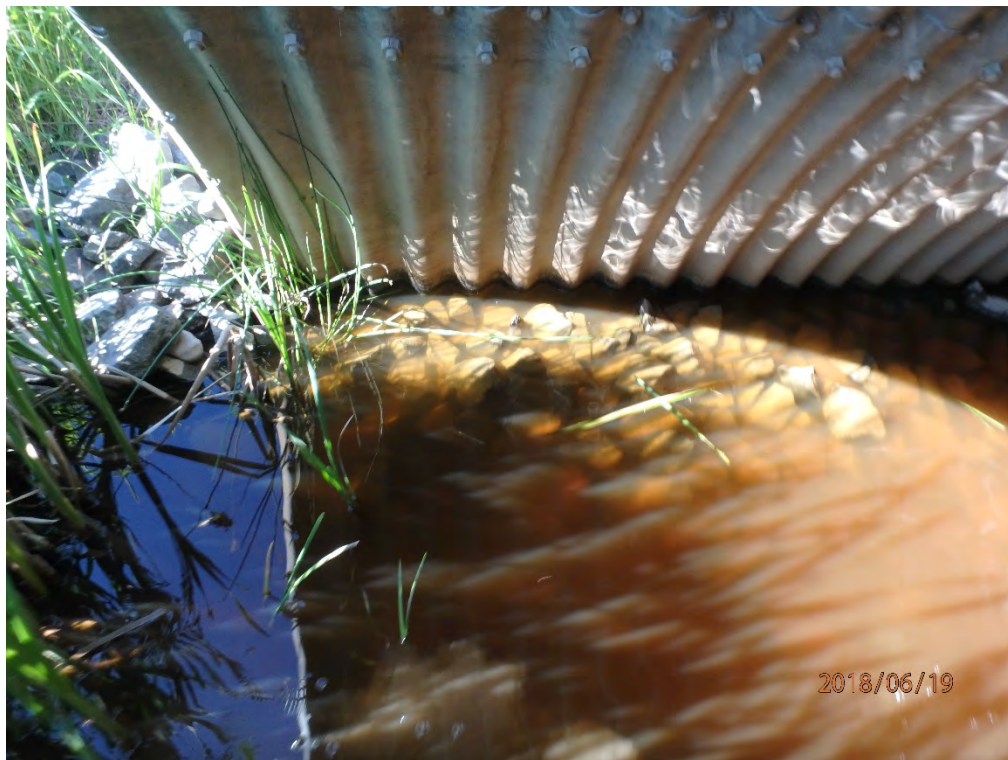
Loss of rock armor at inlet

- Structure does not require posting with a load limit.
- Guiderail cables and posts must be repaired and maintained. The guiderail posts should be checked seasonally for broken or decayed posts.
- Lost armoring stone at the culvert inlet should be replaced to protect the walls of the structure.

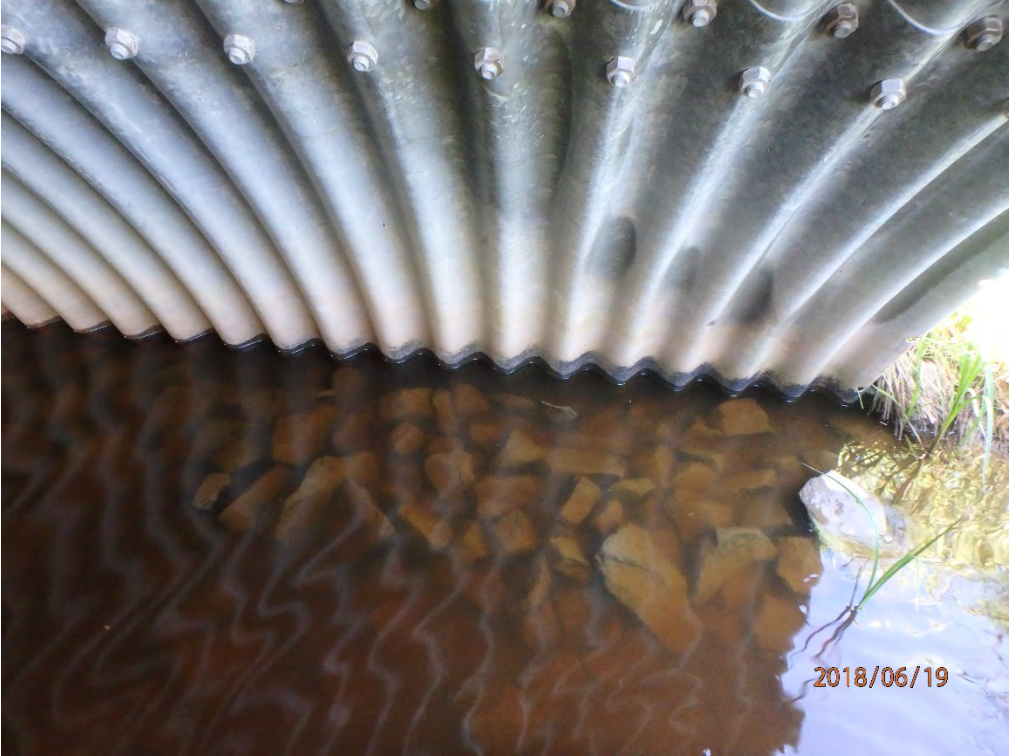
Light staining at waterline

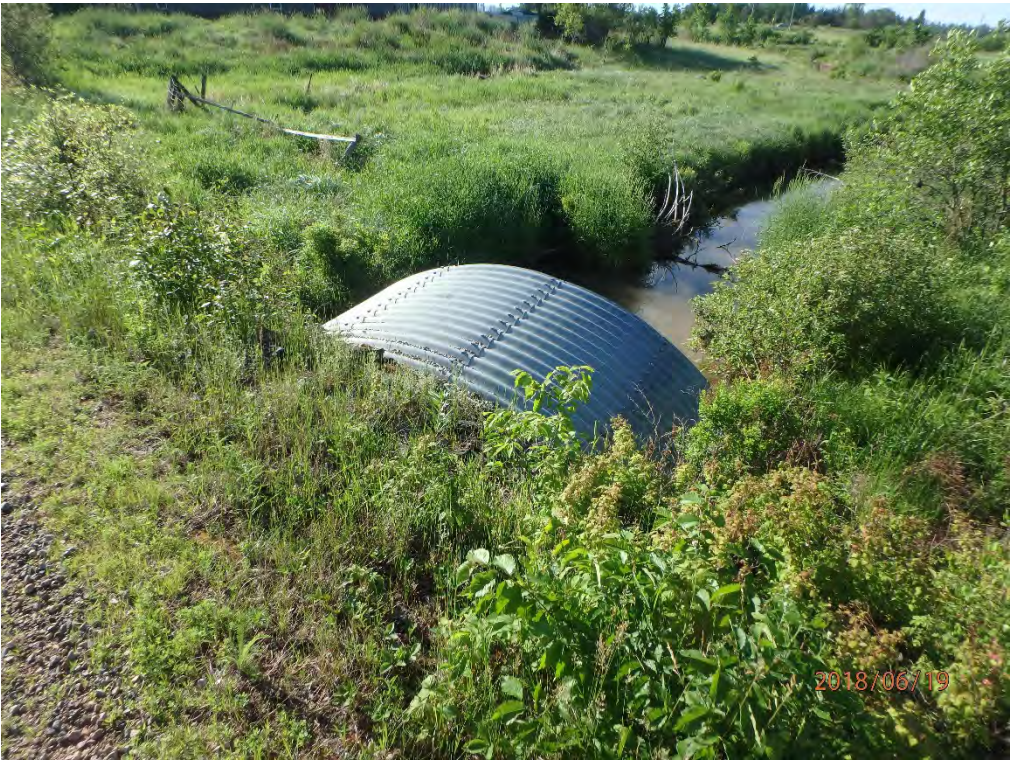
Downstream of culvert. Page wire fence across the creek.

- Structure does not require posting with a load limit.
- Regularly remove any debris caught on page wire fencing
- Provide traffic protection at approaches and across culvert
