**2016 BIENNIAL MUNICIPAL BRIDGE
& CULVERT INSPECTIONS**

16-1055
August 3, 2016

Regarding: Township of Johnson - 2016 Biennial Bridge & Culvert Inspections

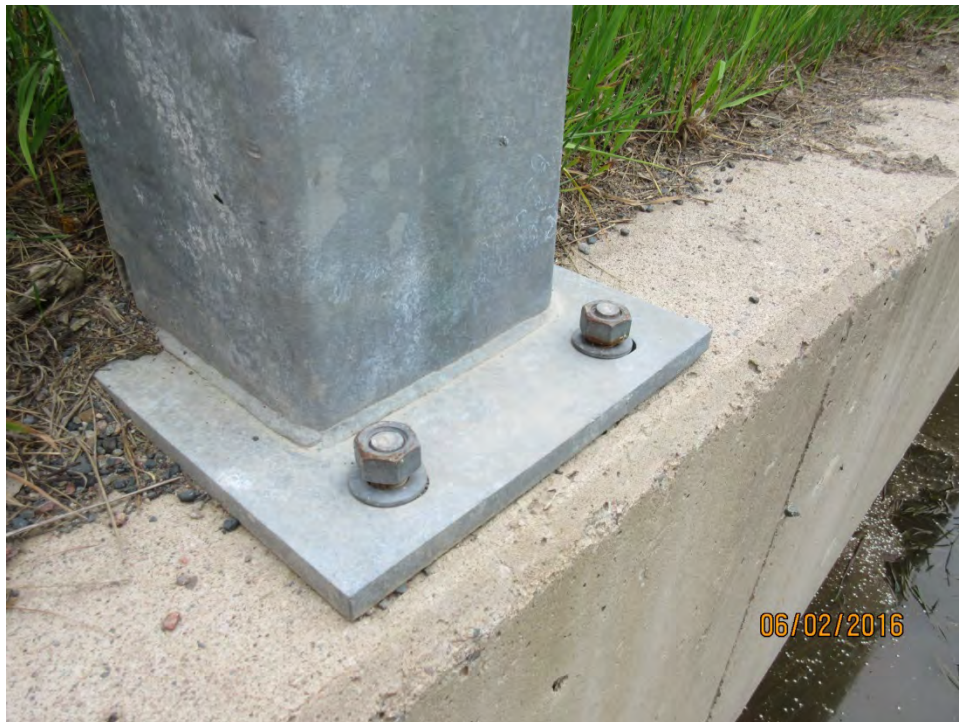
LOOSE NUTS ON BASEPLATE OF EAST GUIDERAIL POST

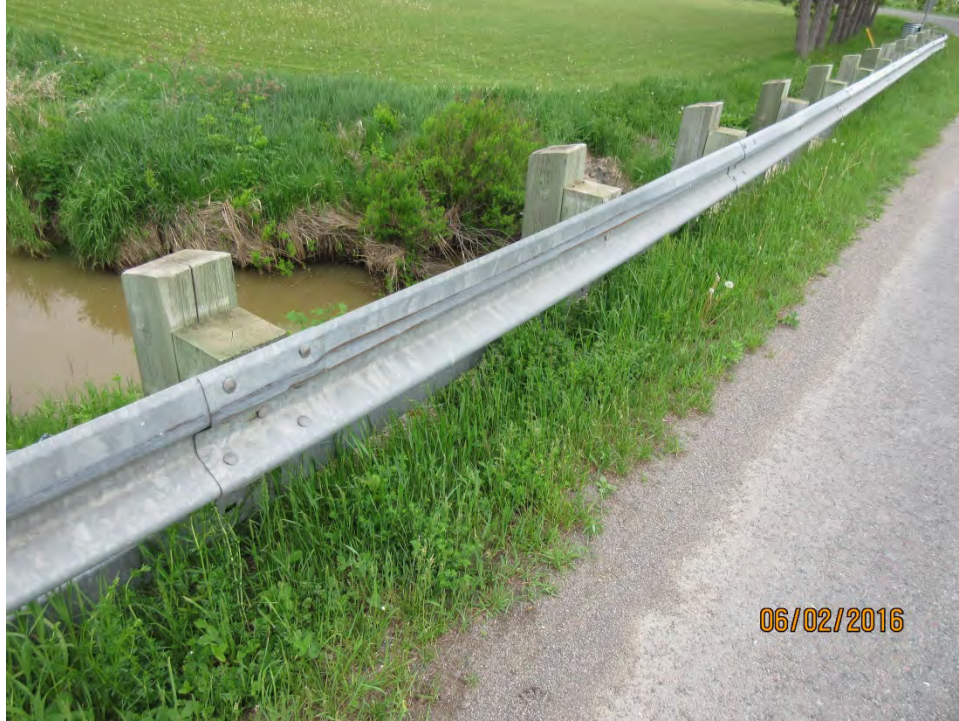
SCRAPE DAMAGE TO EAST GUIDERAIL

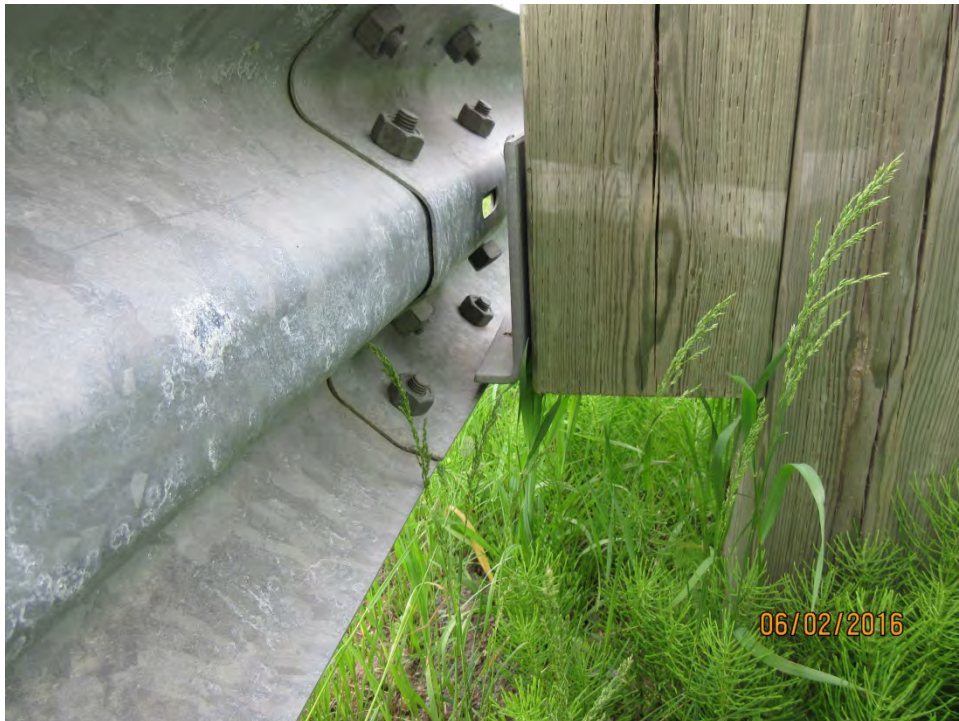
**MEDIUM TO WIDE SPLITS AND CHECKS IN APPROACH
POSTS AND OFFSET BLOCKS**

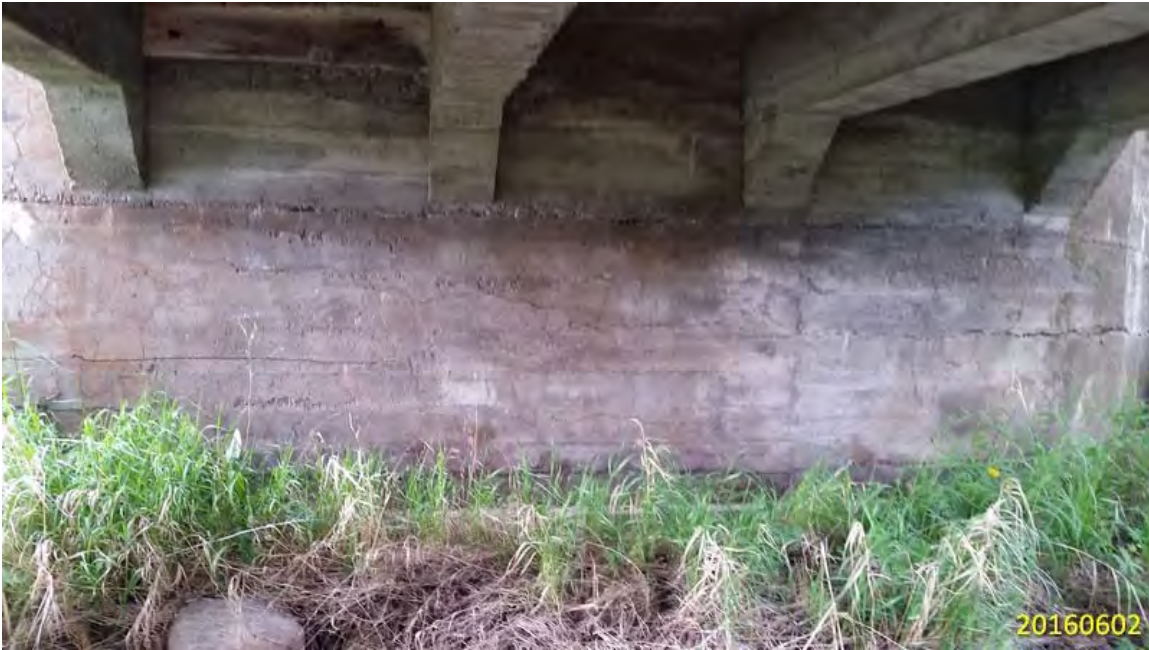
NORTH ABUTMENT WALL – NARROW TO MEDIUM MAP CRACKING, NARROW TO WIDE HORIZONTAL CRACKING AND DELAMINATIONS

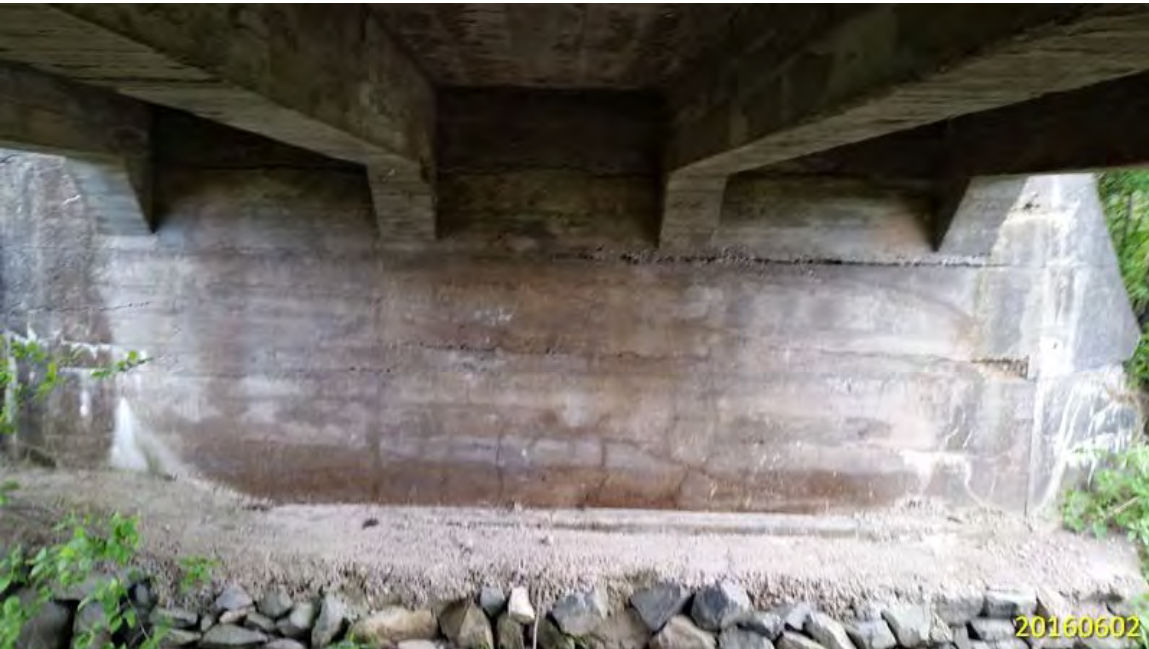
SOUTH ABUTMENT WALL – NARROW TO MEDIUM MAP CRACKING, NARROW TO WIDE HORIZONTAL CRACKING AND DELAMINATIONS

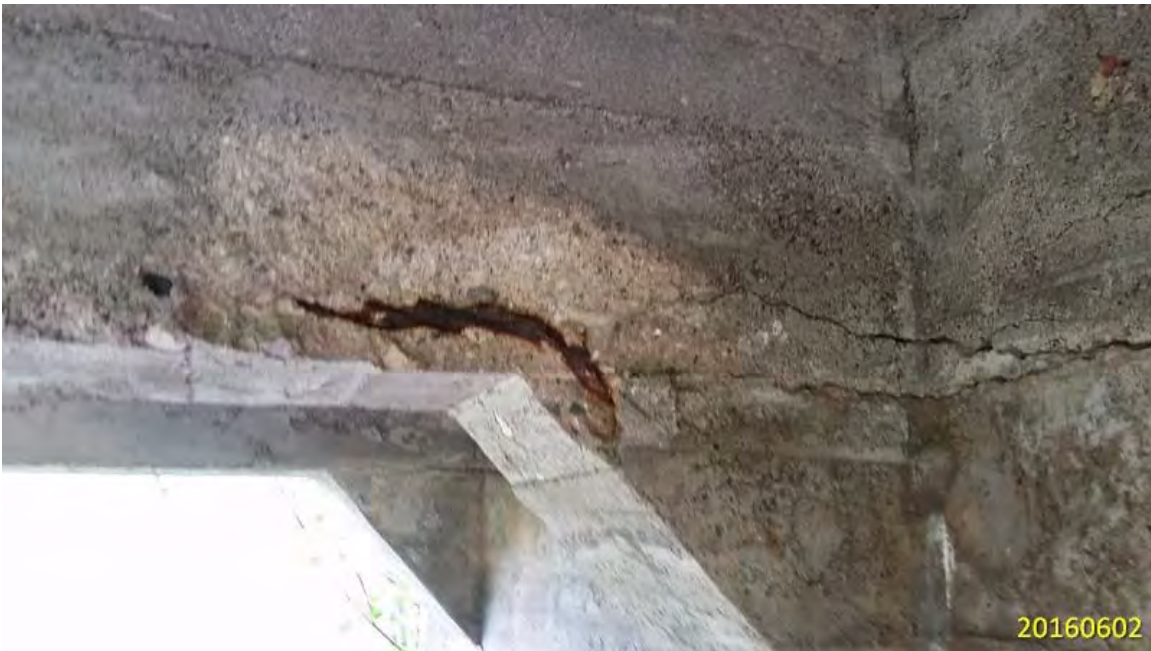
EXPOSED CORRODED REBAR IN SOUTHEAST INTERIOR BEAM

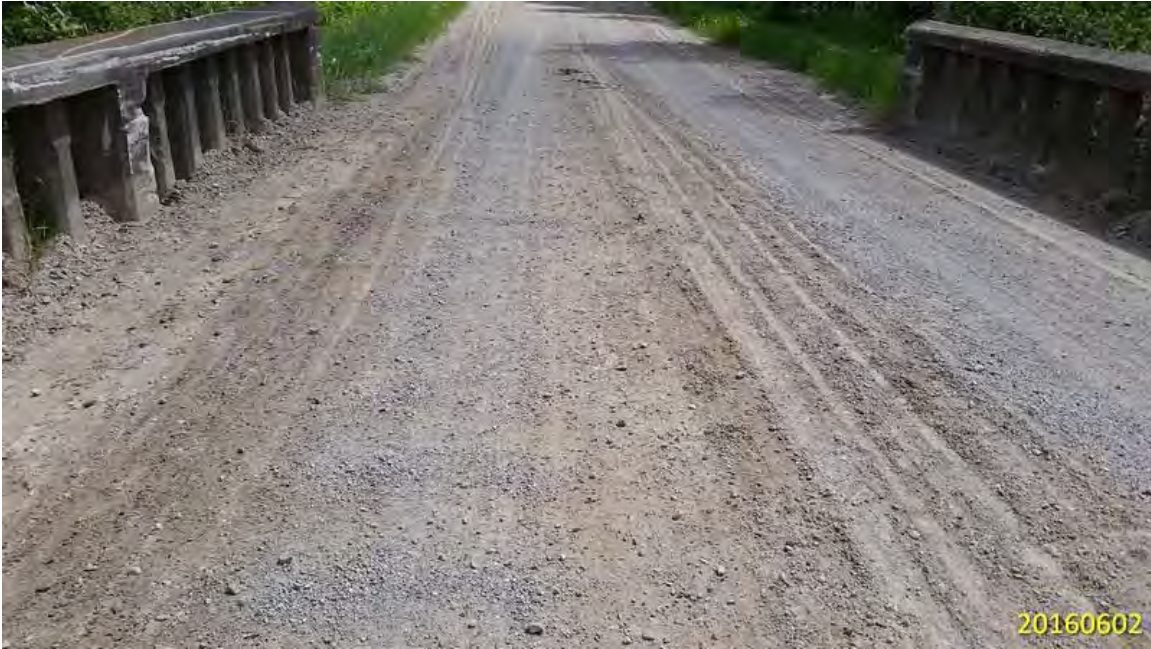
GRAVEL WEARING SURFACE – BUILDUP OF GRAVEL ON BRIDGE DECK AND LIGHT WASHBOARD

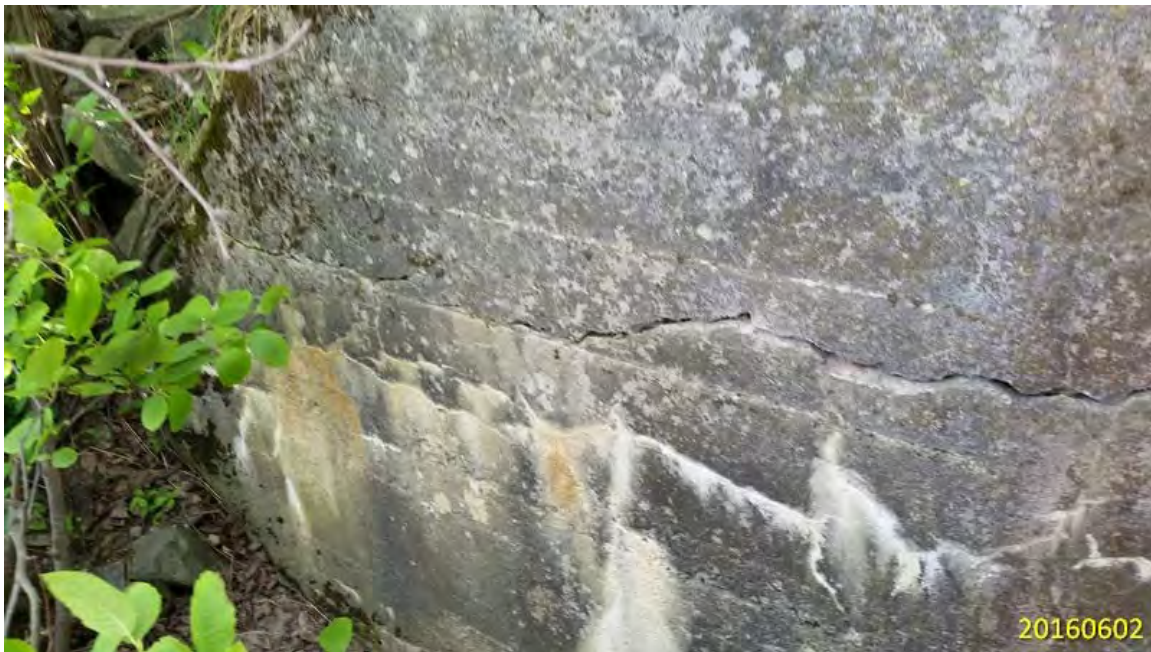
SOUTHEAST WINGWALL – NARROW TO MEDIUM MAP CRACKING AND WIDE HORIZONTAL CRACK

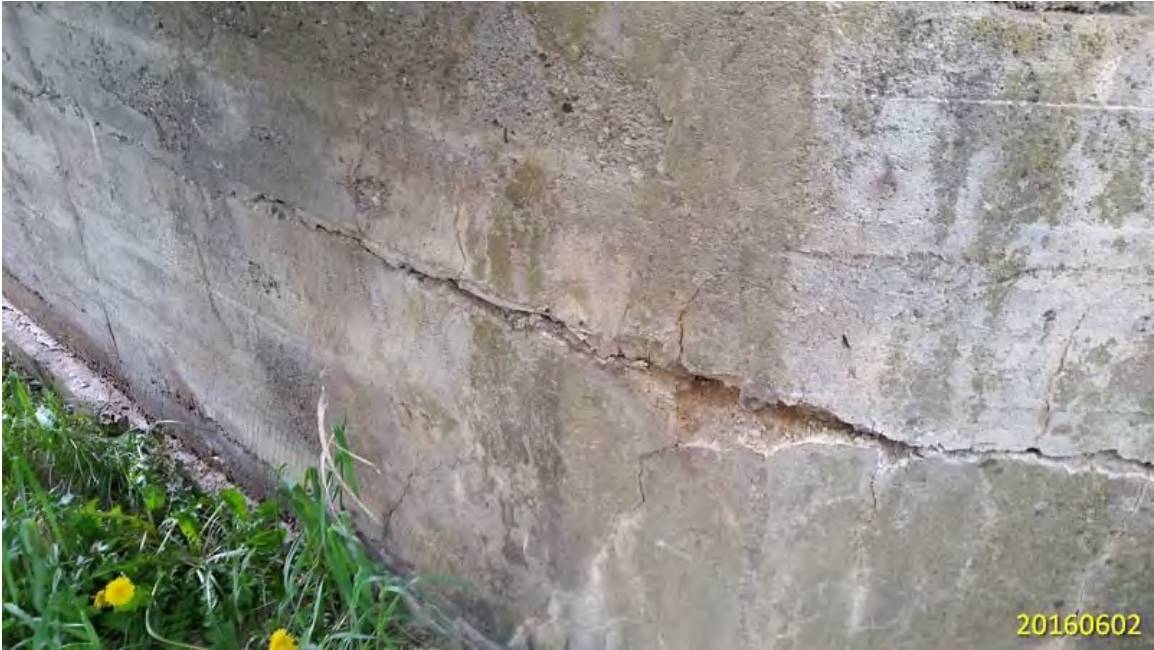
NORTH ABUTMENT AND NORTHEAST WINGWALL - LOCALIZED SPALL WITH DELAMINATIONS

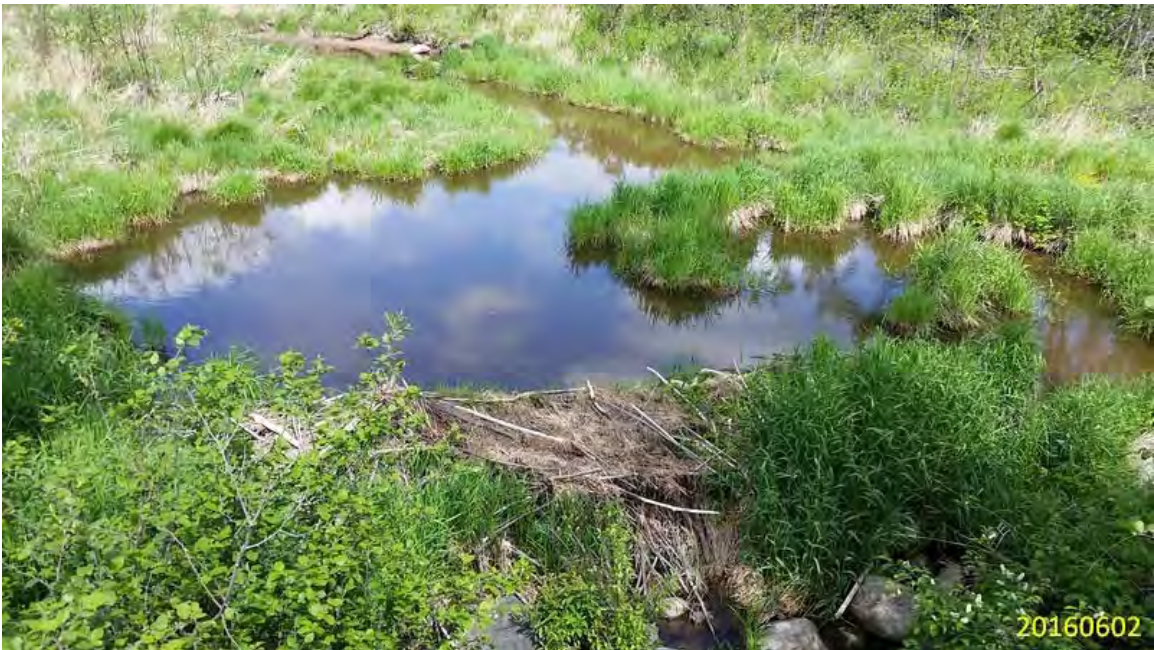
BEAVER DAM UPSTREAM FROM BRIDGE

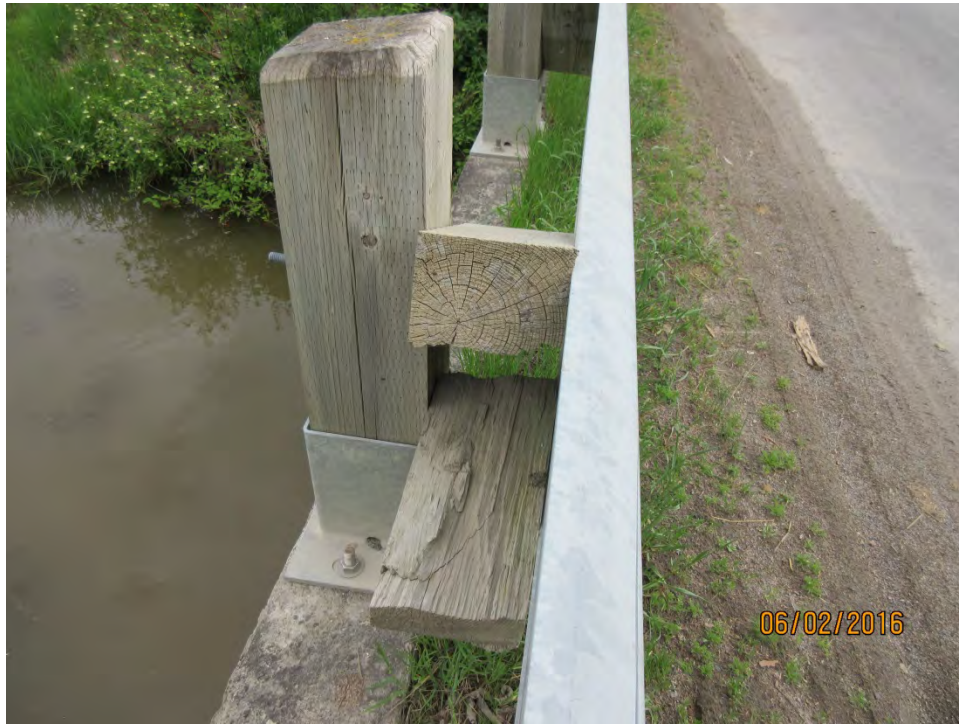
ROTATED AND SPLIT OFFSET BLOCK – NORTH GUARDRAIL

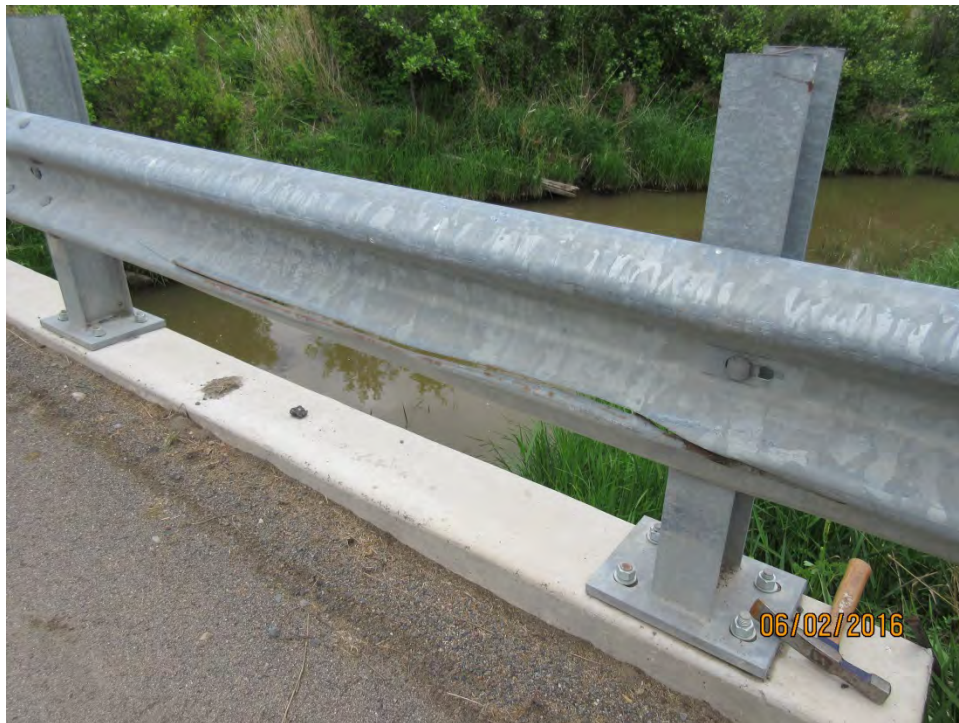
LARGE CUT IN THE SOUTHWEST GUIDERAIL

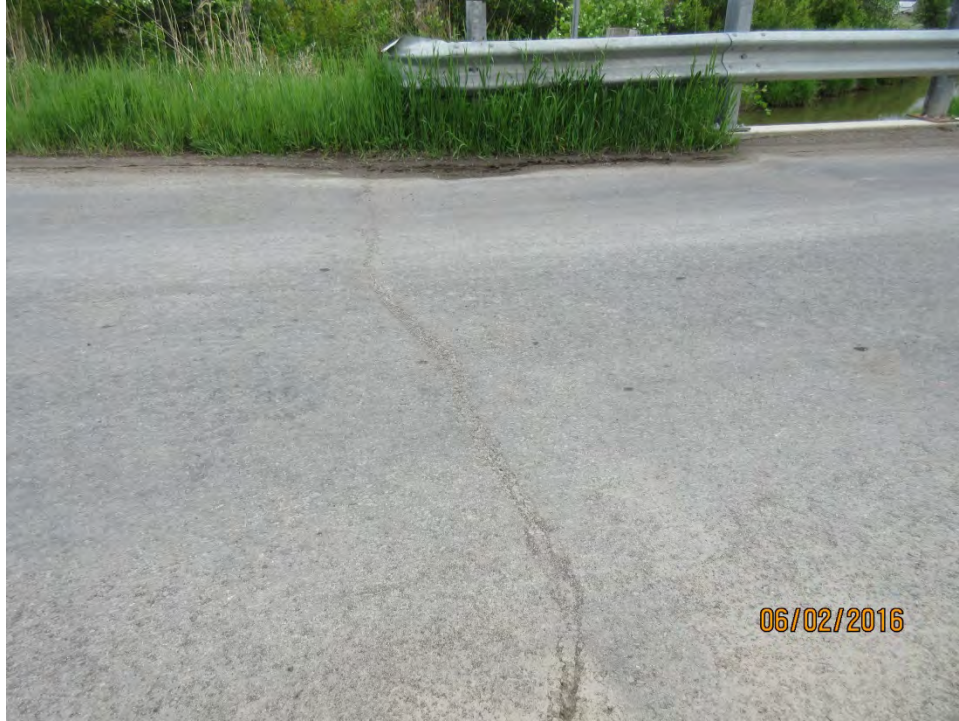
MODERATE TO WIDE TRANSVERSE CRACK IN EAST APPROACH

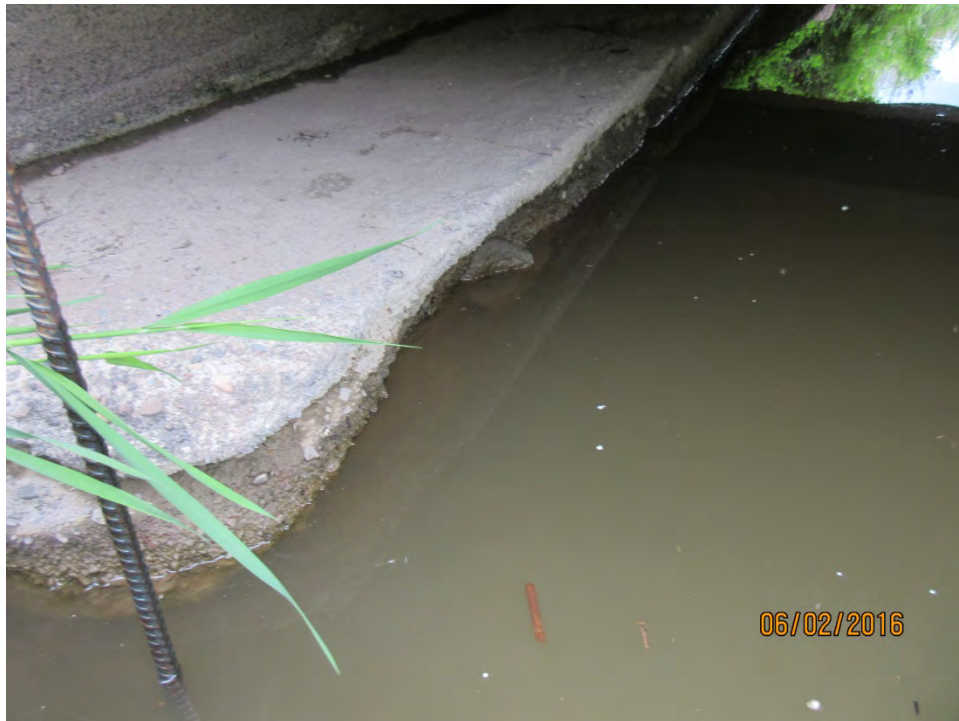
CONCRETE EROSION AND LARGE SPALL IN FOOTING

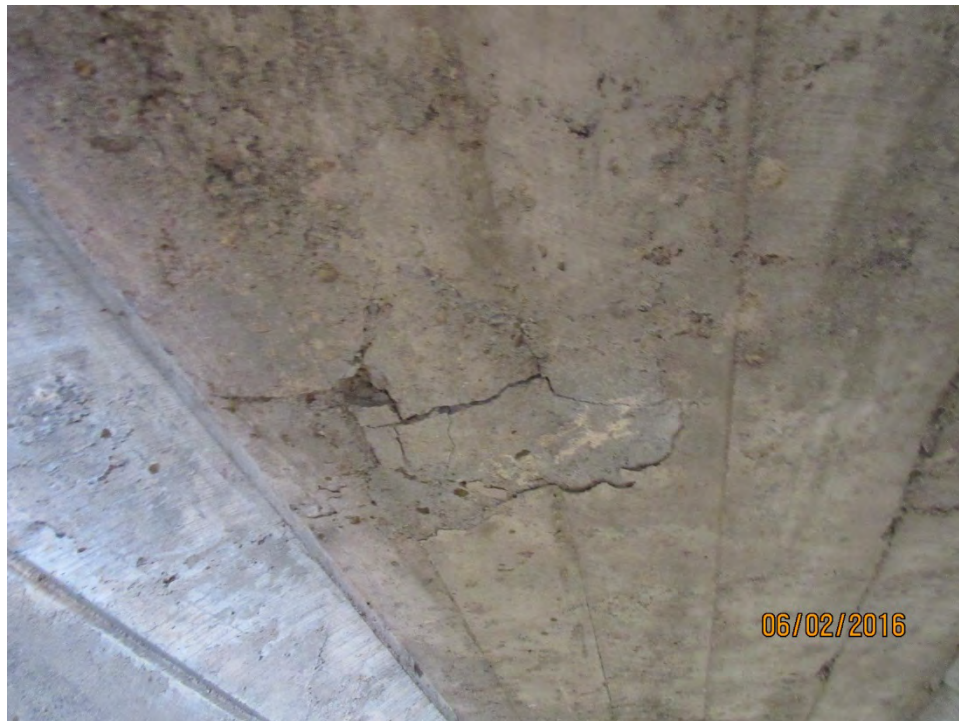
**LOCALIZED MEDIUM TO WIDE CRACKING OF INTERIOR DECK SOFFIT
AT THE EAST ABUTMENT**

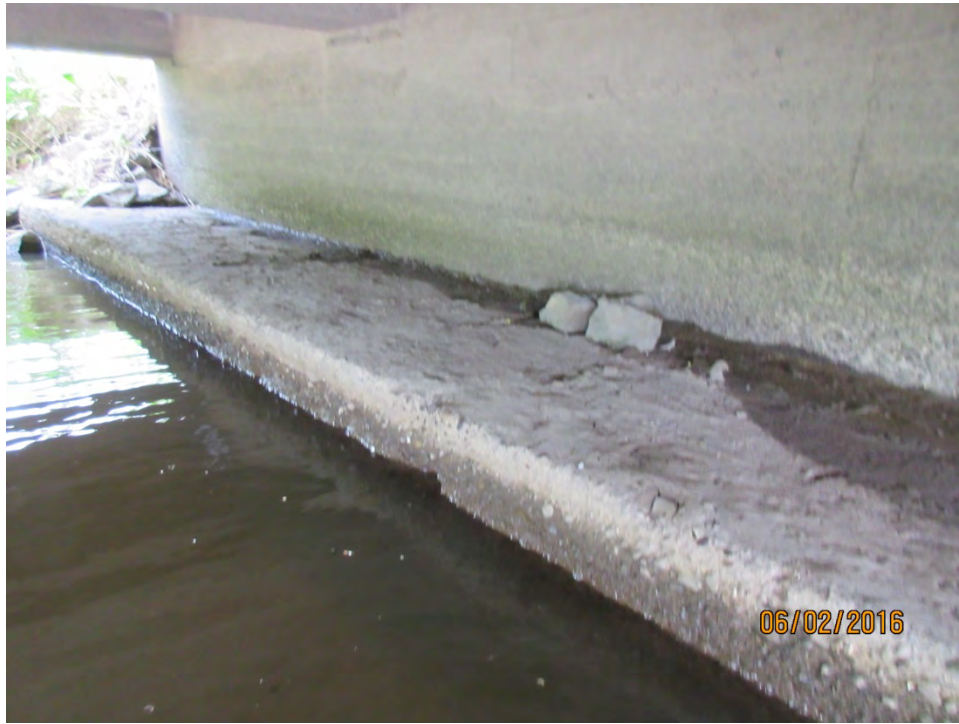
EAST ABUTMENT WALL AND FOOTING – EROSION OF CONCRETE FOOTING

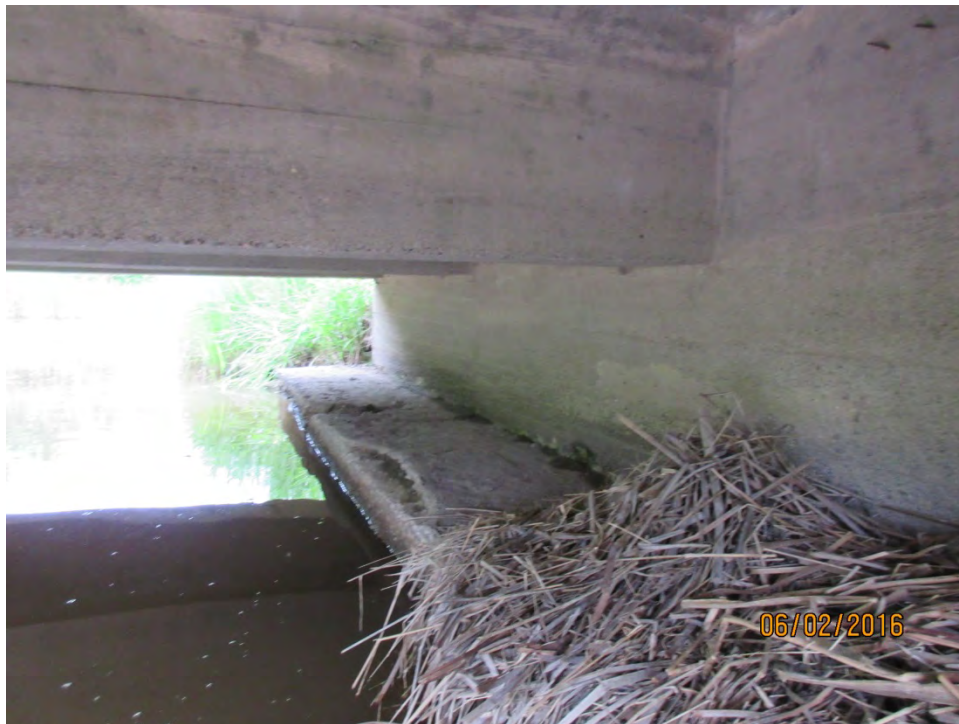
WEST ABUTMENT WALL AND FOOTING – SEVERE DELAMINATION OF TOP OF FOOTING

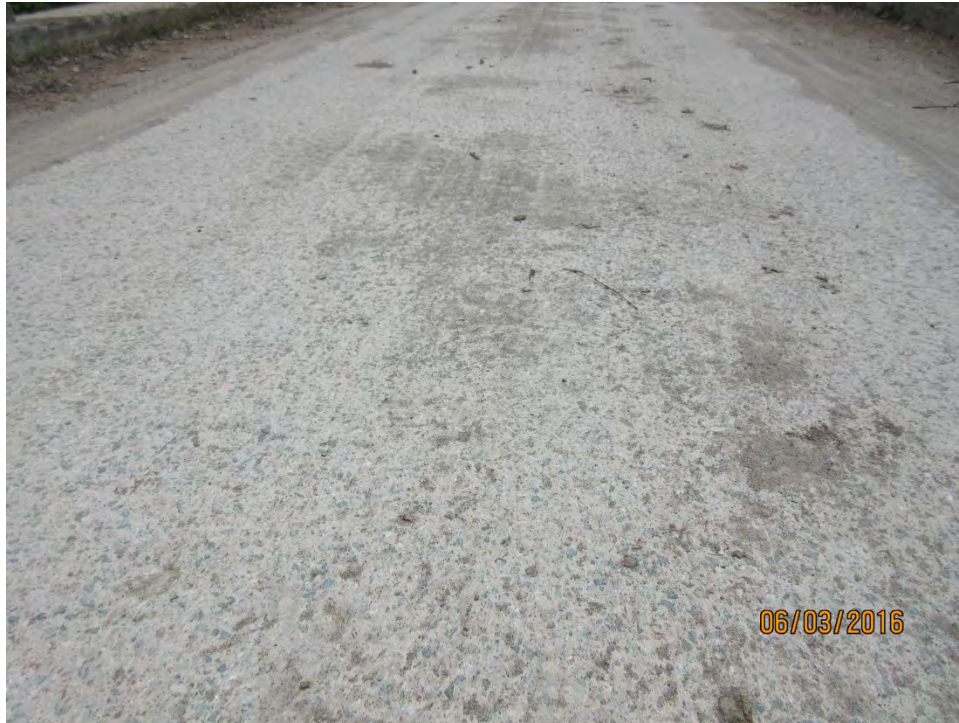
BRIDGE DECK WEARING SURFACE – LIGHT TO MODERATE SCALING AND ABRASIONS

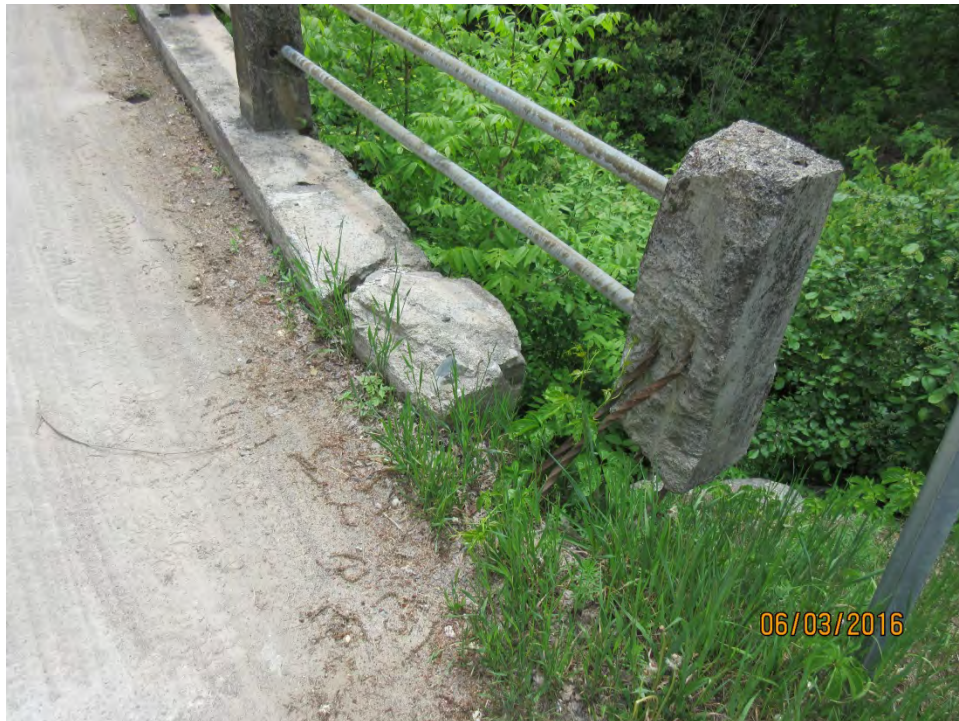
BROKEN SECTION OF CURB AND MISSING SECTION OF RAILING POST IN THE NORTHWEST CORNER

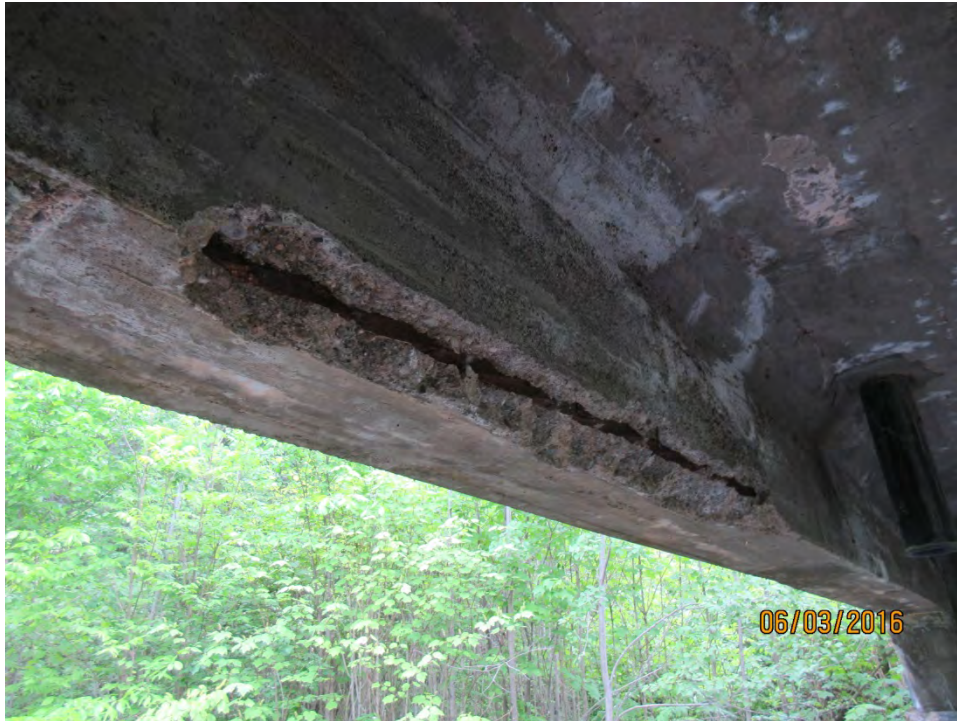
**EXPOSED CORRODED REBAR IN EAST EXTERIOR BEAM'S
NORTH SPAN**

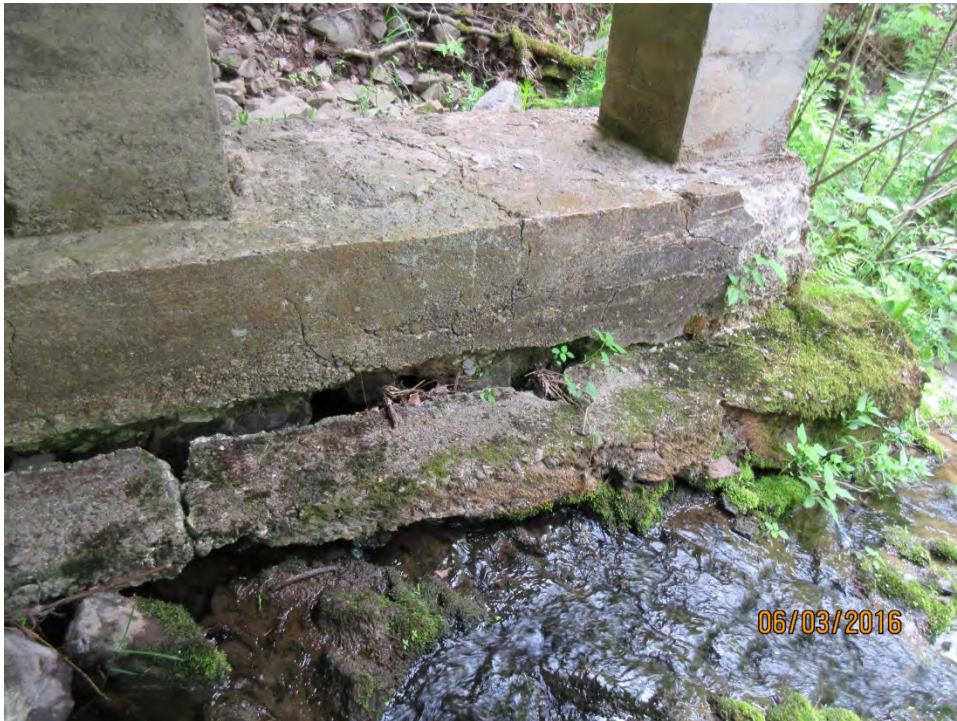
**BROKEN CONCRETE FOOTING WITH MODERATE TO
SEVERE UNDERMINING**

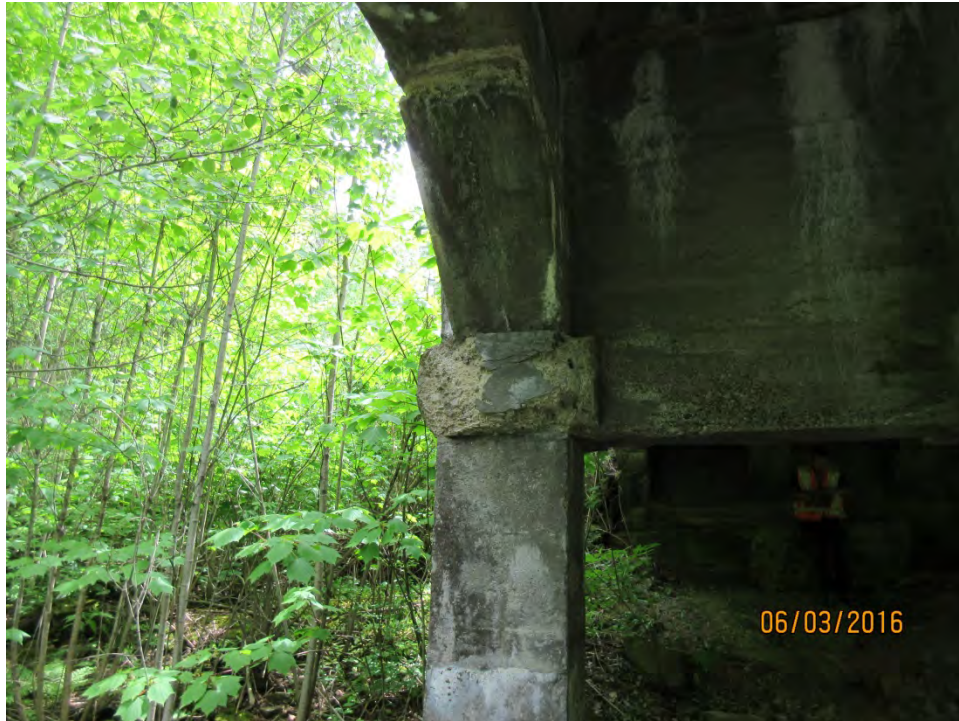
CONCRETE SPALL AND DISINTEGRATION OF SOUTH PIER

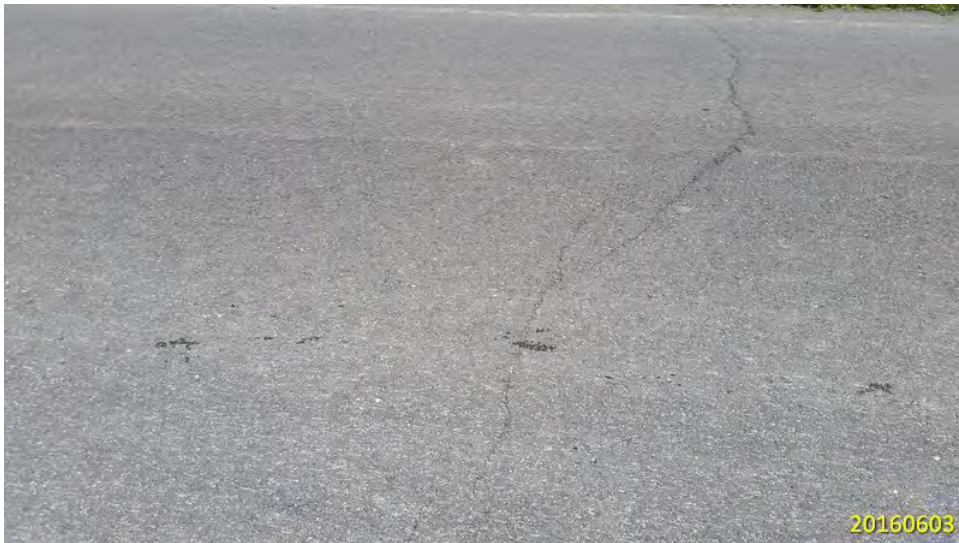
MEDIUM TRANSVERSE CRACK IN SOUTH APPROACH
WEARING SURFACE

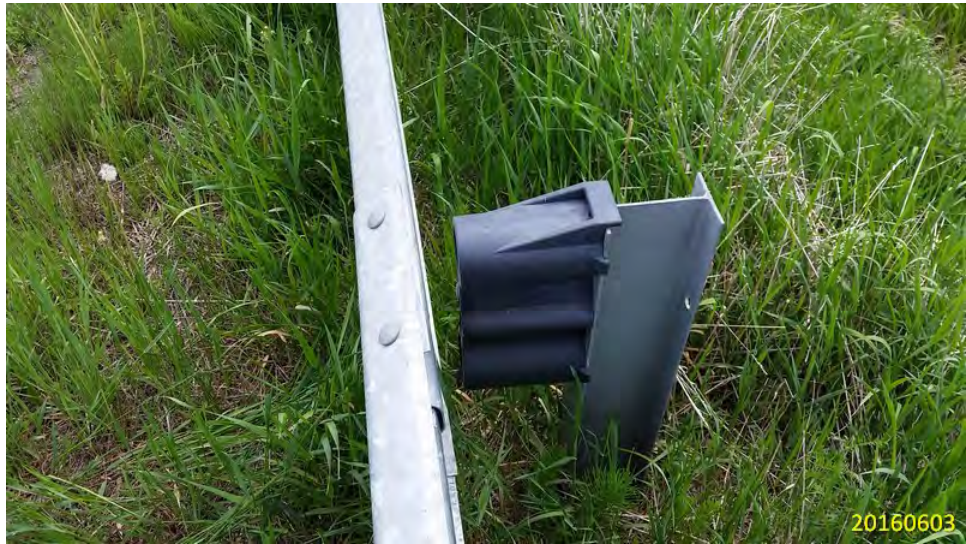
GUIDERAIL POST MISSING BOLT

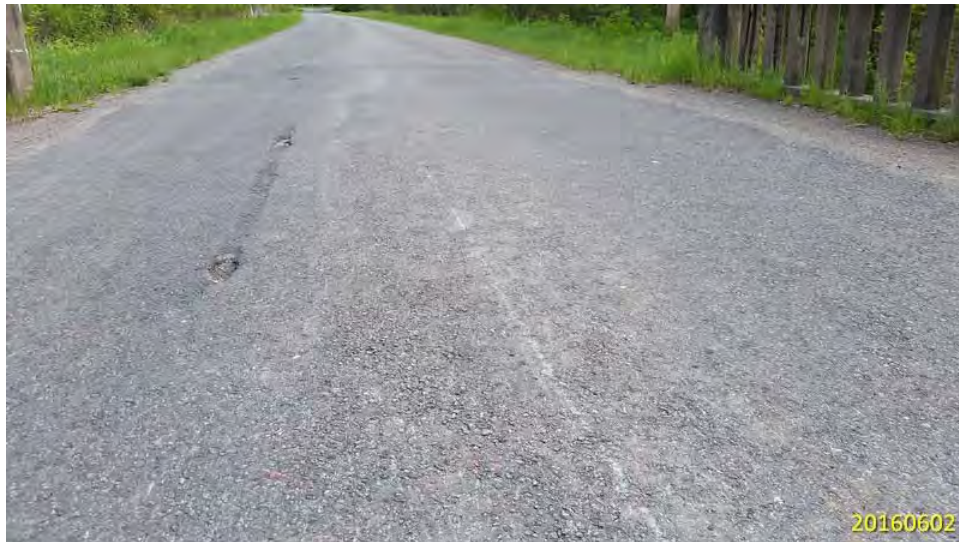
DECK WEARING SURFACE WITH LIGHT WEAR, ABRASIONS AND LOCALIZED POTHOLES

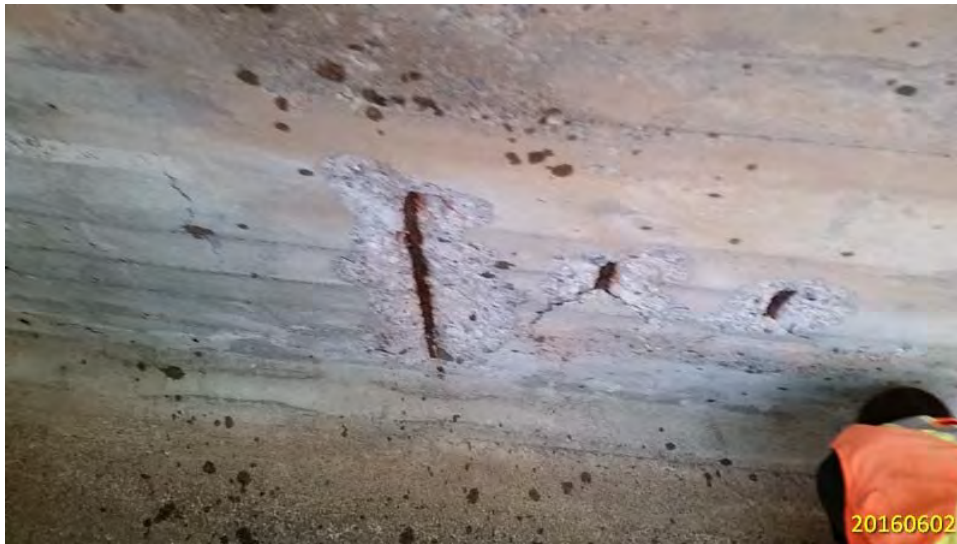
LOCALIZED DELAMINATION WITH EXPOSED CORRODED REBAR IN WEST DECK SOFFIT

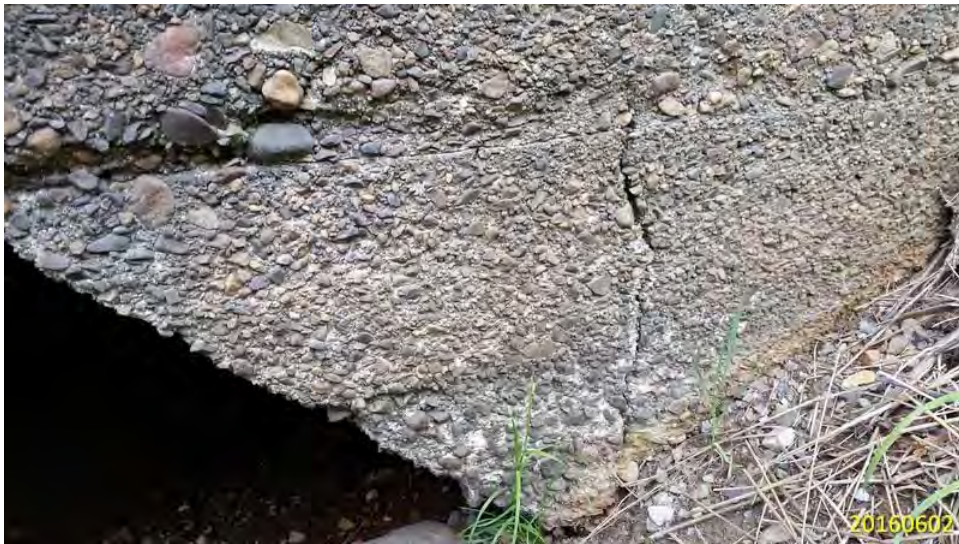
MEDIUM TO WIDE CRACK IN SOUTHWEST BEAM HAUNCH

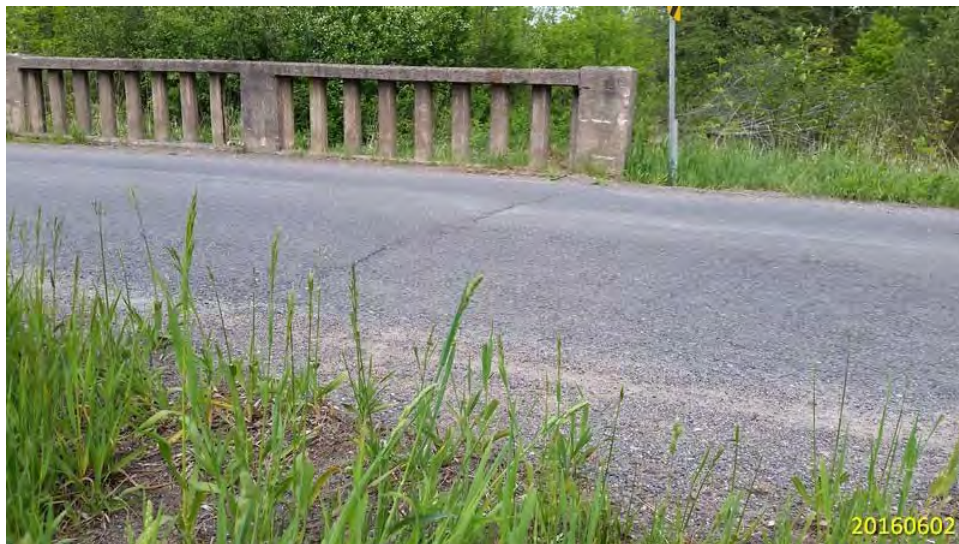
SETTLEMENT OF SOUTH APPROACH AND CRACKING OF WEAR SURFACE AT END OF BRIDGE DECK

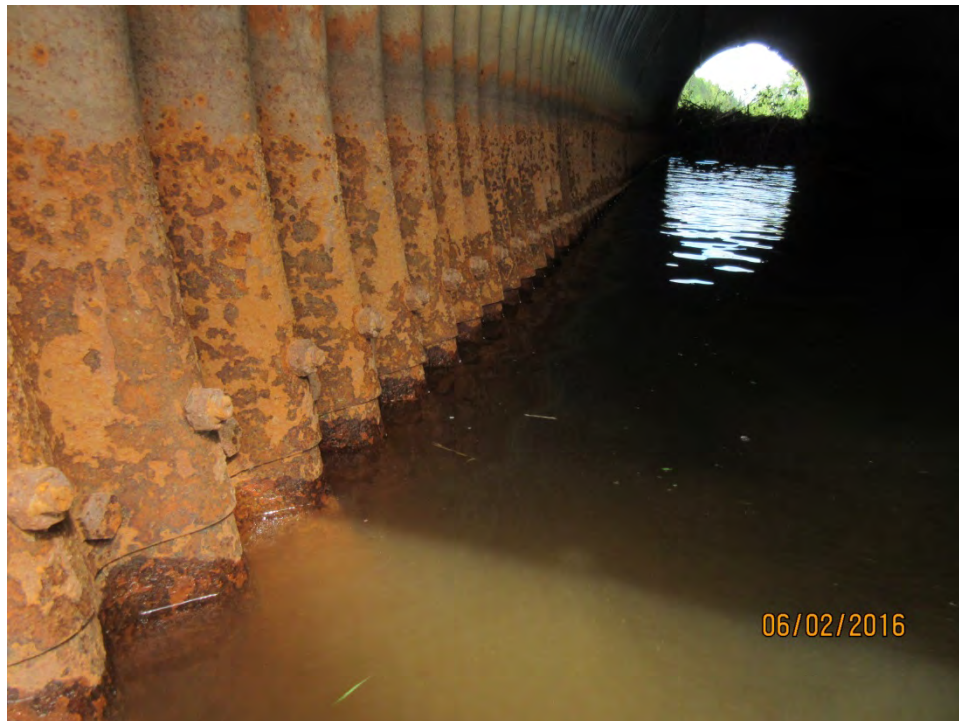
LIGHT TO MODERATE CORROSION OF CULVERT BARREL WITH FLAKING AT WATERLINE

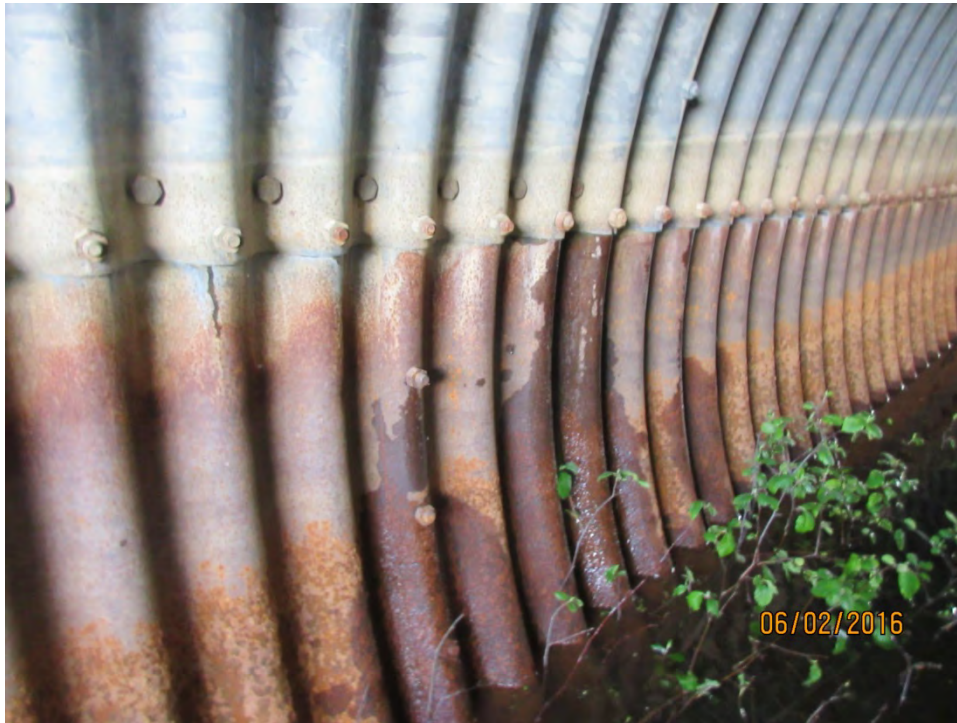
WATER INFILTRATION AT BOLT JOINT IN NORTH SECTION
OF WEST WALL

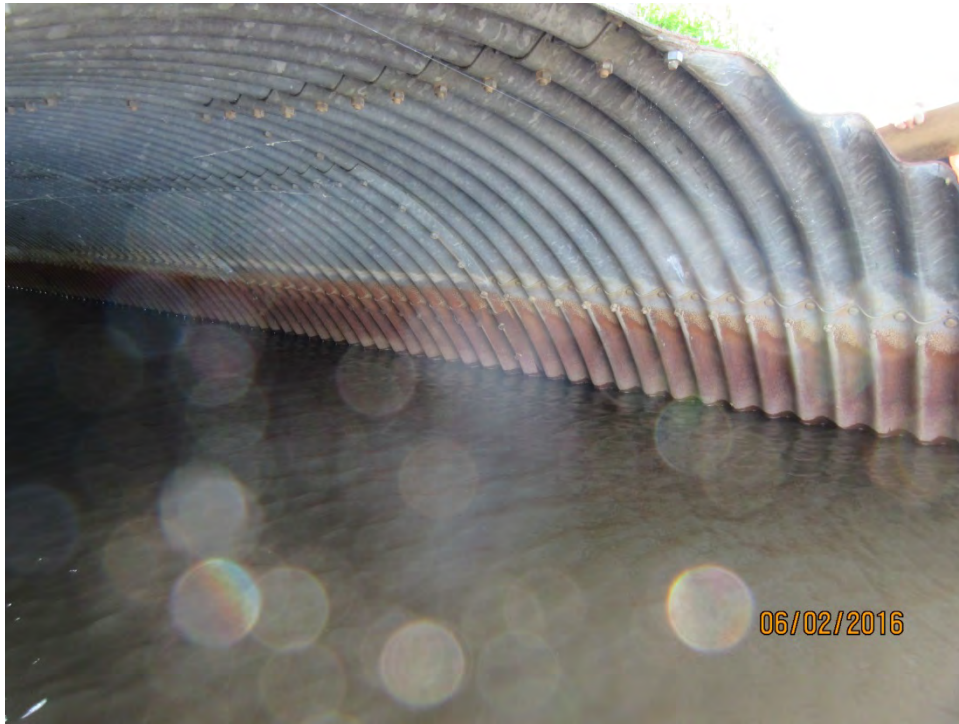
LIGHT TO MODERATE CORROSION OF CULVERT BARREL
AT WATERLINE

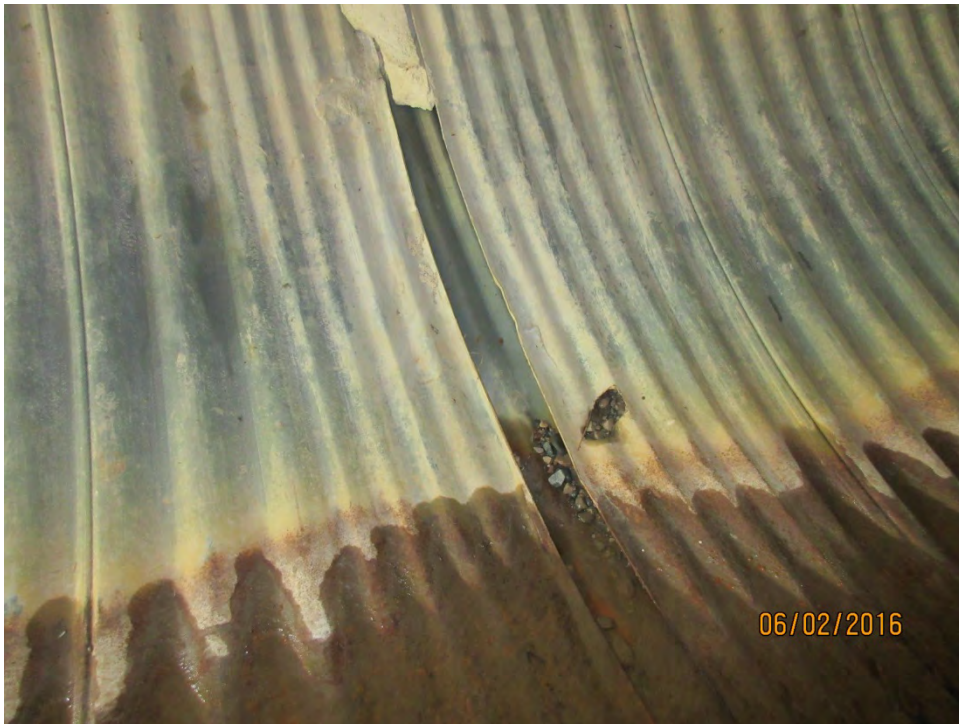
TYPICAL OVERLAP JOINT MISSING PARGING

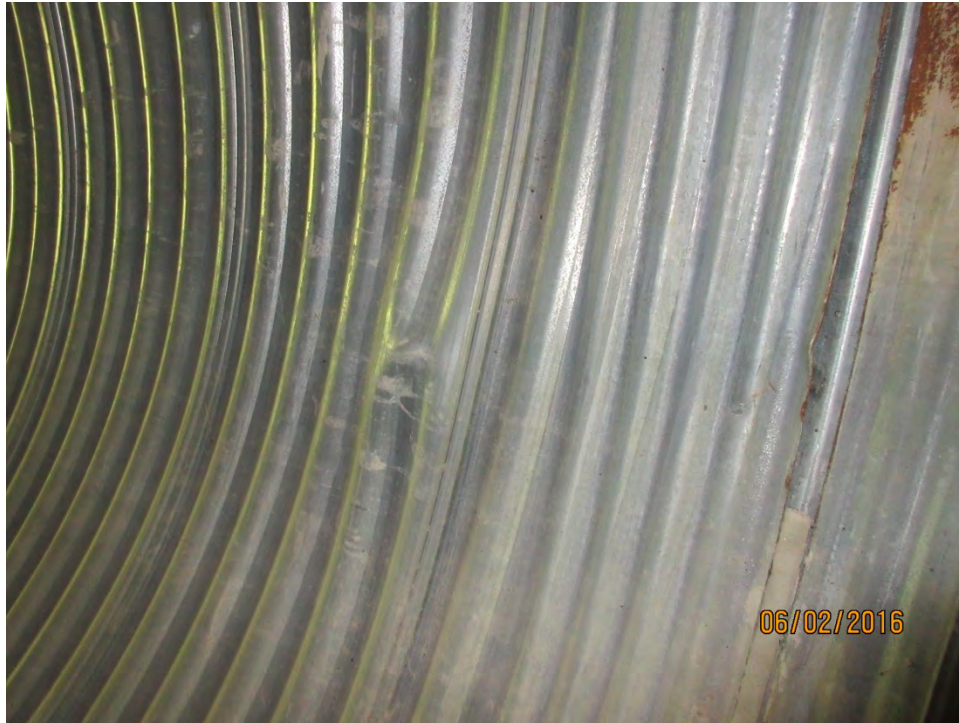
LOCALIZED PROJECTION ON EAST WALL
