**2016 BIENNIAL MUNICIPAL BRIDGE
& CULVERT INSPECTIONS**

16-1055
August 3, 2016

Regarding: Township of Johnson - 2016 Biennial Bridge & Culvert Inspections

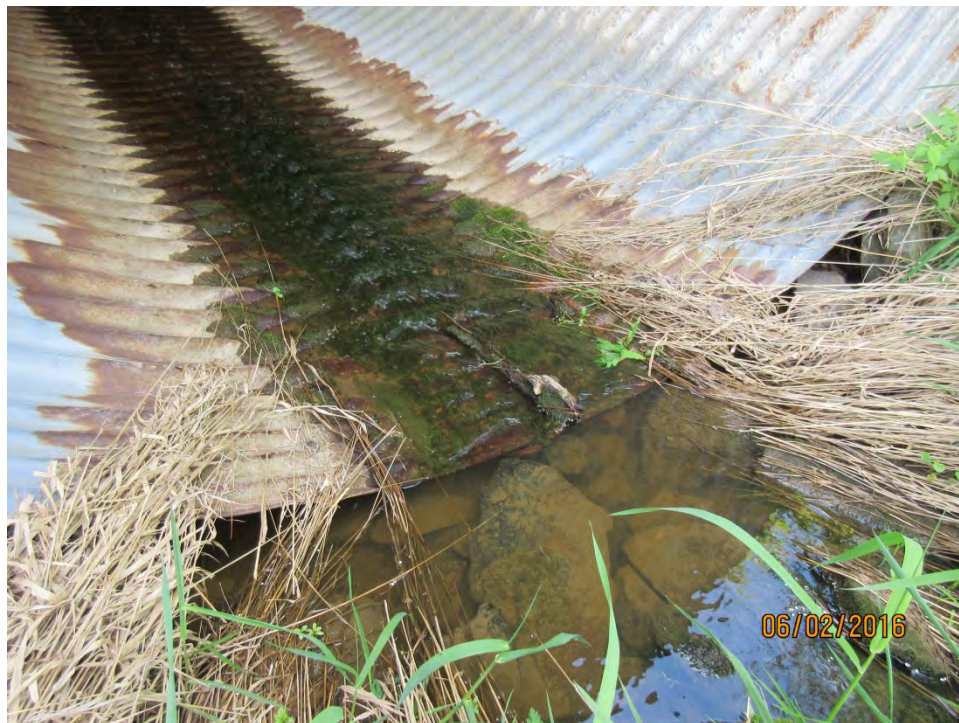
CULVERT INLET WITH MODERATE UNDERMINING

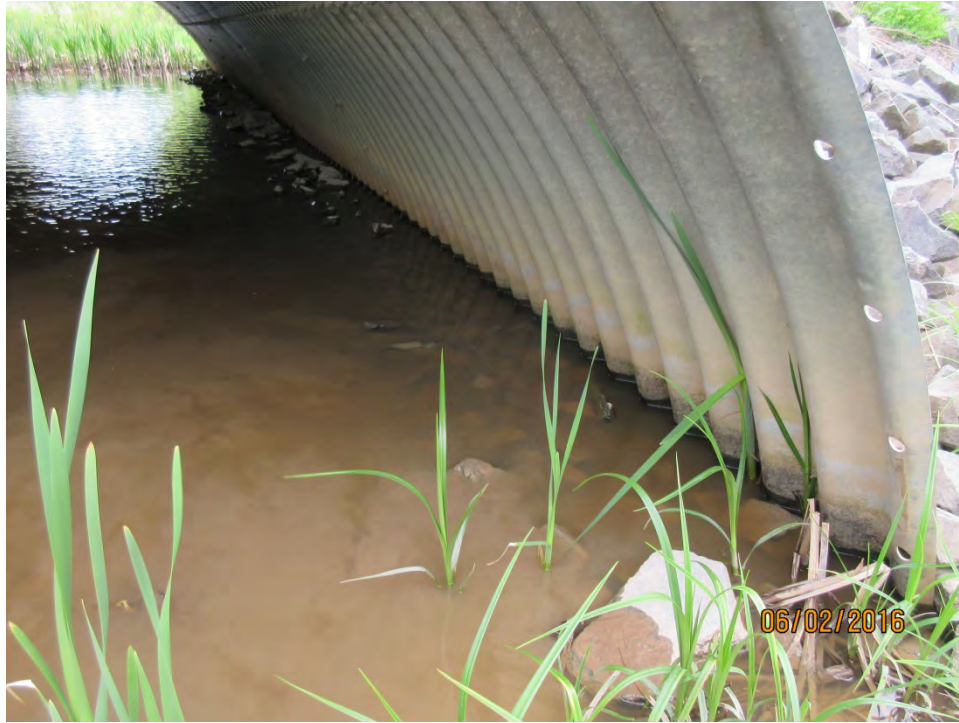
**LIGHT STAINING OF CULVERT BARREL AT WATERLINE AND
LOSS OF ARMORING STONE AT INLET**

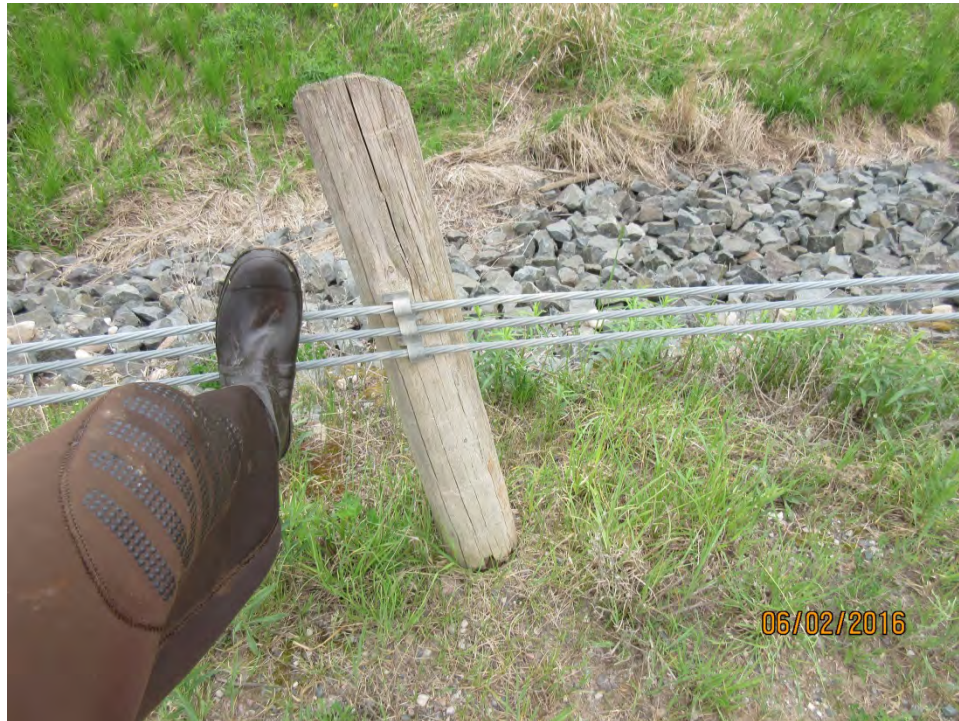
BROKEN GUIDERAIL POST ALONG EAST GUIDERAIL

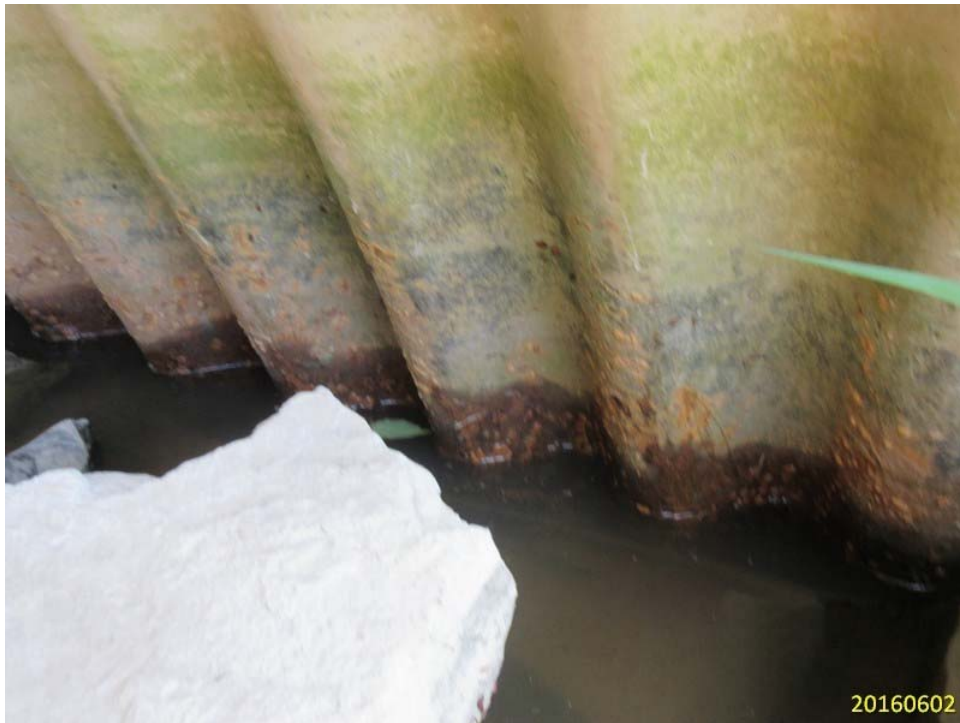
LIGHT STAINING AND BLISTERING OF COATING
AT WATERLINE – SOUTHEAST QUADRANT
