## REPORT FOR 2026 OSIM INSPECTION

**Township of Johnson**

**R&R ENGINEERING SERVICE**

**Township of Johnson**  
**2026 OSIM Inspection**  
**Report**

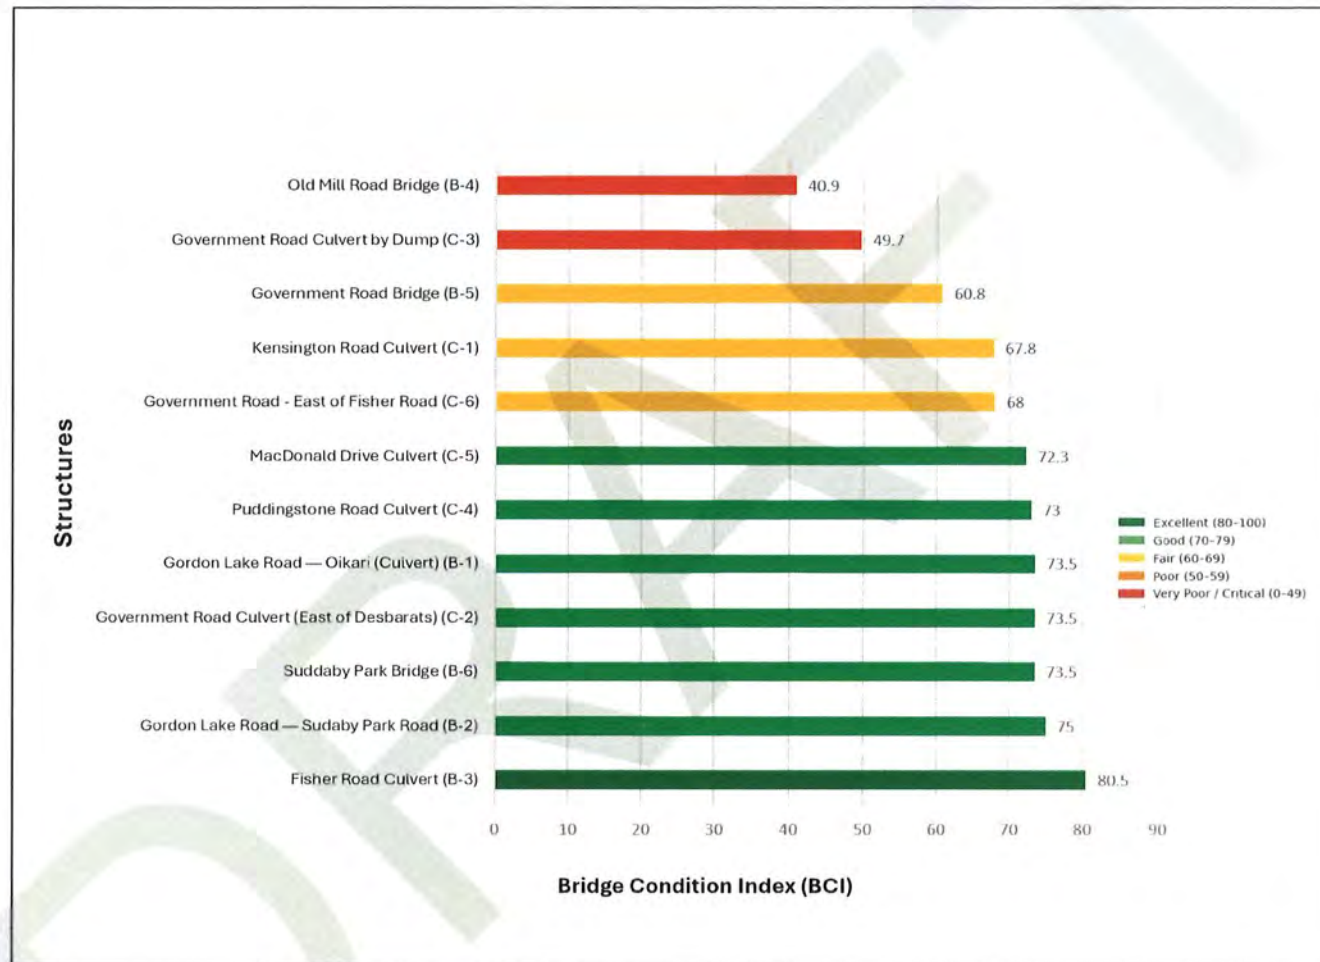
Figure 1: BCI summary for inspected structures

The following summary presents the BCI results for the inspected structures within Johnson Township, organized by condition category from Excellent to Very Poor / Critical. These ratings provide a clear, objective basis for identifying maintenance priorities, allocating rehabilitation resources, and planning future capital investments.
