Township of Johnson

Biennial Bridge and Culvert Inspections 2020

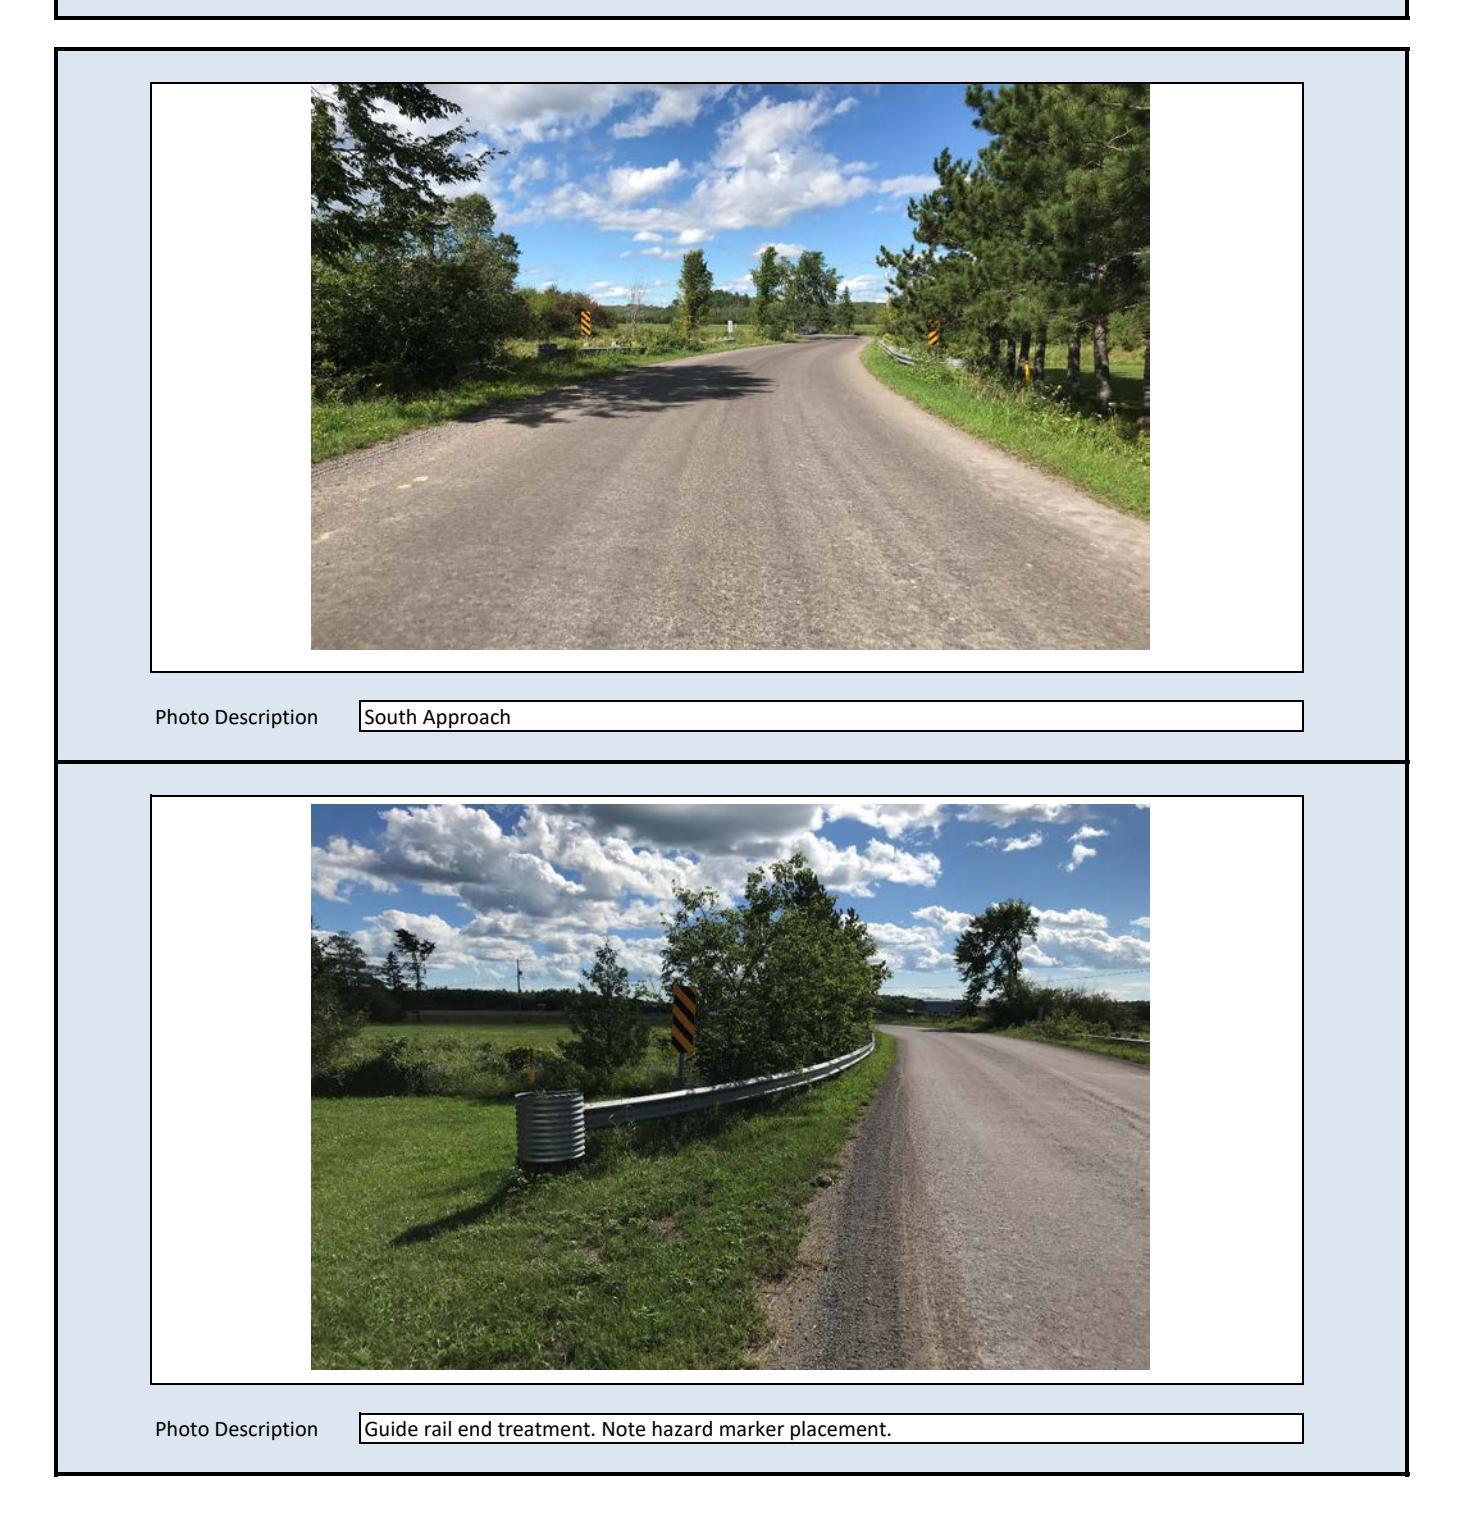
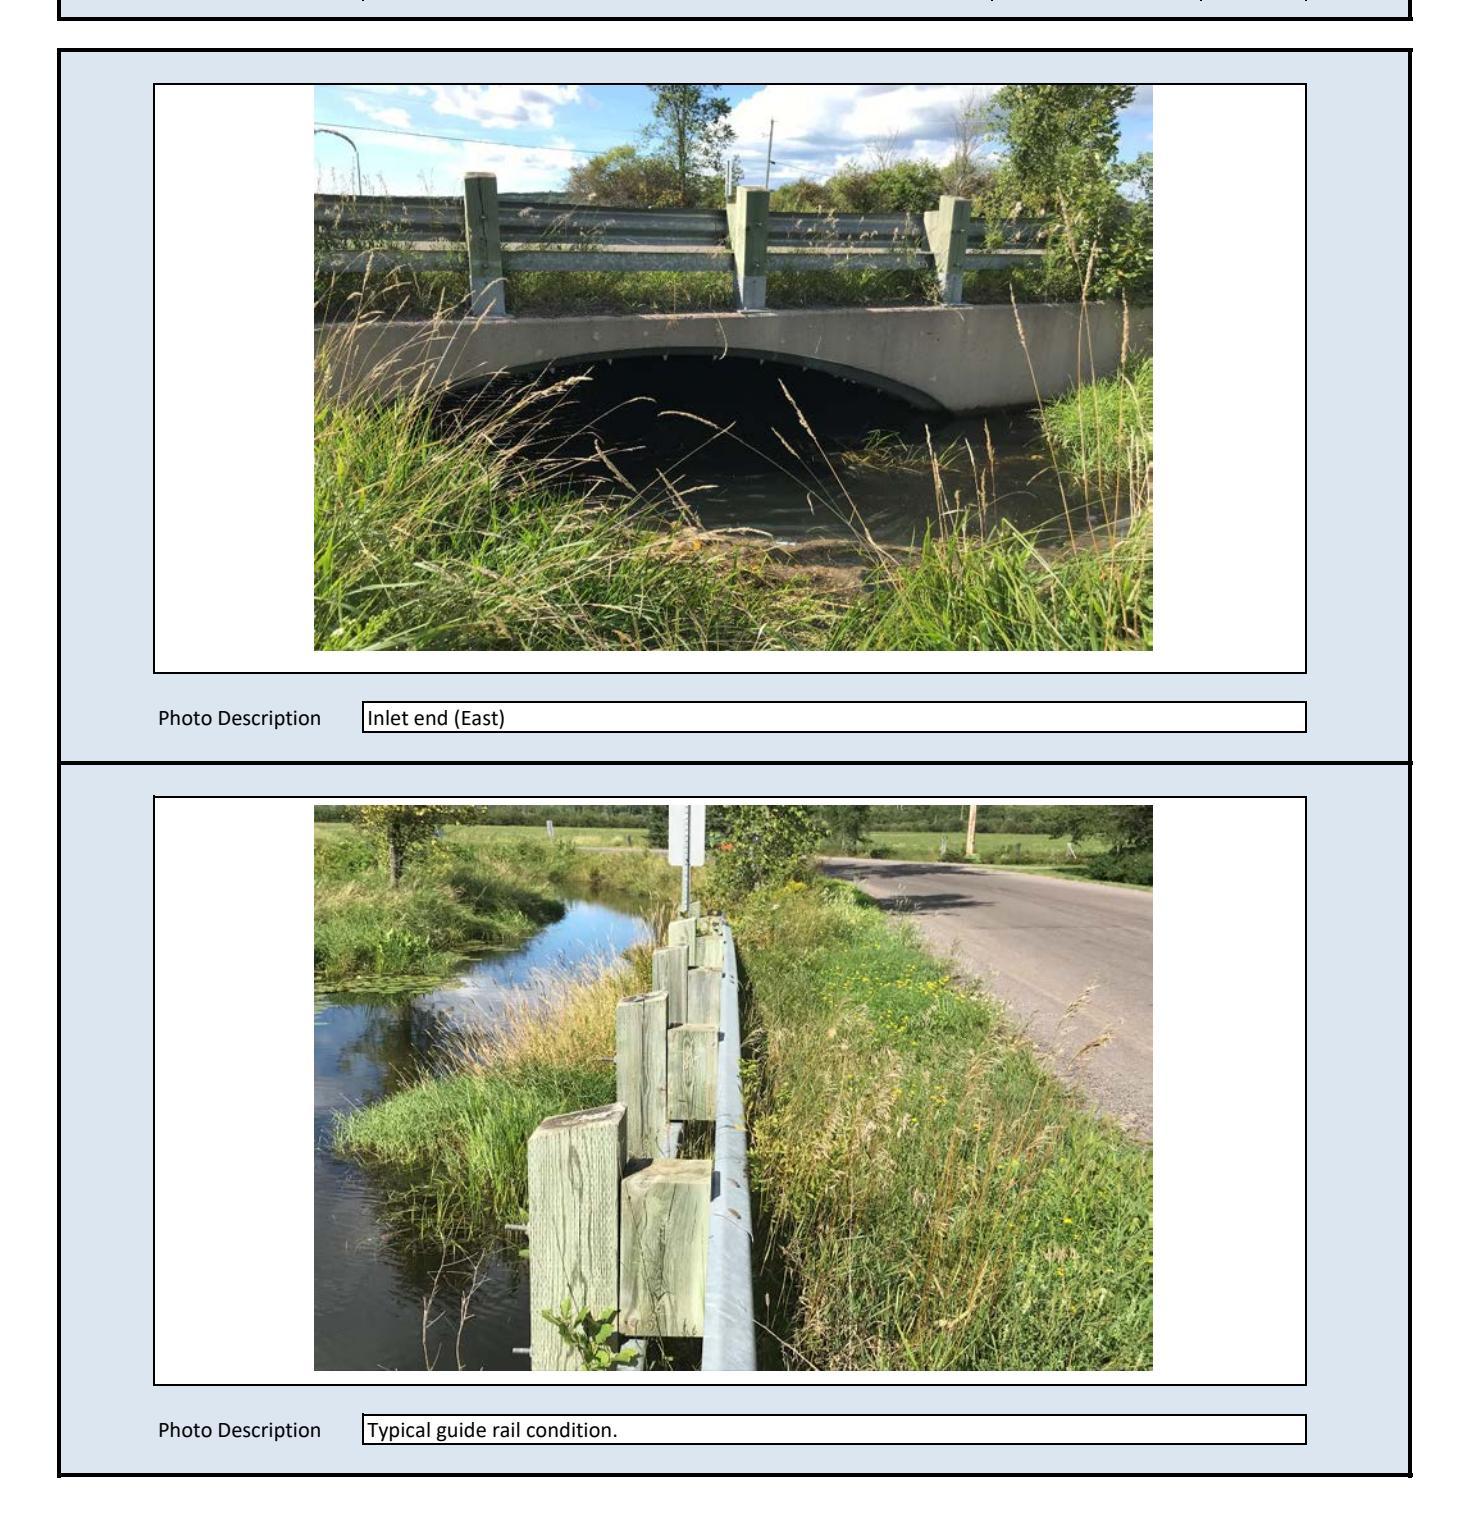
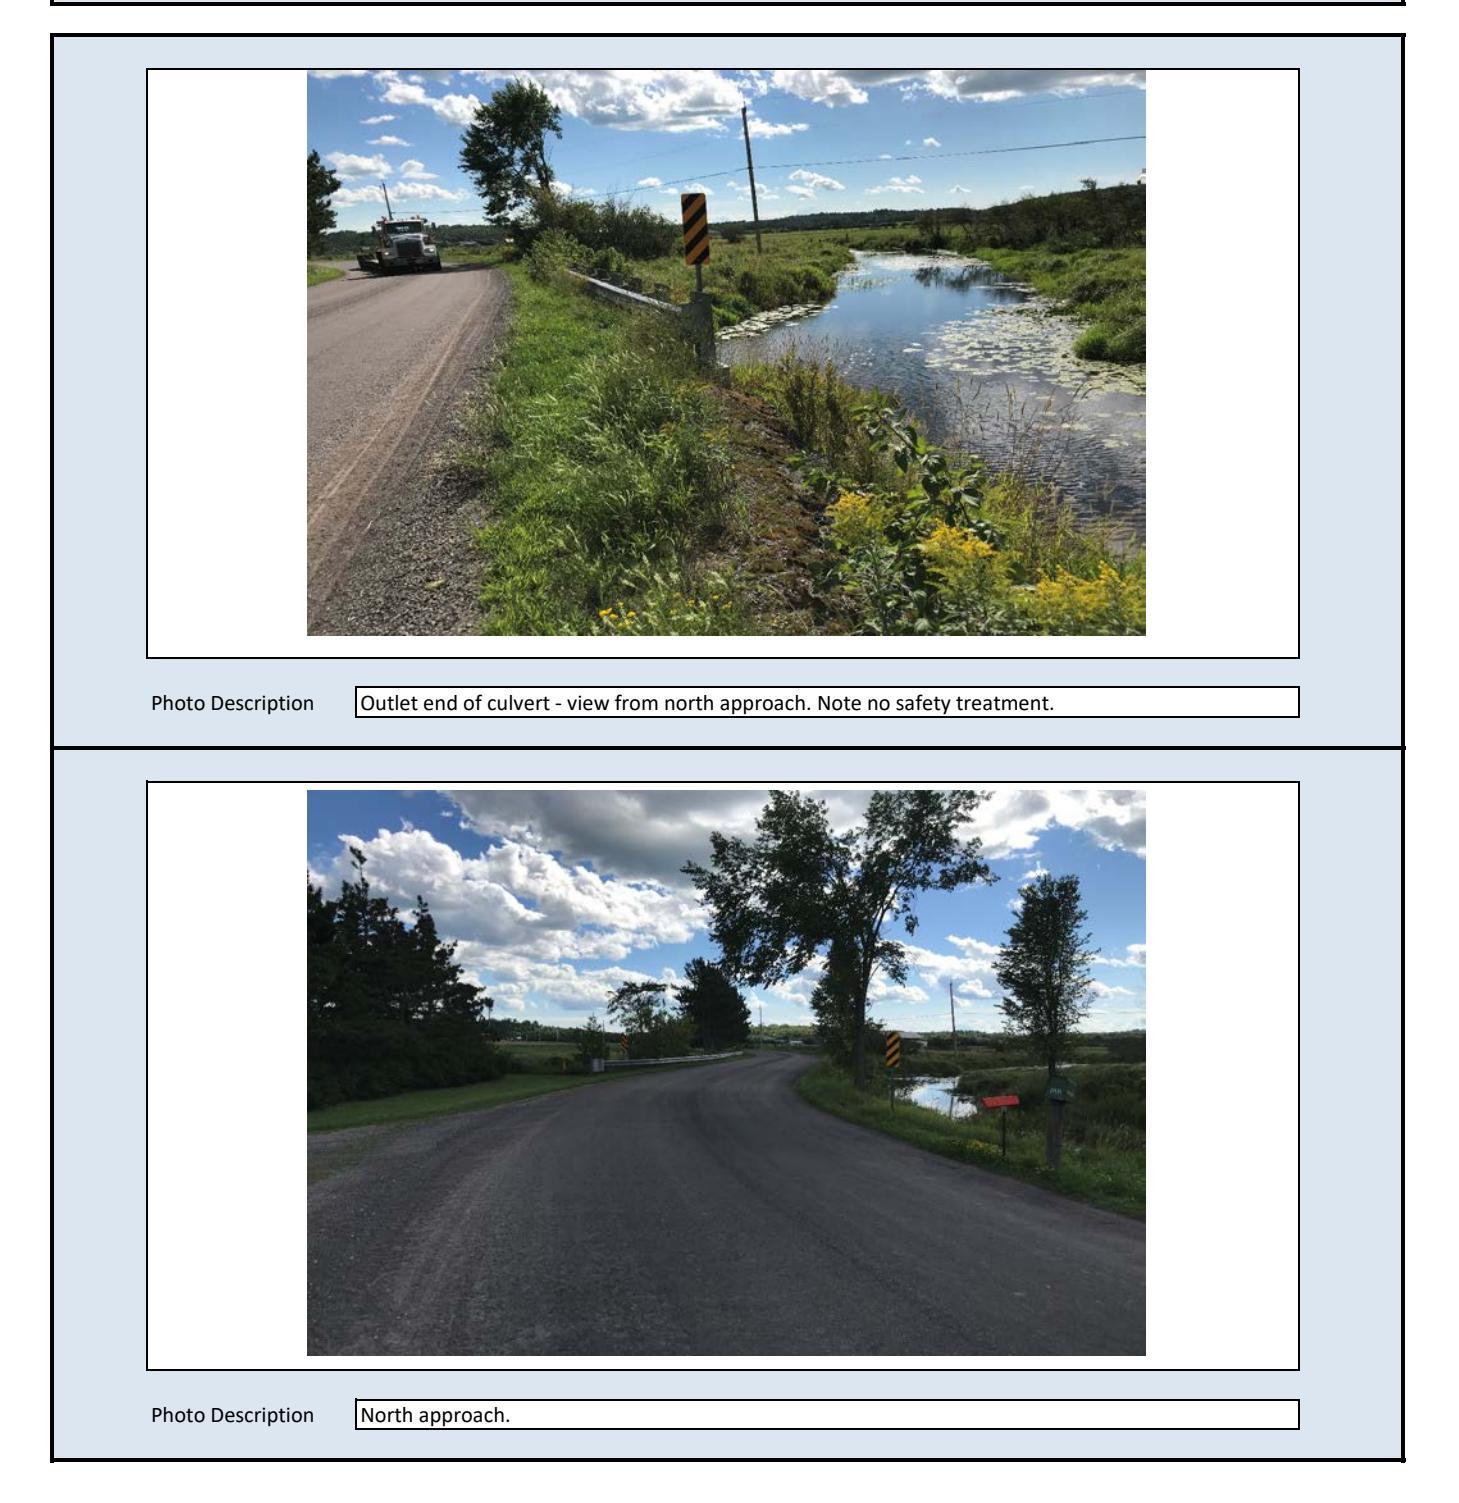
CULVERT PHOTOGRAPHS		20)20 Biennial	Inspection
Structure:	Johnson Township - Oikari Culvert	Structure #:	B1

This structure is an open floor corrugated steel arch culvert. Overall the structure appears in good condition and no specific action items are noted.

M. REMARKS		
191	INSPECTION NOTES:	
	- Culvert is a structural plate corrugated steel pipe with concrete headwalls on each end.	
	- Flex beam guide rail is installed over culvert complete with eccentric loader barrel terminations.	
	- Surface treated road over culvert appears in good condition.	
	- Road embankments appear in good condition with some minor erosion evident.	
	- The stream appears stable and in good condition.	
	- Some guide rail offset blocks are rotated.	
	 Vegetation is encroaching on shoulders and guide rails. 	
	 Inspection limited due to high water and vegetation obscuring culvert installation. 	
	RECOMMENDATIONS:	
	- Continued routine mainteance is reocmmended, including tightening guide rail bolts, erosion repairs.	
	- Vegetation management is recommended.

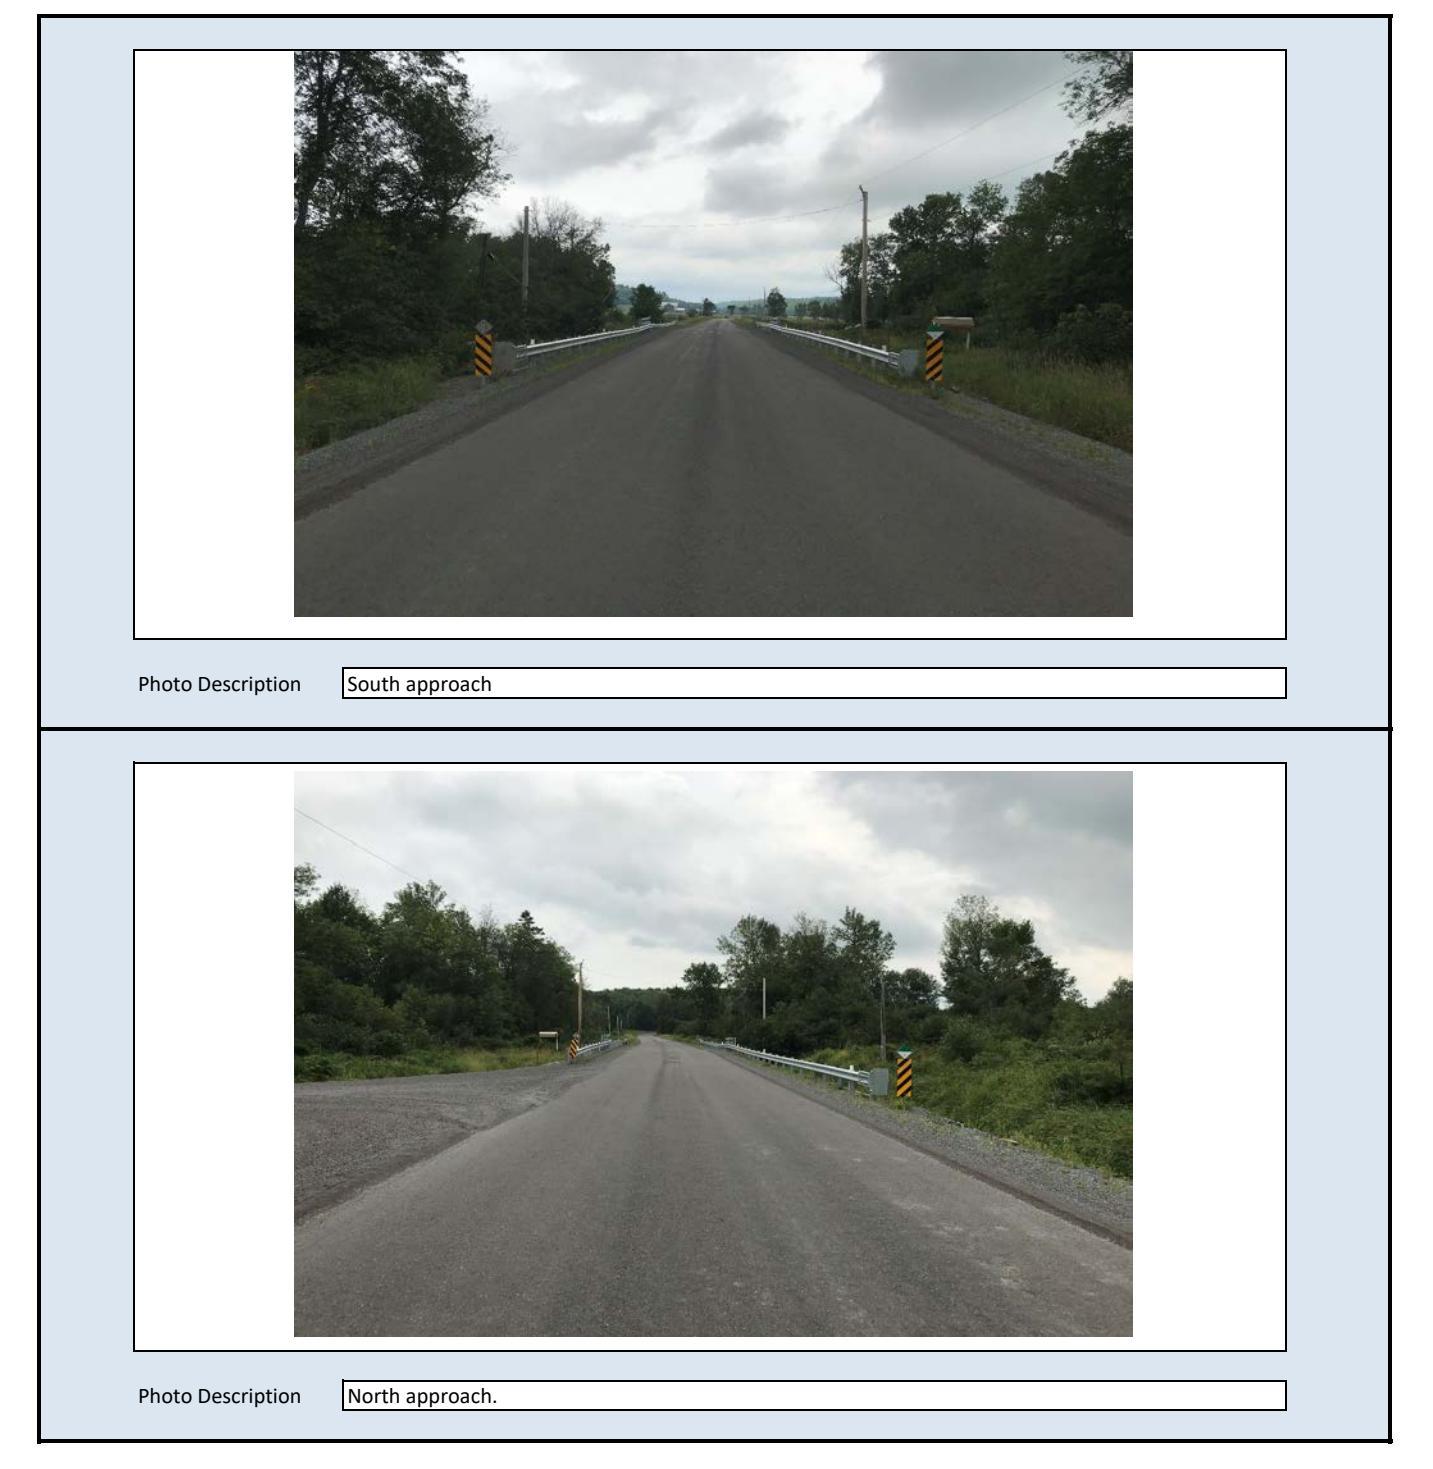
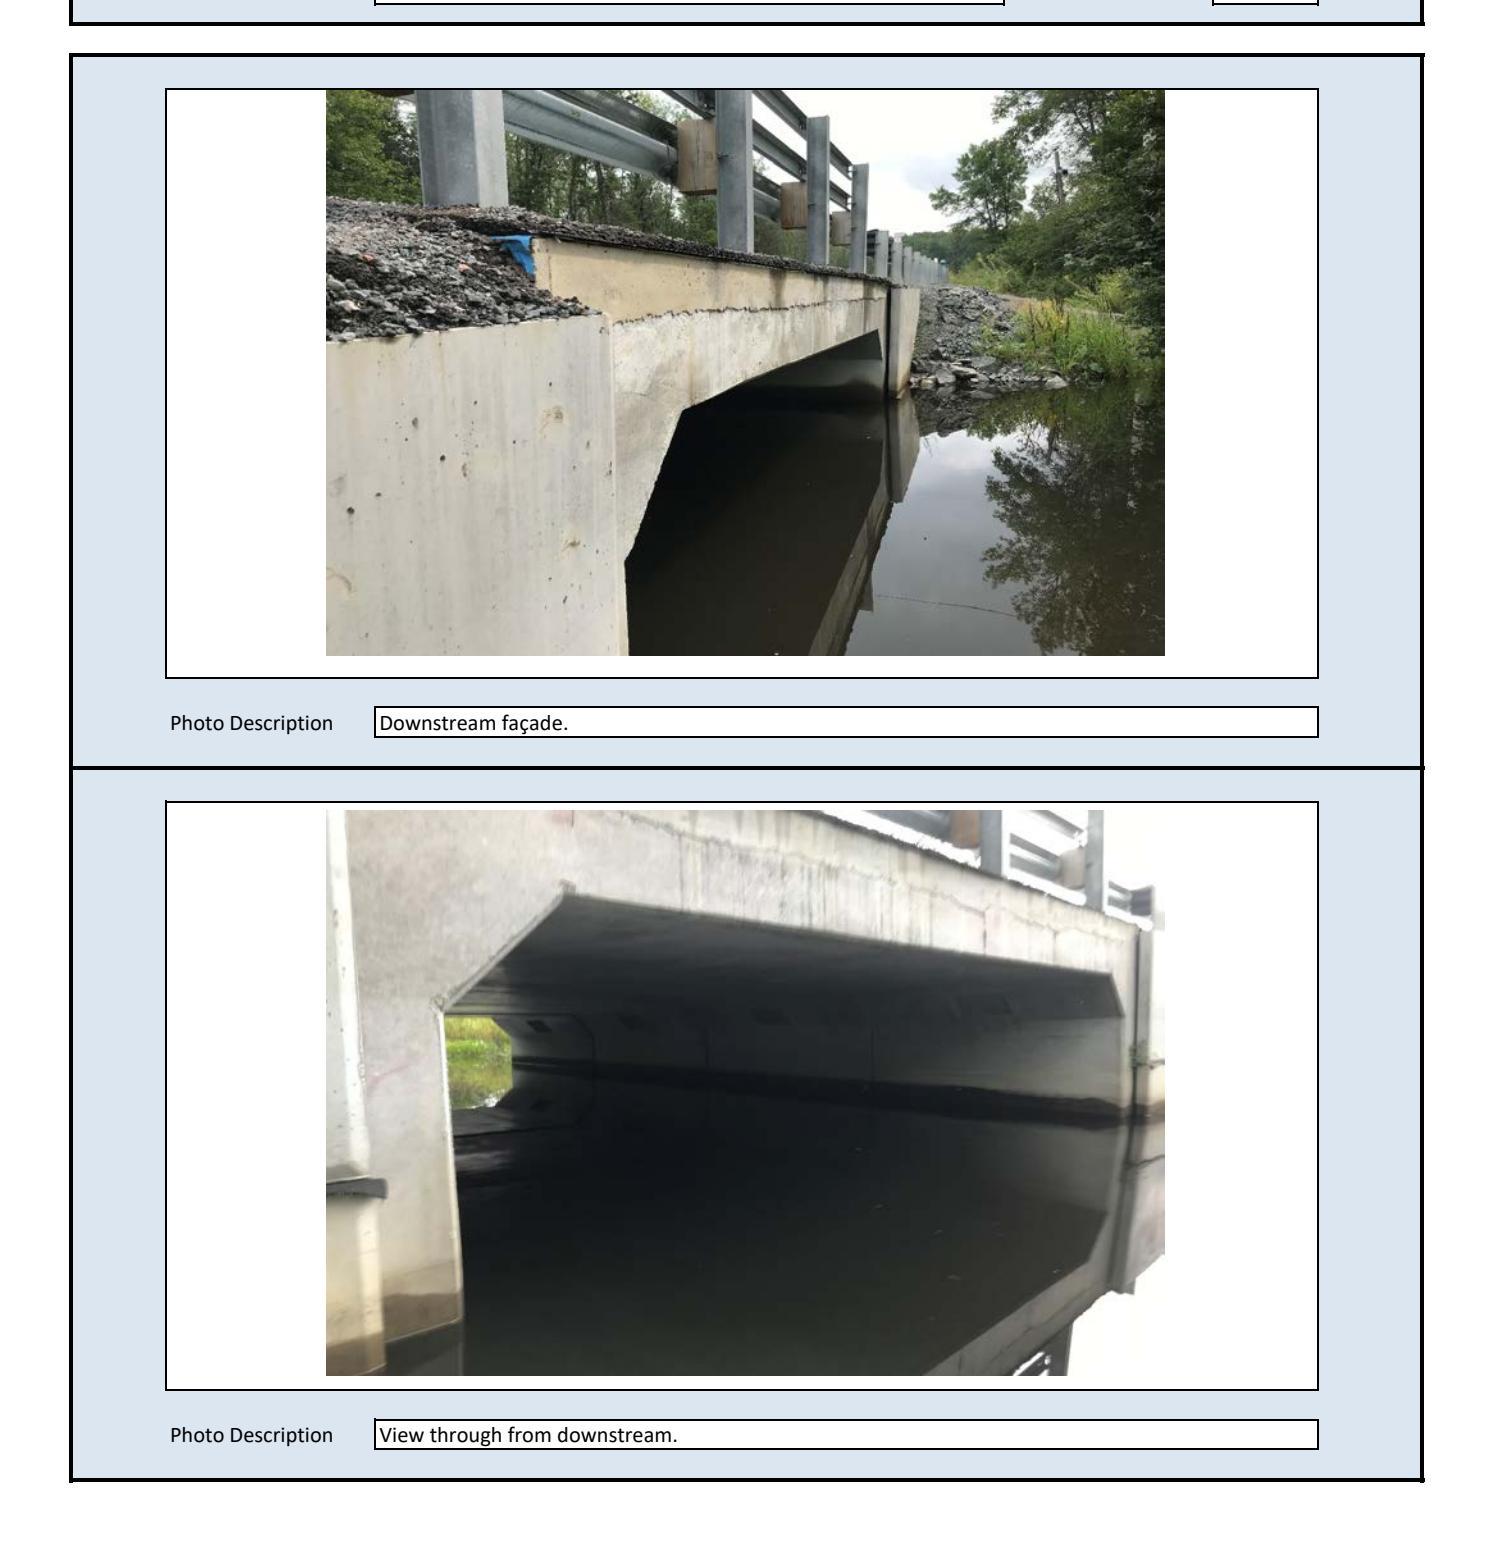
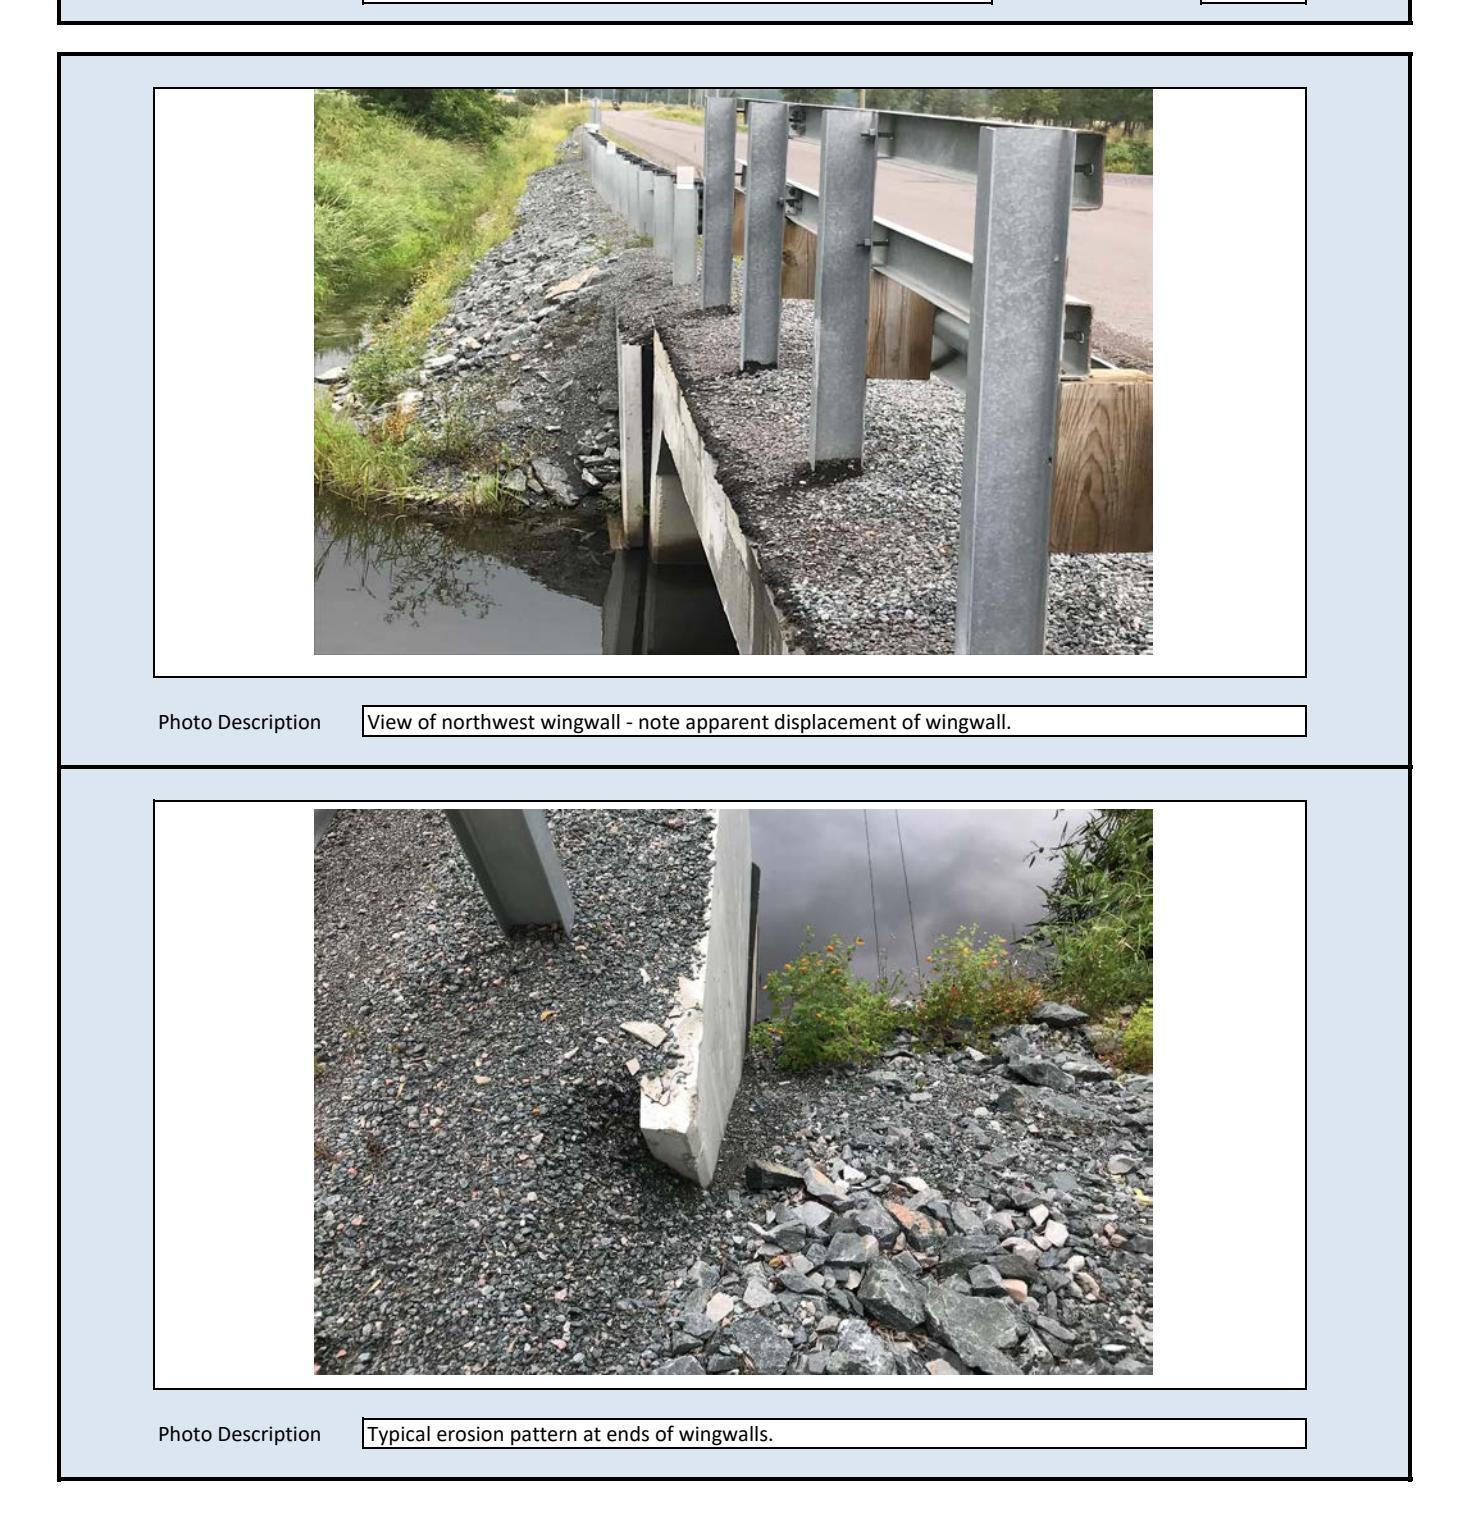
BRIDGE PHOTOGRAPHS		2020 Biennial Inspection
Structure:	Township of Johnson - Sudaby Park Bridge	Structure #: B6

This structure is a concrete box culvert constructed in about 2009. Overall the structure appears in good condition. It is noted that the wingwall at the northeast

quadrant appears to have slightly shifted away from the structure; this specifically should be reviewed at the next biennial inspection. If further displacement is noted, a remediation plan should be developed at that time.

M. REMARKS	
191	INSPECTION NOTES:
	 Inspection limited due to high water level.
	Precast concrete box culvert.
	 Steel flex beam guide rail with safety end treatments on all approach quadrants.
	• Guide rail system includes additional upper channels at bridge. No safety end treatments on upper channels.
	Hazard markers are located at all four quadrants.
	Snowplow wing markers are installed on all four quadrants.
	Surface treated roadway is in good condition.
	Minor sand and gravel accumulation at shoulders. Minor shoulder erosion at ends of wing walls.
	Precast concrete wingwalls in good condition; however some displacement is apparent at northwest quadrant.
	Rip-rap slope protection on roadway embankment appears in good condition.
	• Stream is in good condition.
	RECOMMENDATIONS: • Monitor wingwalls for continued movement.

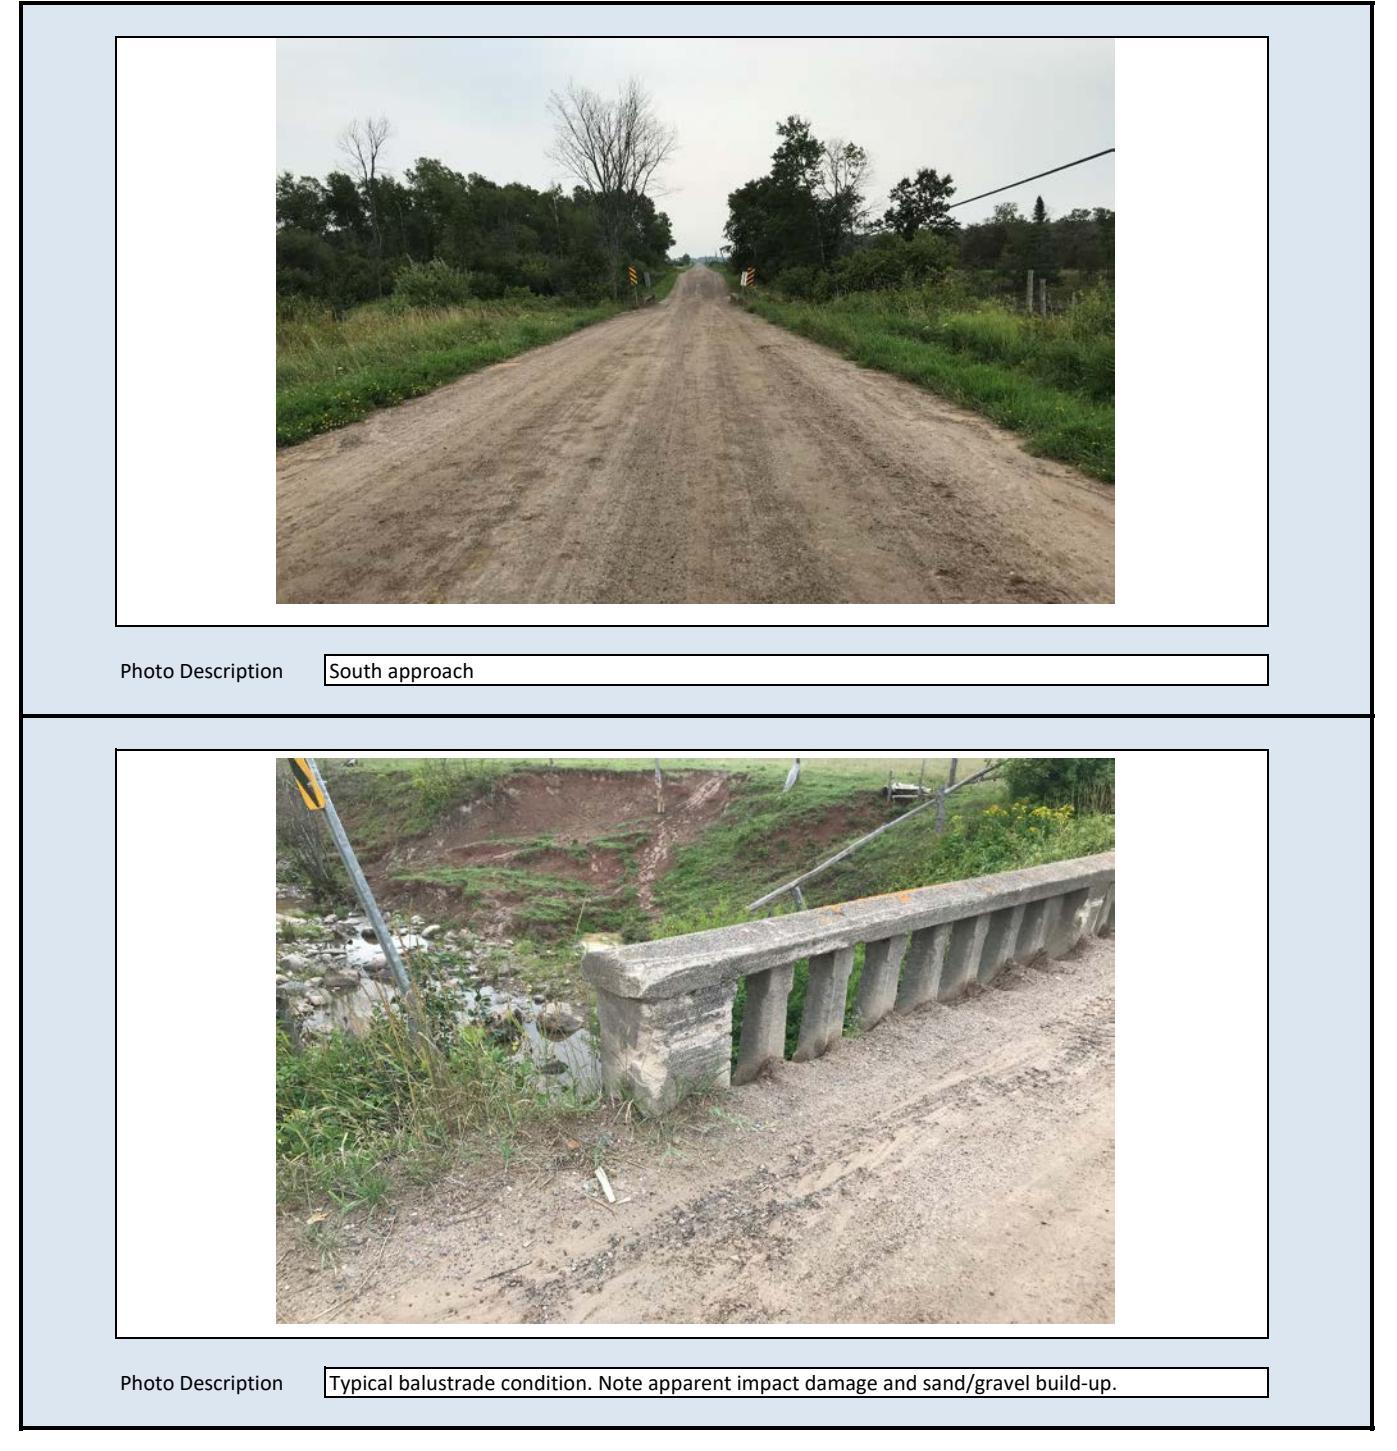
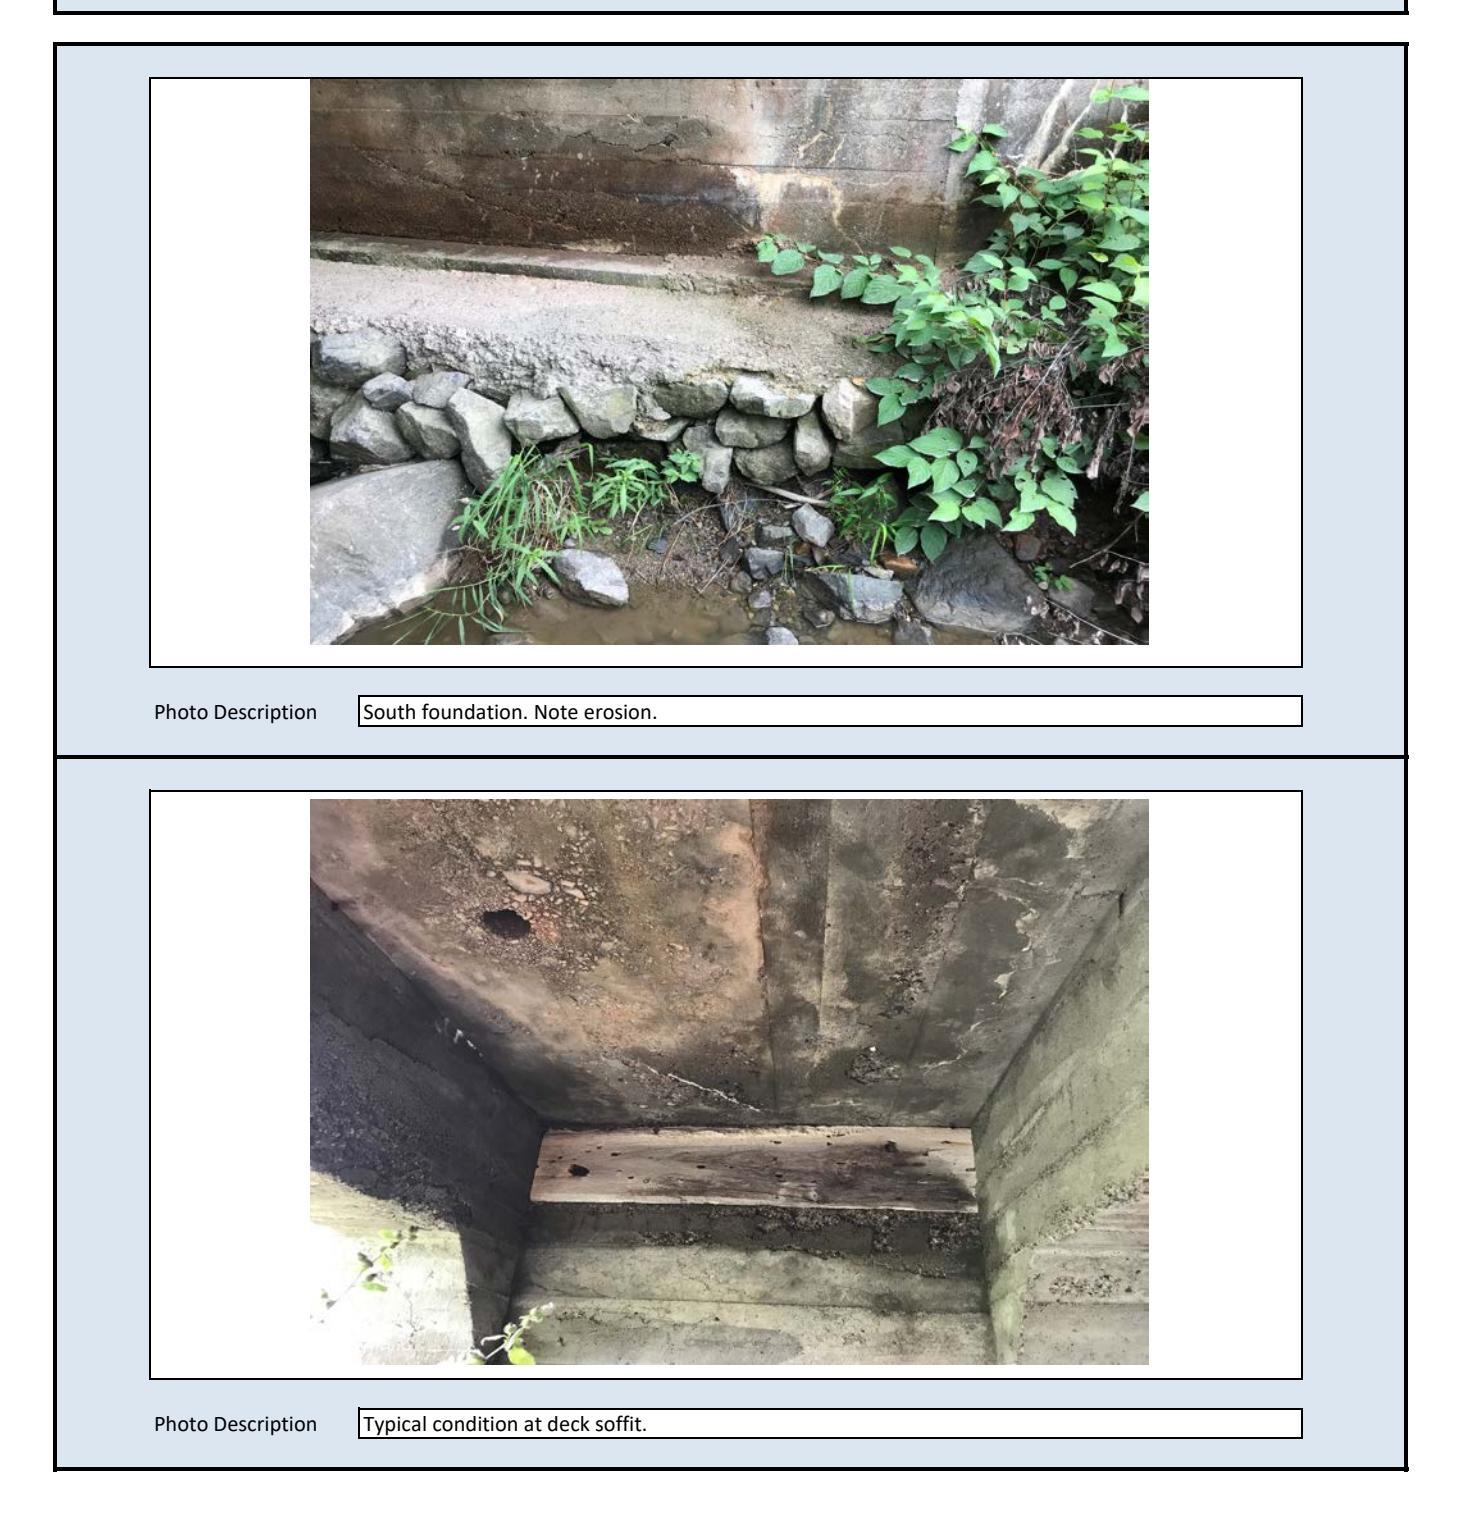
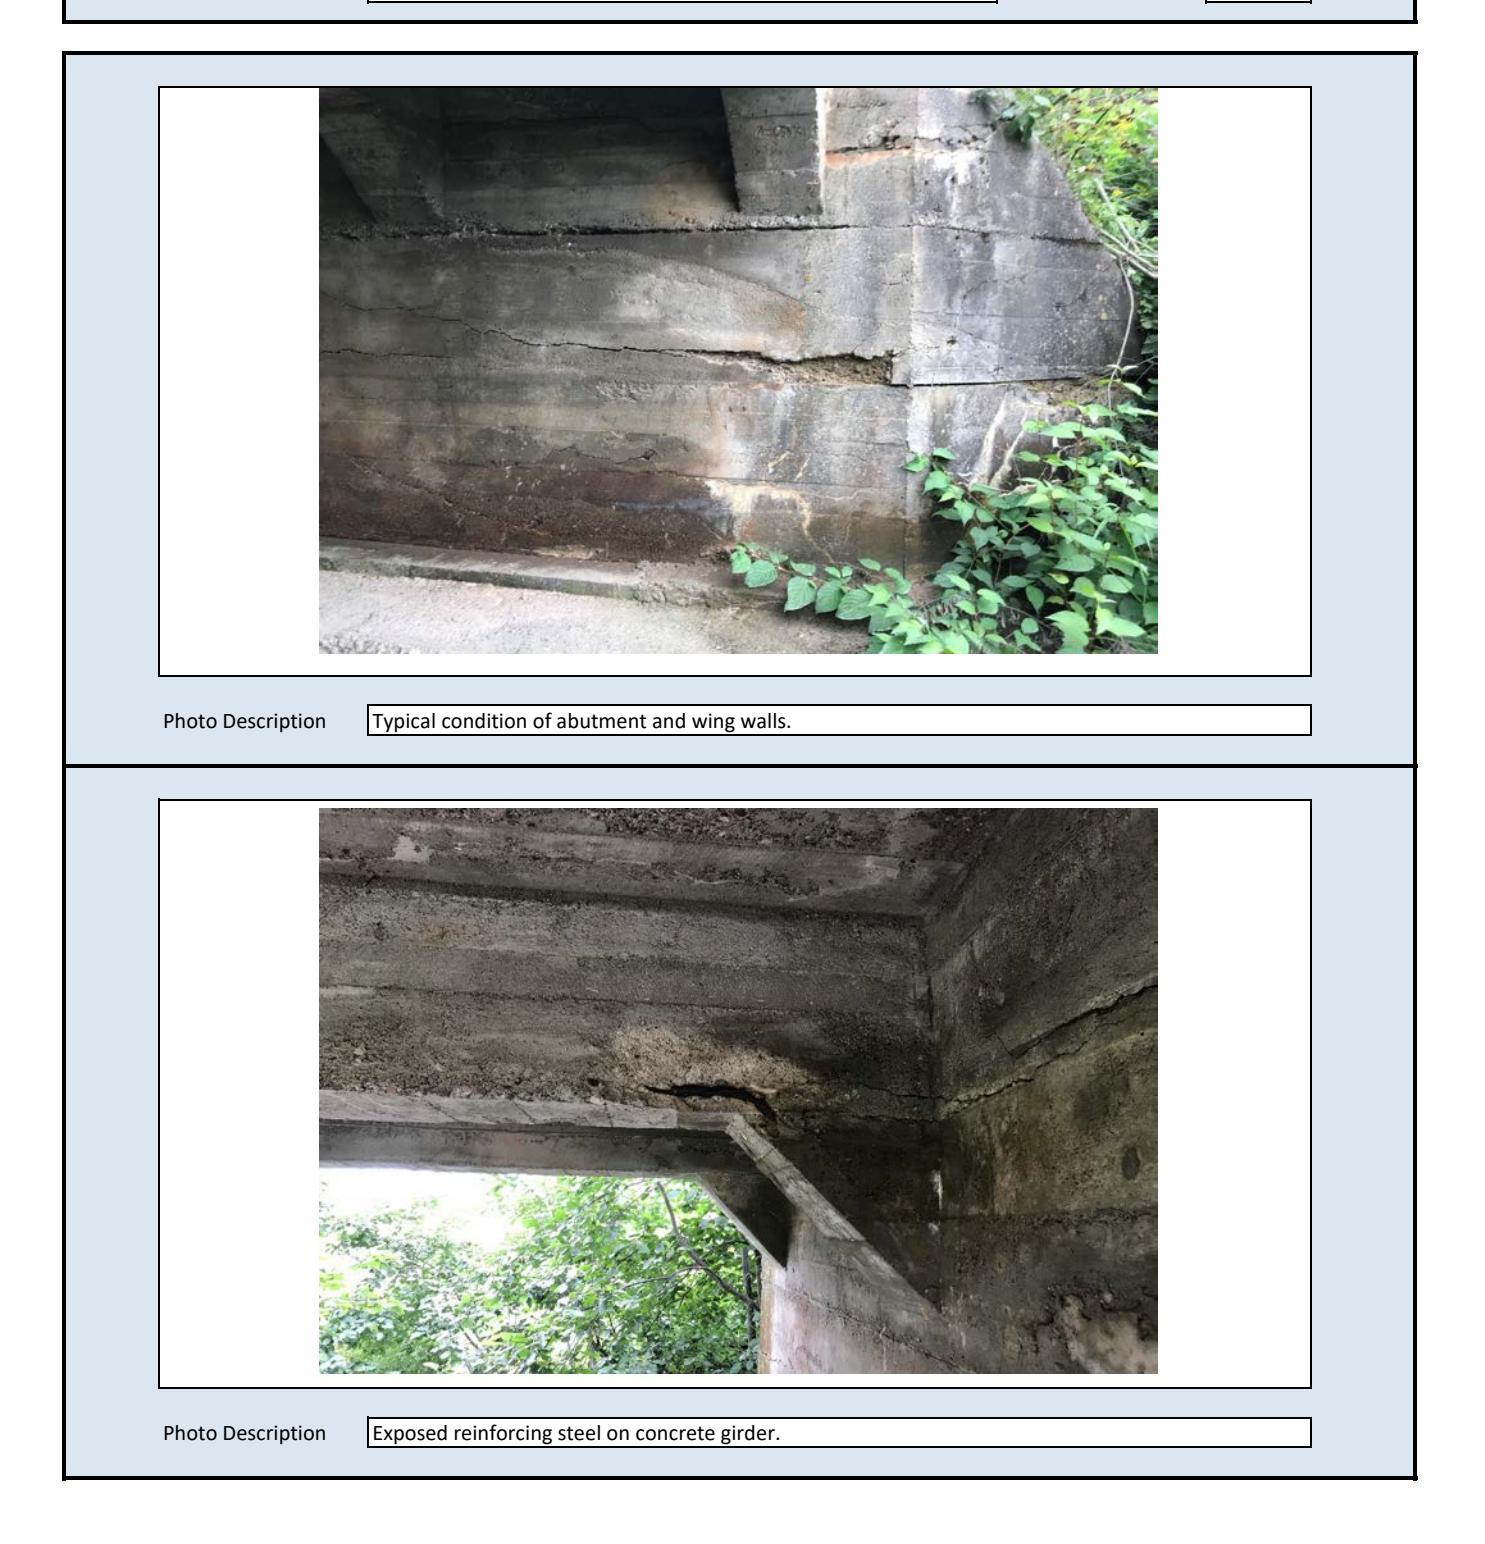
Structure: Township of Johnson - Fisher Road Bridge Structure #: B2	BRIDGE PHOTOGRAPHS	2020 Biennial Inspection
	Structure: Township of Johnson - Fisher Road Bridge	Structure #: B2

The Fisher Road Bridge is a concrete structure dating to about 1950. The structure is in fair to poor condition and is likely near the end of its serviceable life. It is recommended that the Township initiate a replacement/rehabilitation study to develop a plan addressing their needs.

A. REMARK	S
191	INSPECTION NOTES:
	 Single span cast in-place concrete bridge with gravel riding surface.
	Concrete balustrade railing has sustained damage from impacts.
	Accumulation of sand/gravel on the deck.
	No guide rails on approaches.
	Hazard markers are located at all four quadrants.
	Snowplow wing markers are not present.
	Gravel surface roadway is generally in good condition.
	Cast in-place concrete wingwalls in fair condition with cracking and efflorescence throughout.
	Cast in-place abutments and ballast walls in fair conditionwith cracking and efflorescence throughout.

• Concrete soffit and girders are in fair to poor condition with efflorescence and cracking throughout, as well as localized areas
	of exposed reinforcing steel.
	Minor erosion at foundations.
	Stream is in good condition.
	RECOMMENDATIONS:
	Clean accumulation from the deck.
	Install approach guide rails.

• Structure is likely near the end of its servicable life. Rehabilitation or replacement study is recommended.

In the interim, it is recommended that sand and gravel accumulations be removed from the deck and that the Township consider installation of approach guide rails.
