Township of Johnson

Biennial Bridge and Culvert Inspections 2020

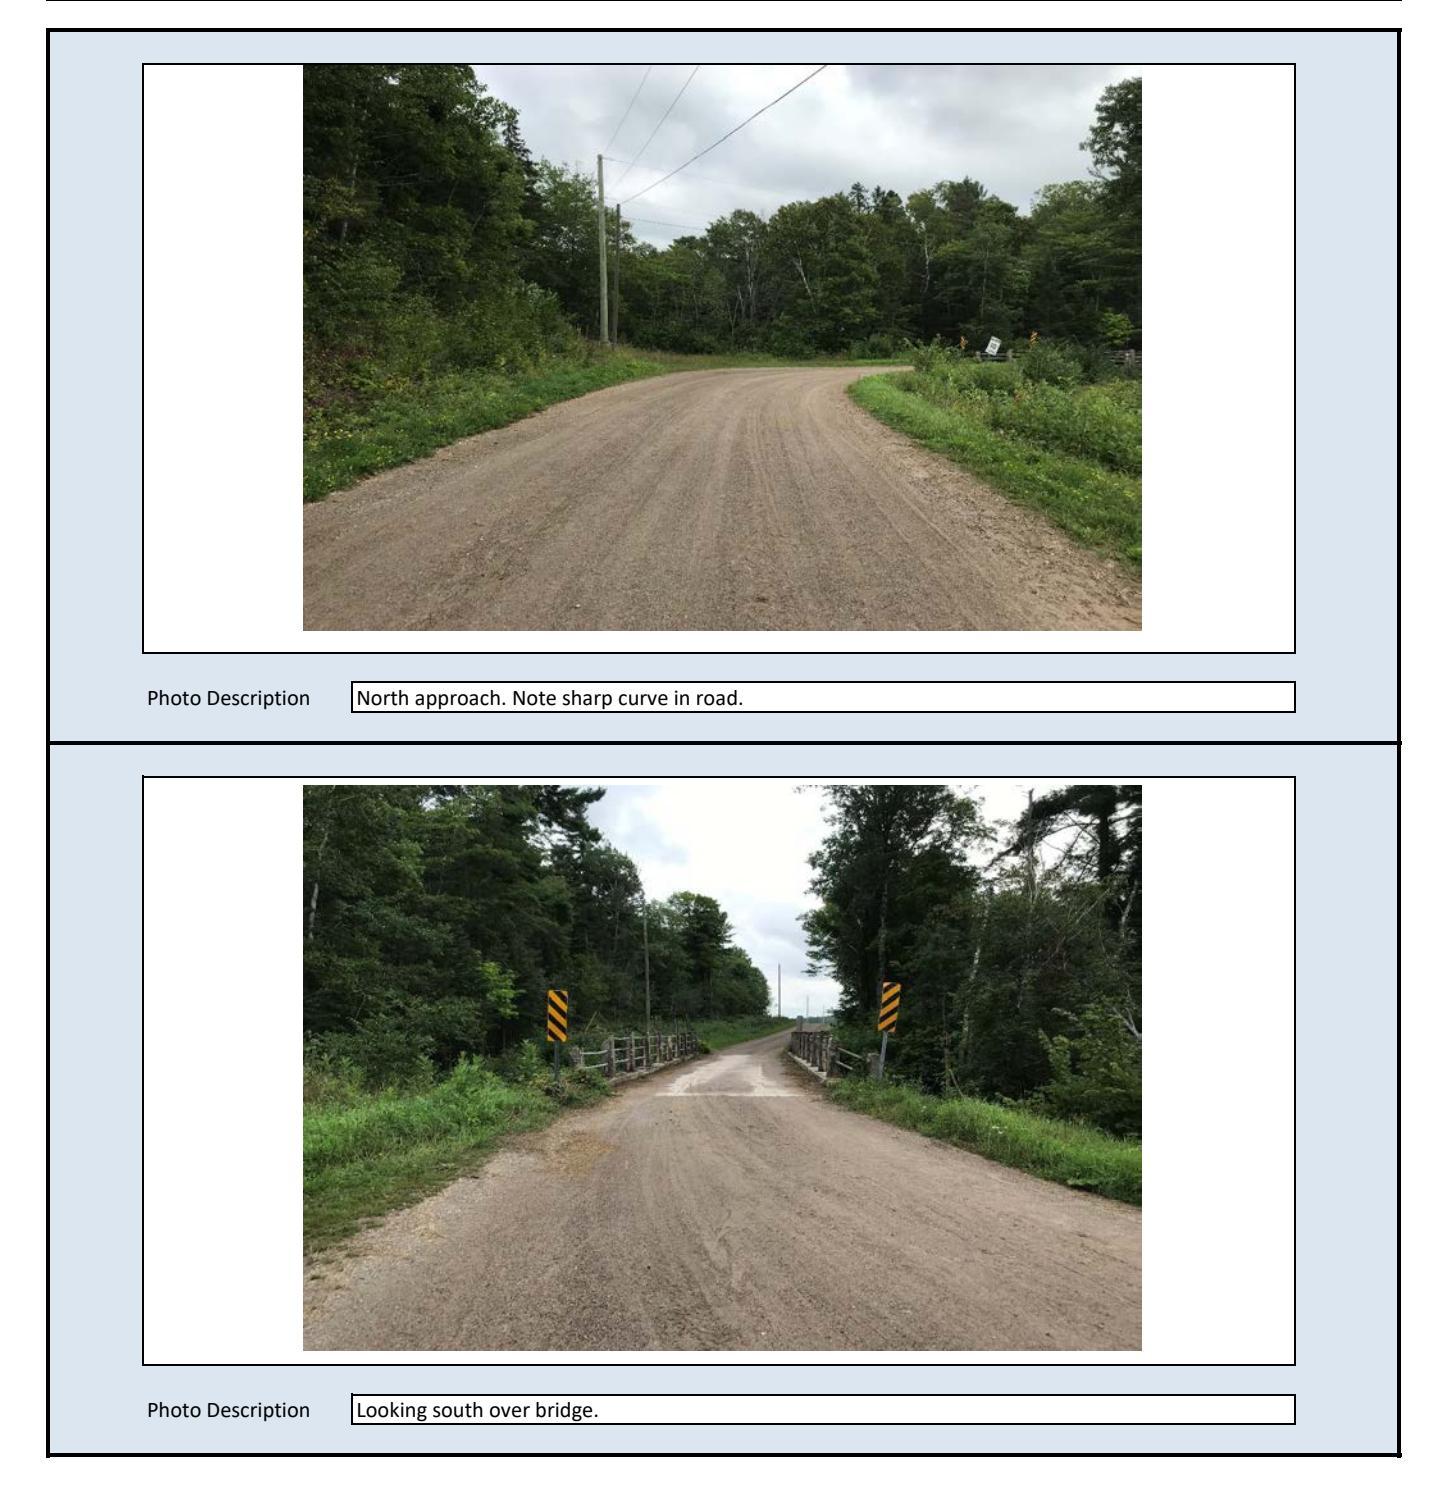
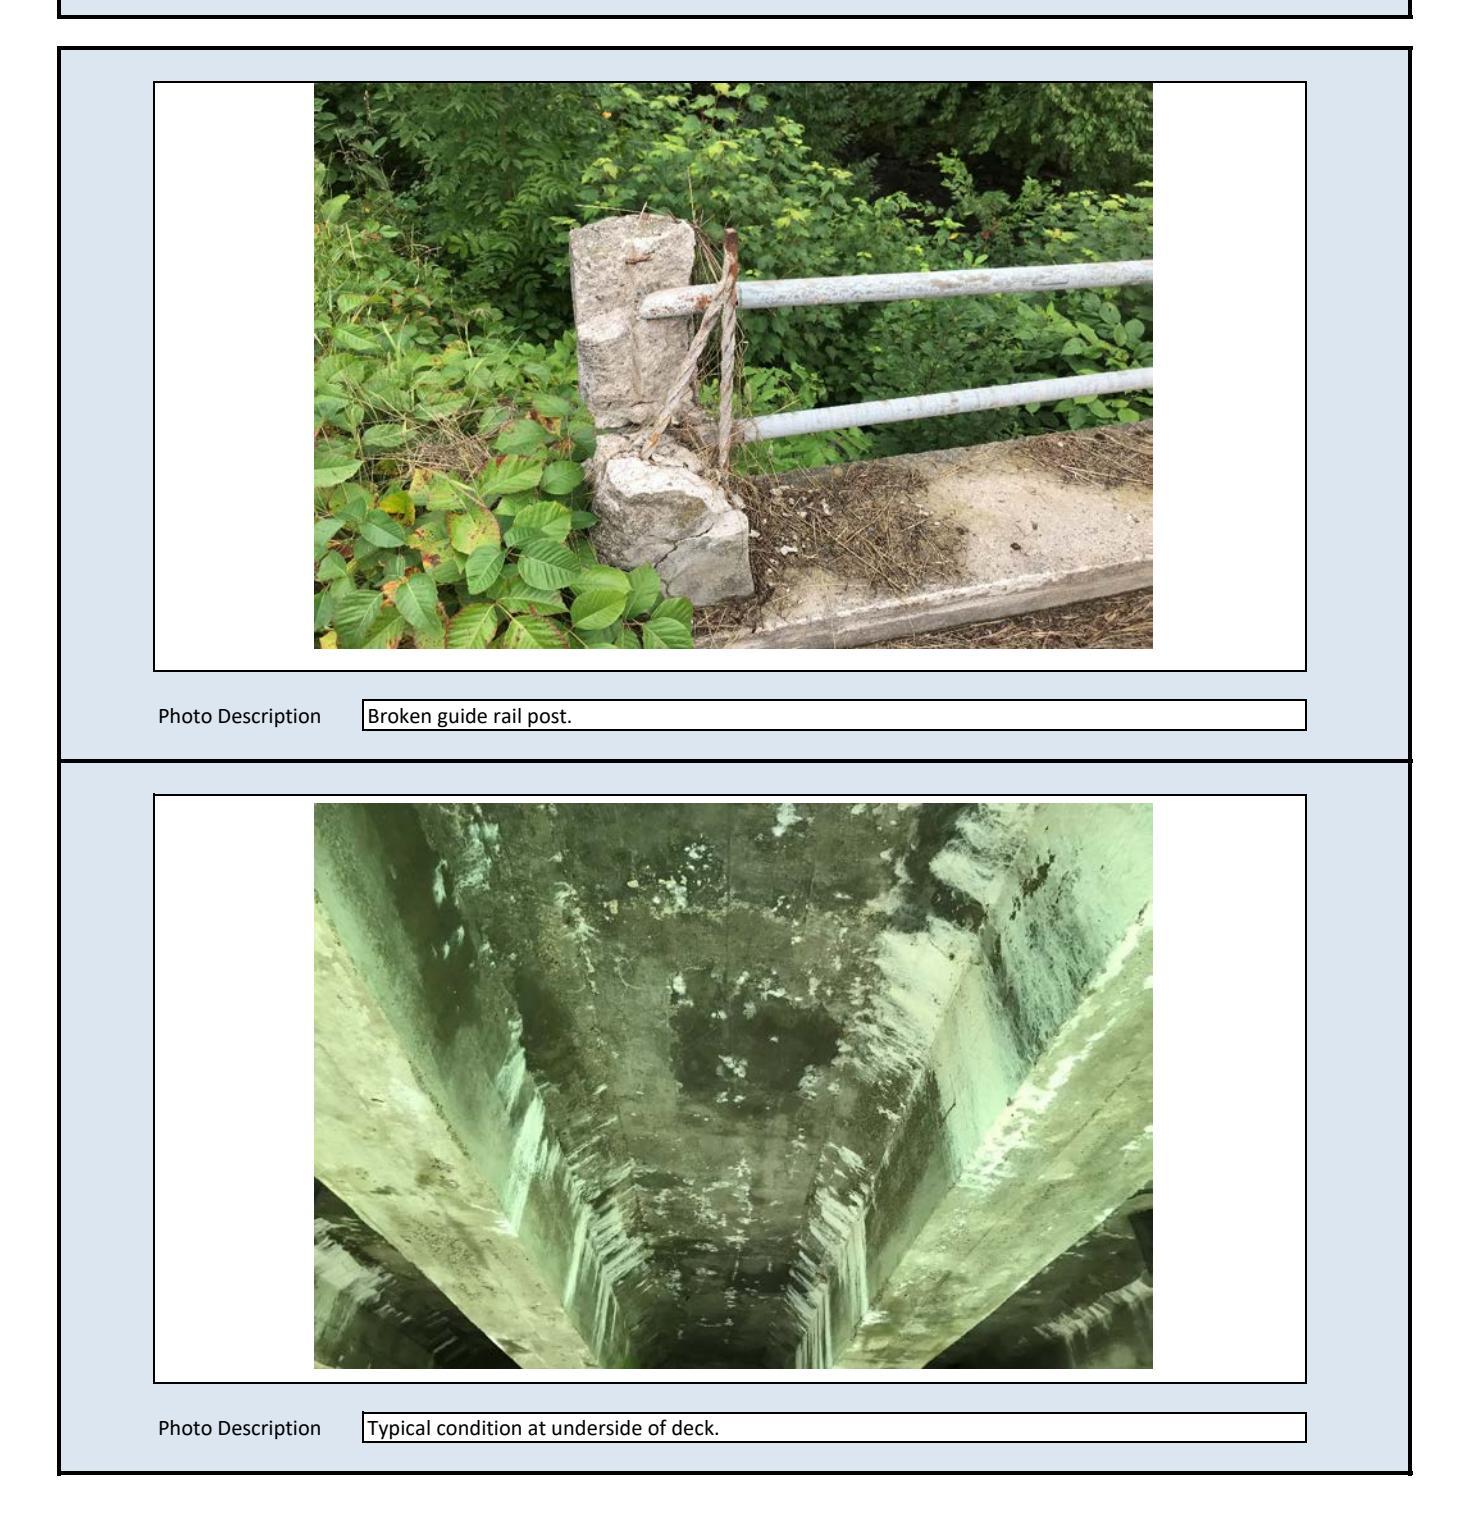
BRIDGE PHOTOGRAPHS		20	20 Biennial Inspection
Structure: Towr	nship of Johnson - Old Mill Road Bridge	Structure #:	B4

This bridge, constructed in about 1913 is a concrete structure with a steel pipe guide rail.

The structure is in poor condition and requires replacement or rehabilitation. It is recommended that the Township initiate a replacement/rehabilitation study. Due to the sharp curve in the road at the north bridge approach, the Township may also wish to consider options for road realignment.

M. REMARKS		
191	INSPECTION NOTES:	
	• Triple span concrete bridge with concrete deck.	
	Steel tube railings with concrete posts are in poor condition and require attention.	
	Hazard markers are located at three of four quadrants.	
	No guide rails on approaches.	
	Snowplow wing markers are not installed.	
	Gravel roadway is in fair condition with a sharp curve at the north approach.	
	Concrete wearing surface on bridge deck appears in fair condition. Minor sand accumulation.	
	Road embankments appear stable and in fair condition.

• Cast in-place concrete girders are in poor condition with cracking and exposed reinforcing steel.	
	Concrete soffit in poor condition with efflorescence, spalling and cracking throughout.

• Stream is in fair condition.	
	Inspection limited due to vegetation growth.	
	RECOMMENDATIONS:	
	Clean sand accumulation from the deck.	
	Carry out guide rail repairs and install guide rails on approaches.	
	 Structure is likely beyond its servicable life and requires rehabilitation or replacement.

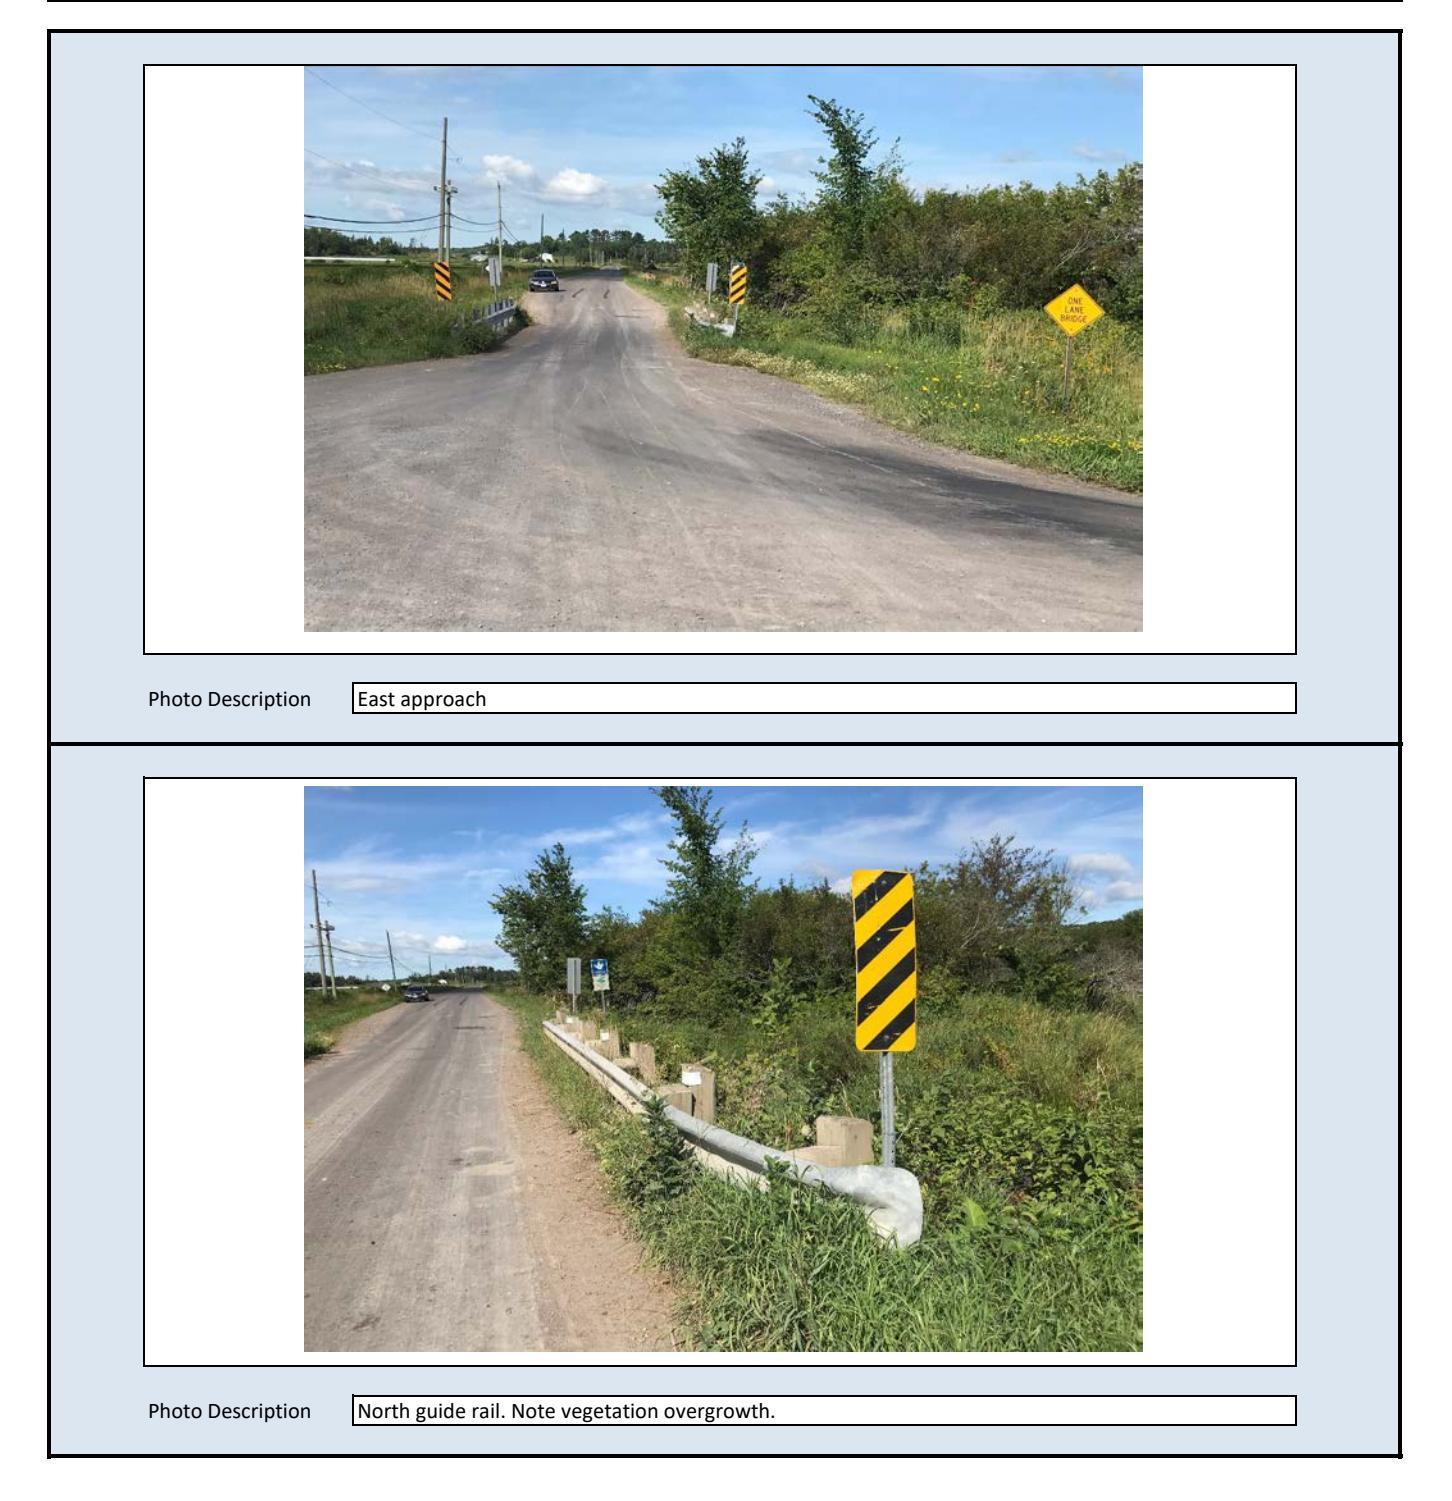
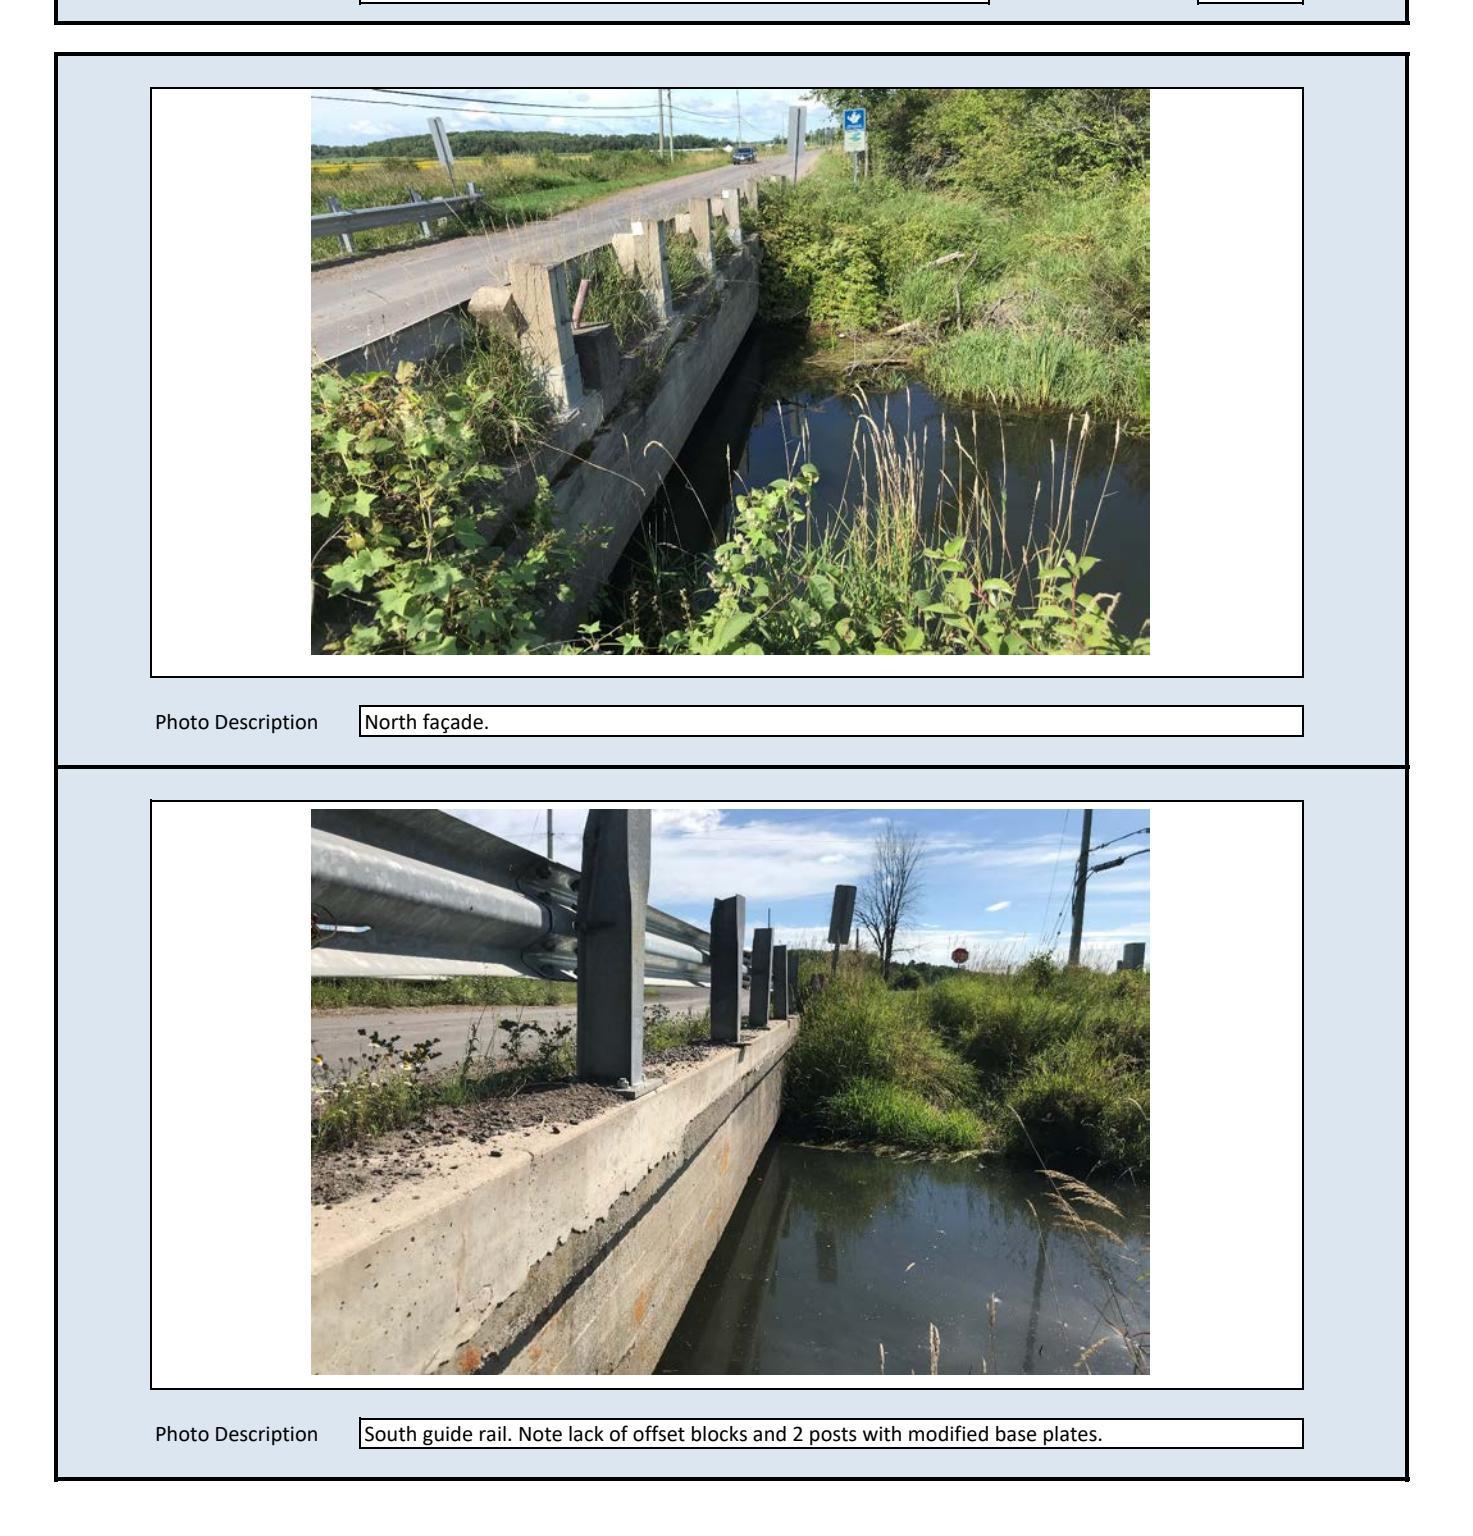
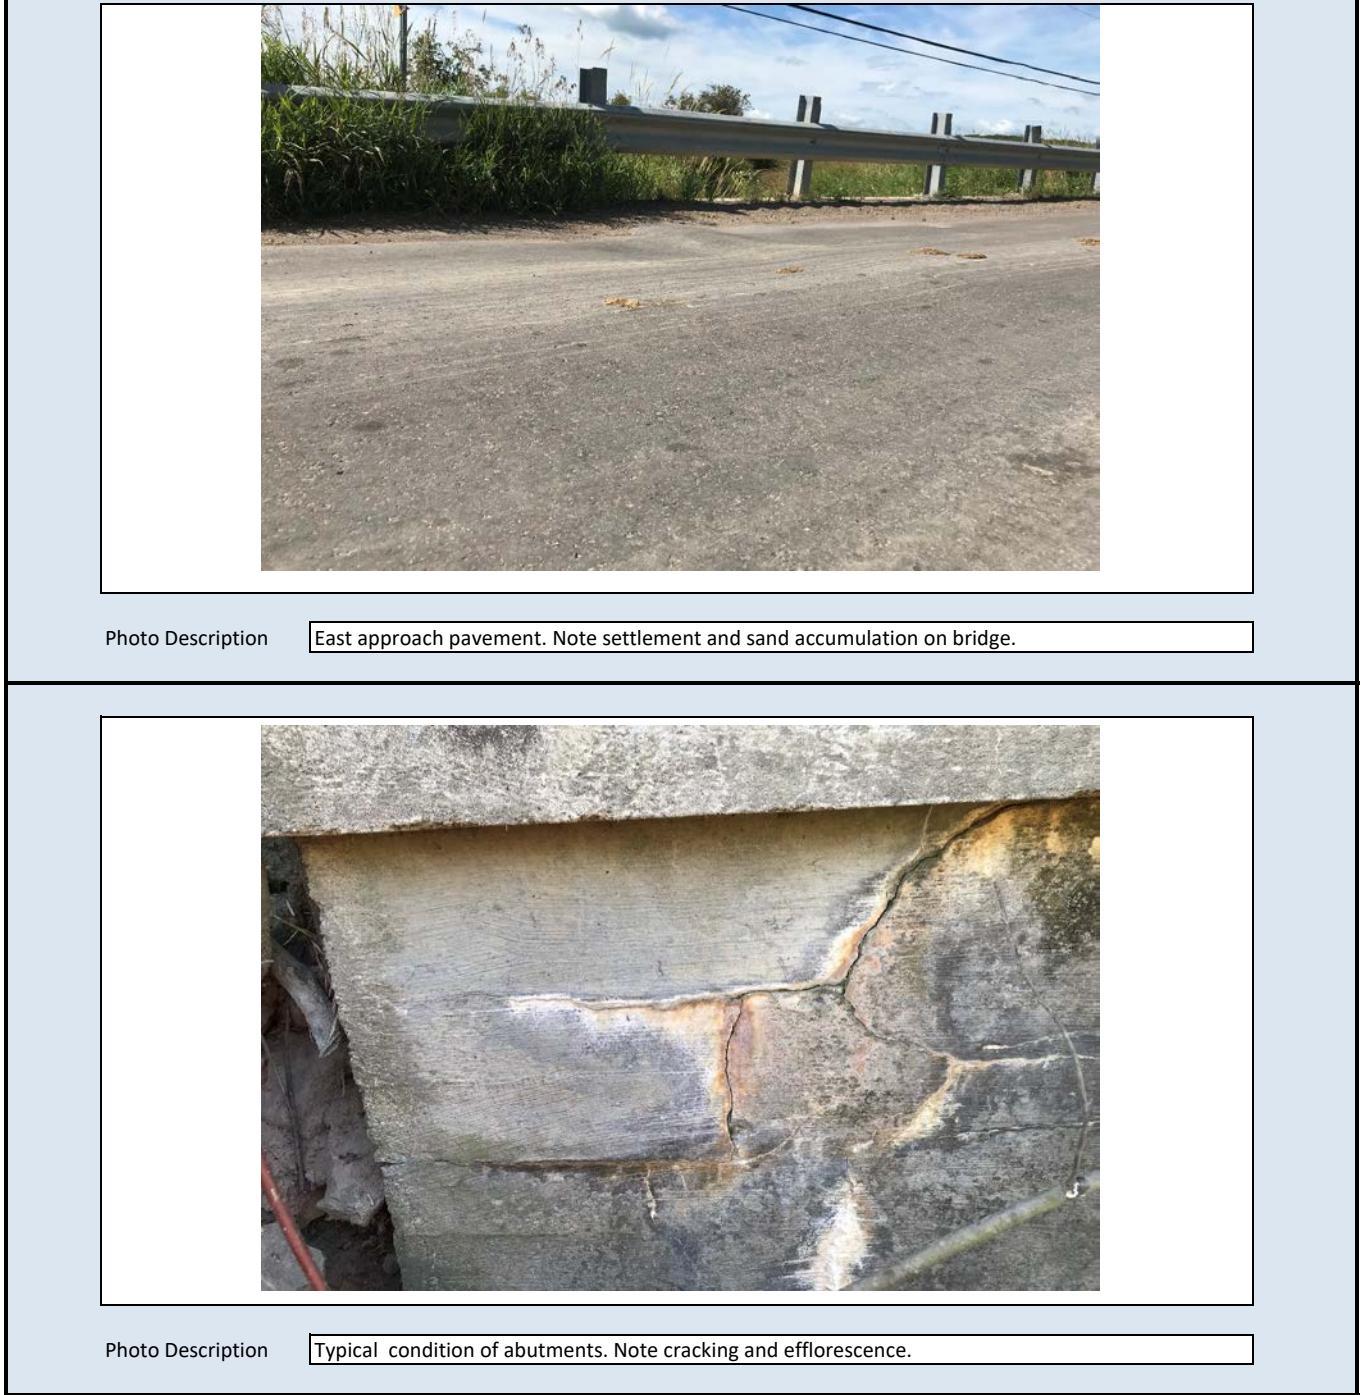
BRIDGE PHOTOGRAPHS		2020 Biennial Inspection
Structure:	Township of Johnson - Government Road Bridge	Structure #: B3

The bridge on Government Road just west of Gordon Lake Road appears in fair condition; however the inspection was limited due to high water obscuring much of the substructure.

M. REMARKS		
191	INSPECTION NOTES:	
	 Single span cast in-place concrete bridge with concrete deck and asphalt pavement wearing surface. Continuous steel flex beam guide rails with steel posts on south side and wood posts with offset blocks on the north side. Steel posts, without offset blocks, extend above flex beam on south side; some impact damage to posts and beams. Some guide rails on approaches. Hazard markers are located on all four quadrants. Snowplow wing markers are not installed. Asphalt paved roadway is in poor condition with potholes and settlement at the approaches. Signs of erosion at abutments. Inspection limited due to high water and vegetation growth. 	
	RECOMMENDATIONS: • Clean sand accumulation and vegetation from bridge deck. • Carry out vegetation management. • Repair asphalt roadway. • Carry out guide rail repairs and install approach guide rails.

Guide rail repairs are recommended, in addition to routine maintenance of the roadway.

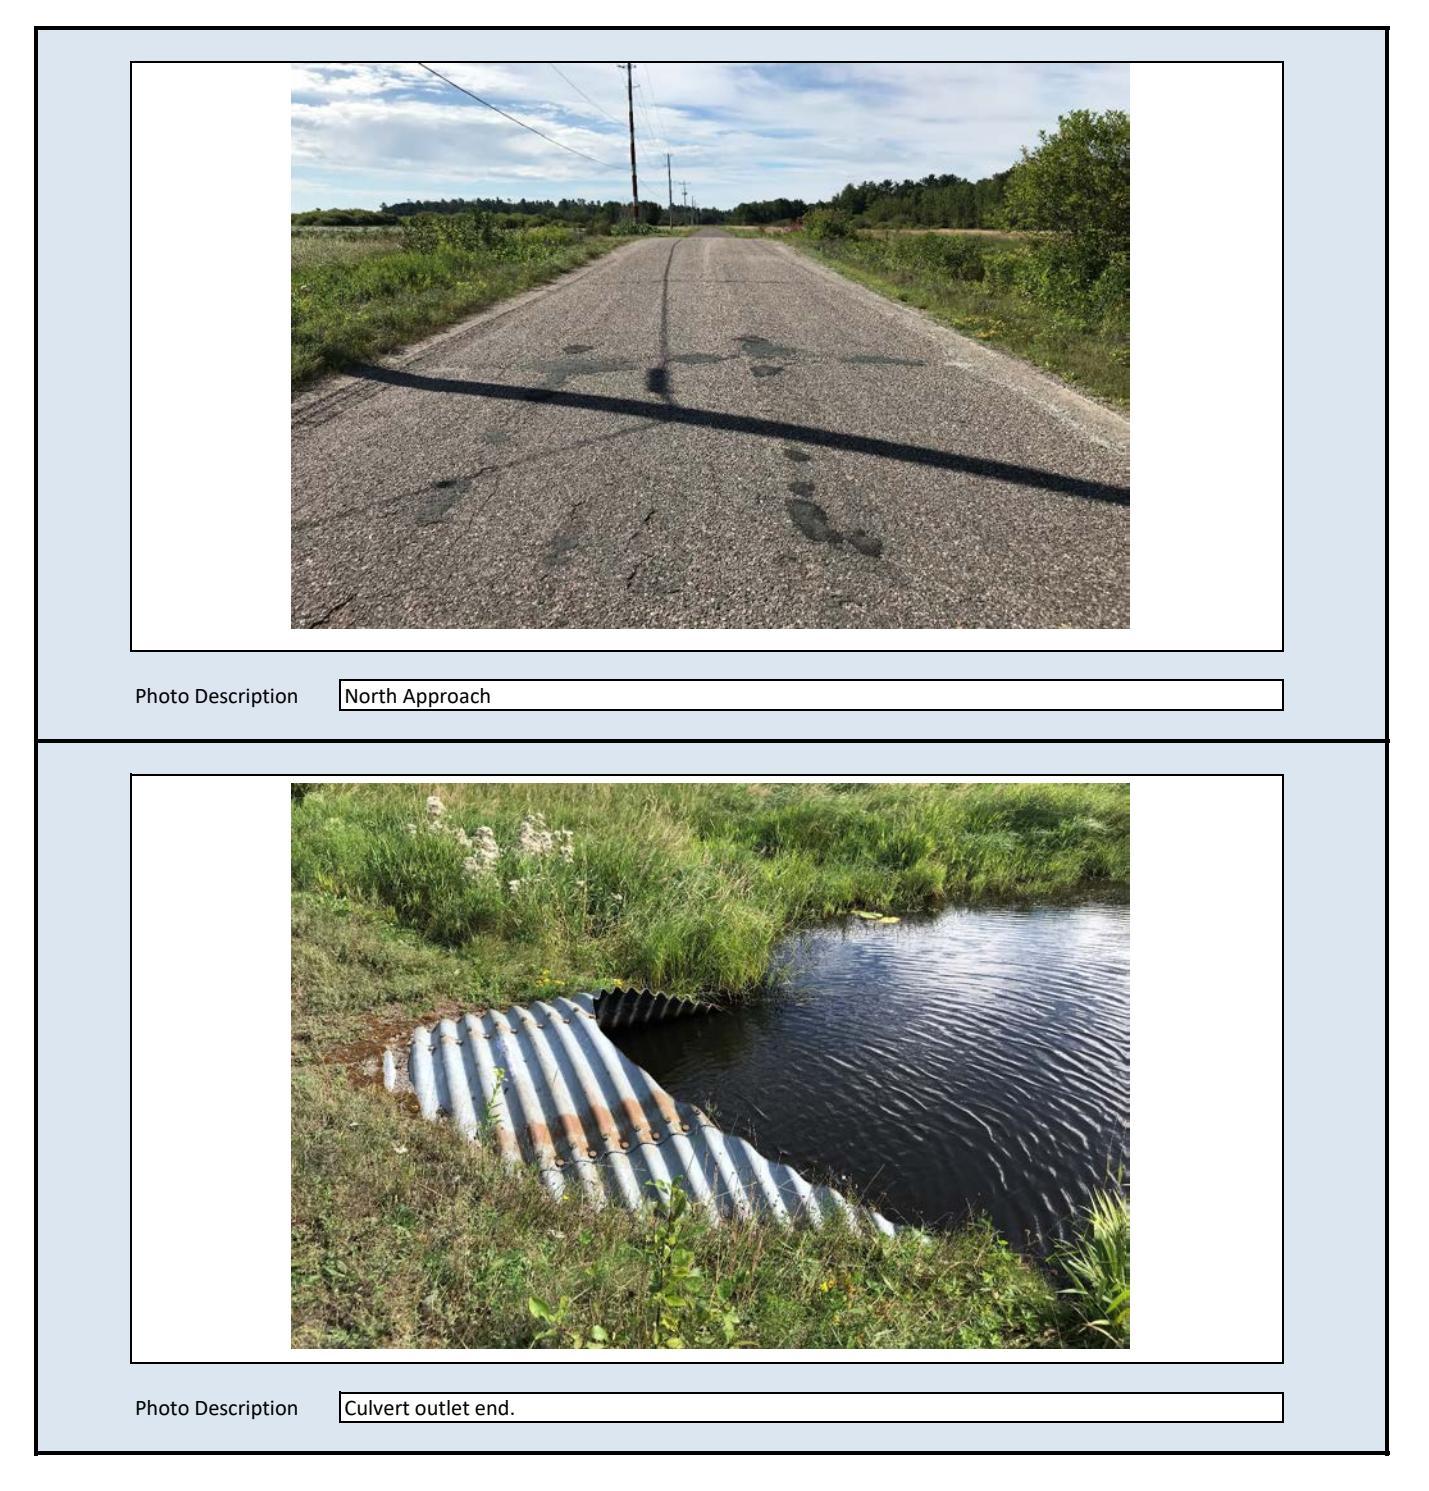
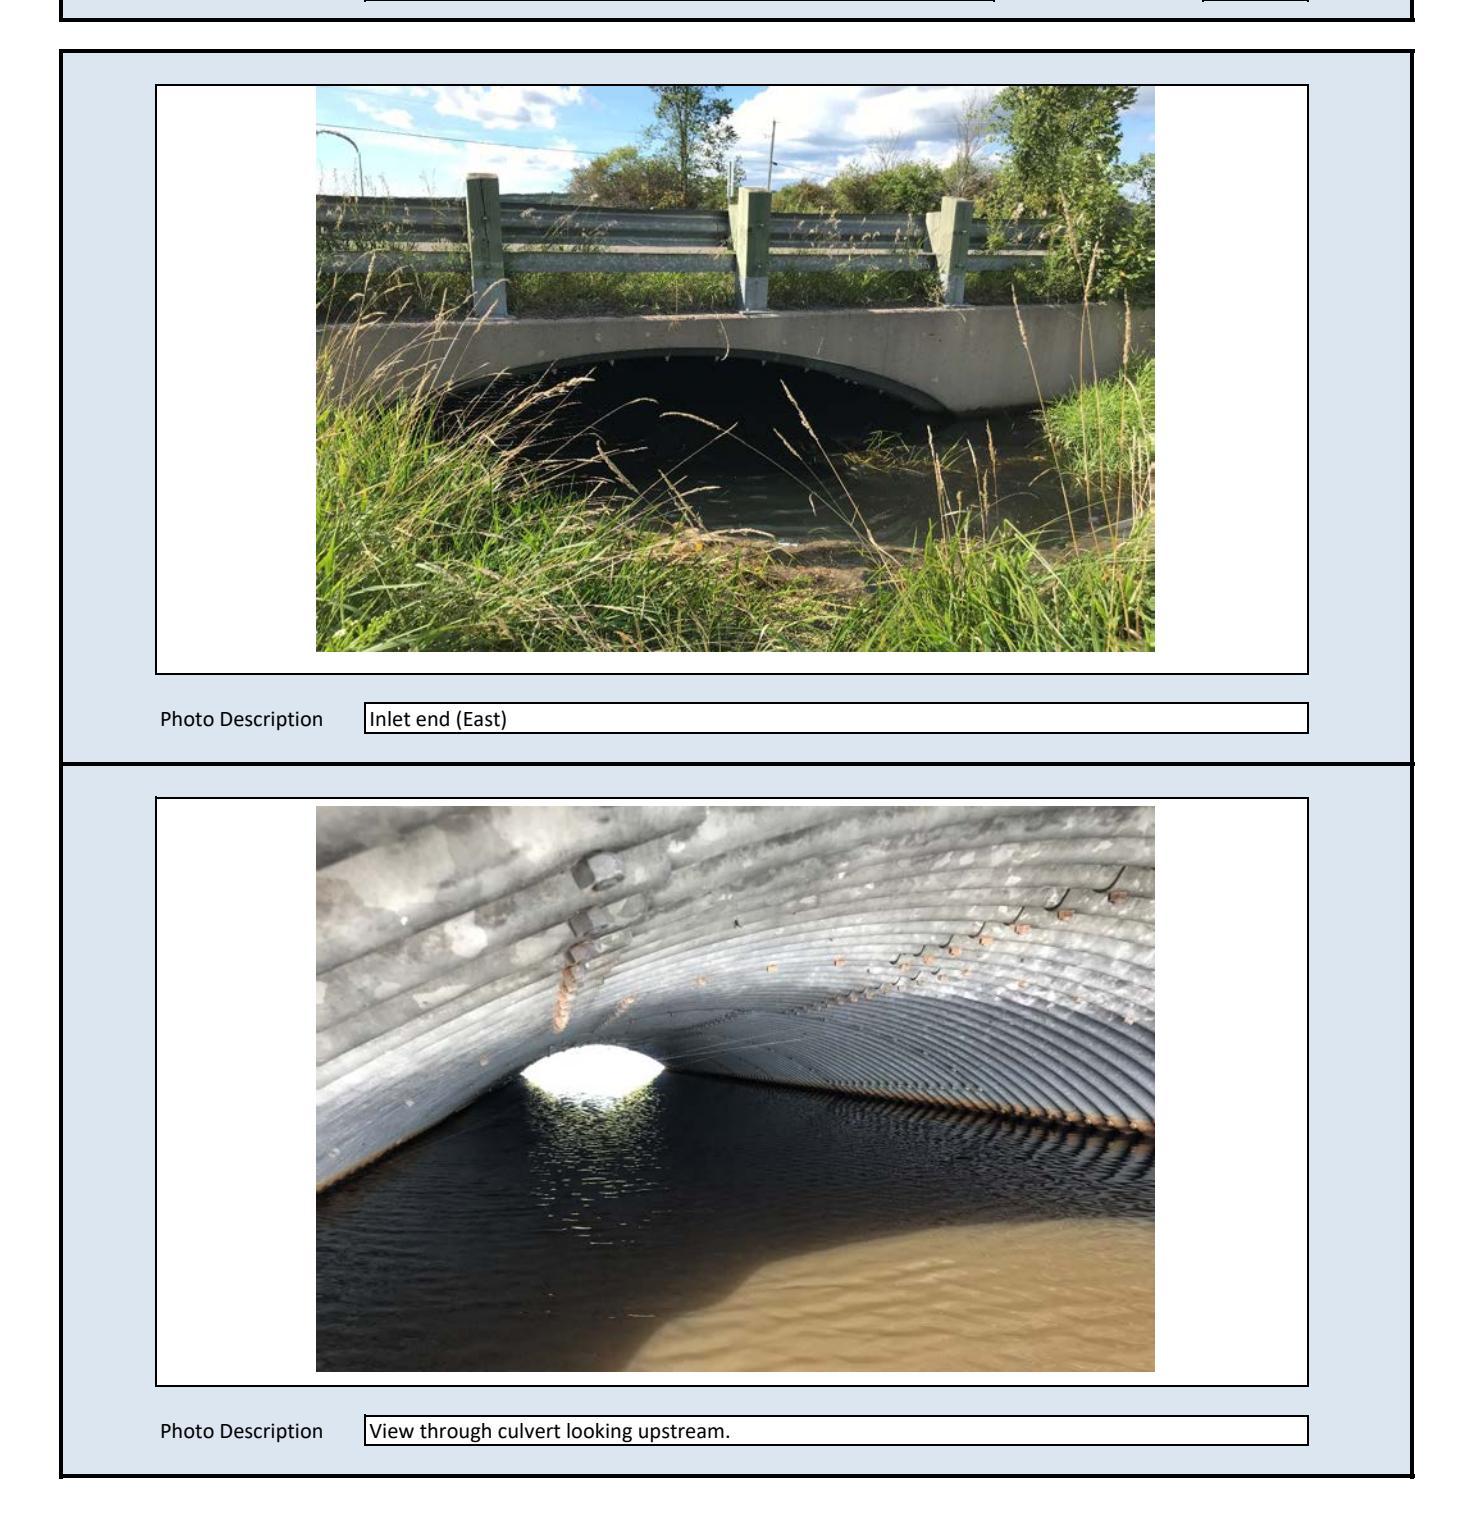
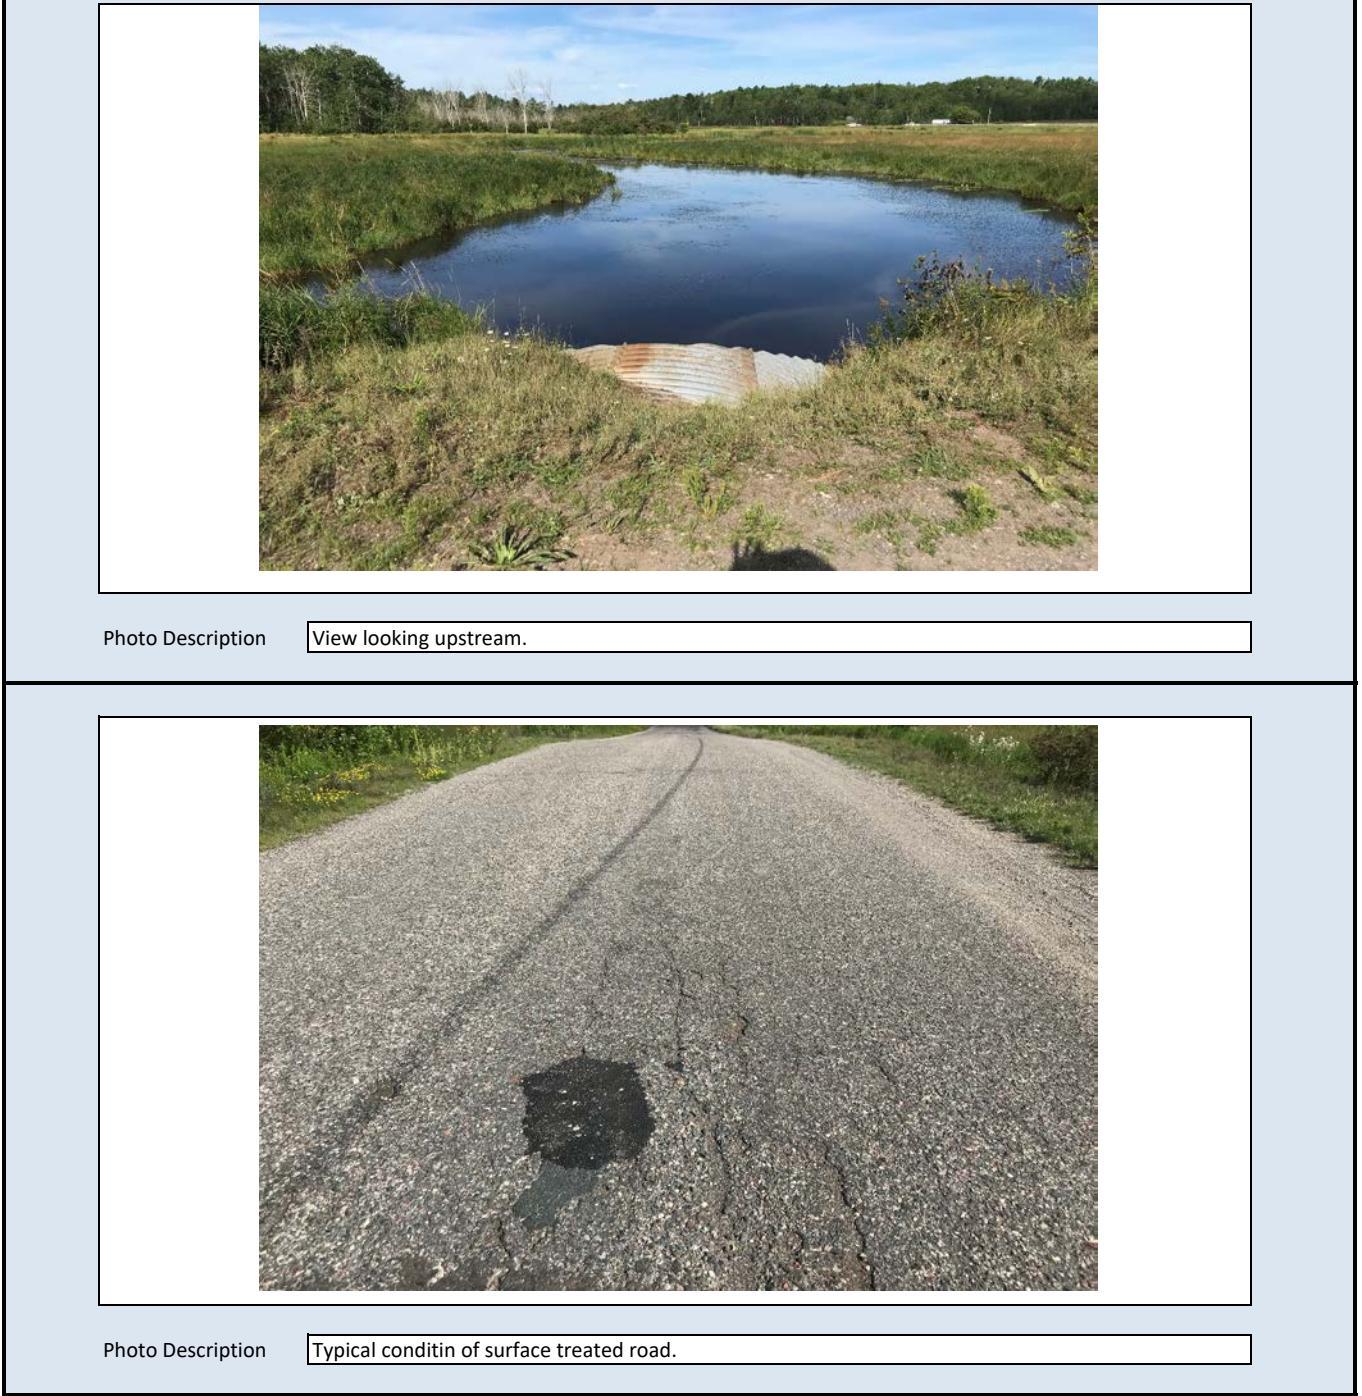
CULVERT PHOTOGRAPHS		2020 Biennial Inspection
Structure:	Johnson Township - Kensington Road Culvert	Structure #: C3

The Kensington Road Culvert appears in fair condition; however much of the culvert was obscured by high water at the time of the inspection. The Township should consider installation of guide rails at the structure.

M. REMARKS		
191	INSPECTION NOTES:	
	- Culvert is a structural plate corrugated steel pipe arch with bevelled ends.	
	- Minor rust staining visible at water line.	
	- Approximately 700mm cover over culvert.	
	- Surface treated road over culvert appears in good condition.	
	- Road embankments appear in good condition.	
	- The stream appears stable and in good condition.	
	- Inspection limited due to high water obscuring culvert installation.	
	RECOMMENDATIONS:	
	- Continued routine mainteance is reocmmended.	
	- Consider installation of guide rails.

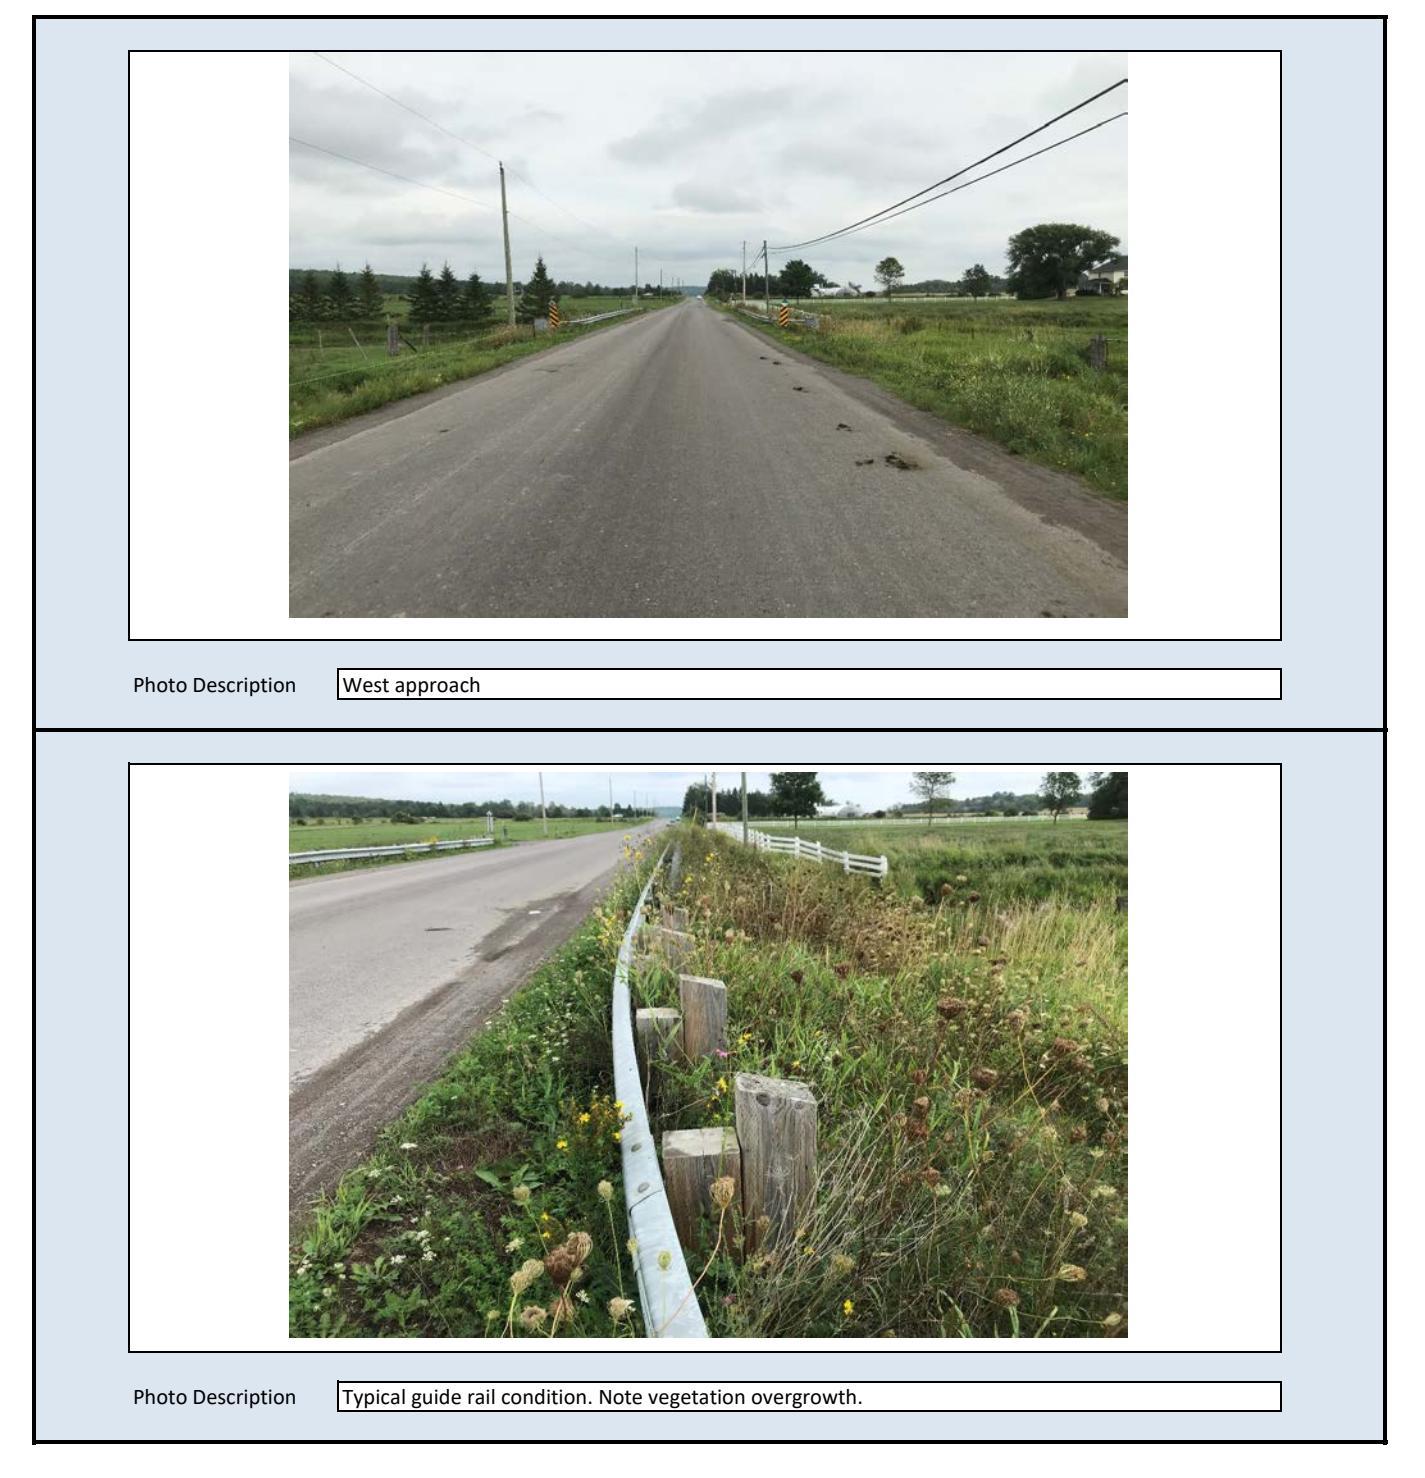
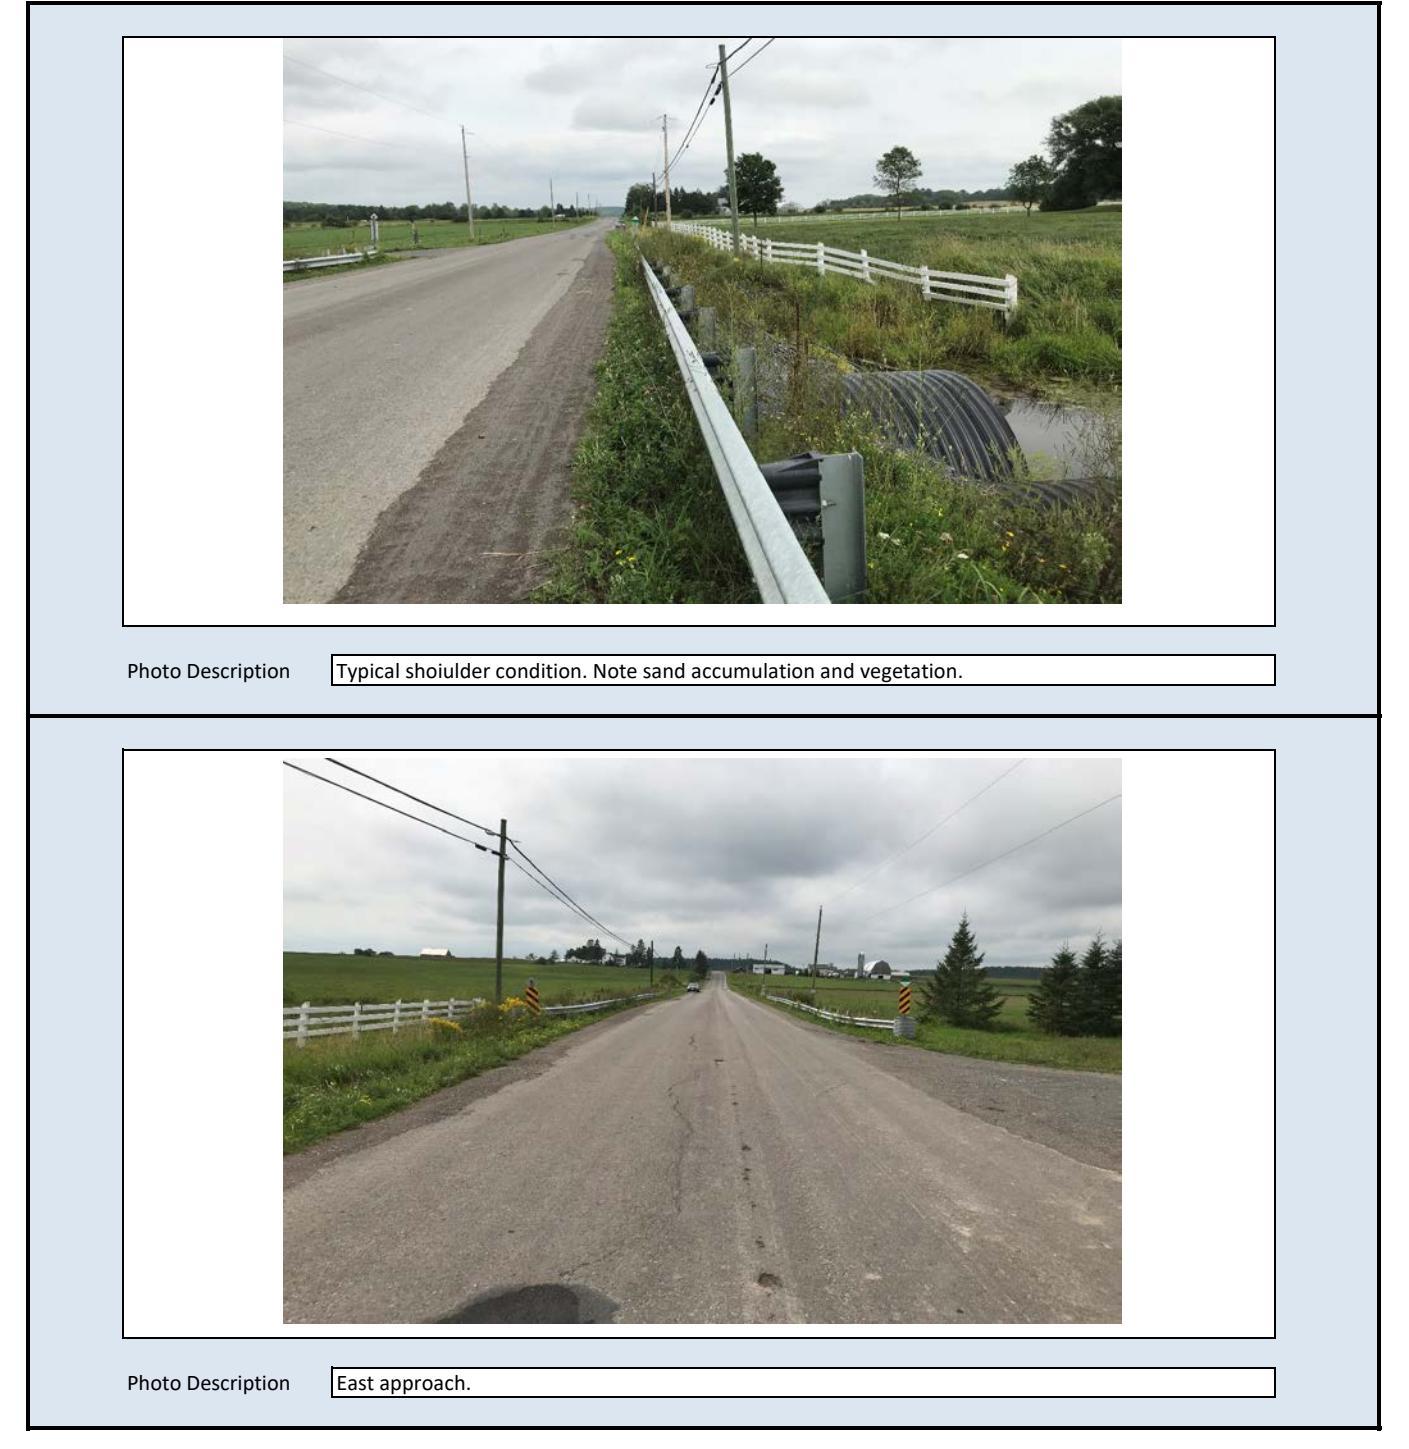
CULVERT PHOTOGRAPHS		2020 Biennial Inspection
Structure:	Johnson Township - Government Road Culvert	Structure #: C1

This structure consists of two round corrugated steel pipes reportedly installed in about 2014. The installation appears in good condition.

M.	REMARKS		
	191	INSPECTION NOTES:	
		- Polymer coated spiral CSPs; main barrel is 3m diameter, relief barrel is 1.2m diameter.	
		- 3m pipe has step bevelled ends.	
		- Flex beam guide rail is installed over culvert complete with eccentric loader barrel terminations.	
		- Guide rail is in fair condition with hazard and snowplow markers at all four quadrants.	
		- Surface treated road over culvert appears in fair to poor condition with potholes and distress.	
		- Road embankments appear in stable condition.	
		- The stream appears stable and in good condition.	
		DECOMMENDATIONS:	
		Continued routing mainteance is recommended including tightening guide rail bolts, erosion renairs	
		- Vegetation management is recommended
