2018 Biennial Bridge and Culvert Inspection

Township of Johnson

STEM Engineering Group Inc.
875 Queen Street E. Suite 2
Sault Ste. Marie, ON
P6A 2B3

July 27, 2018

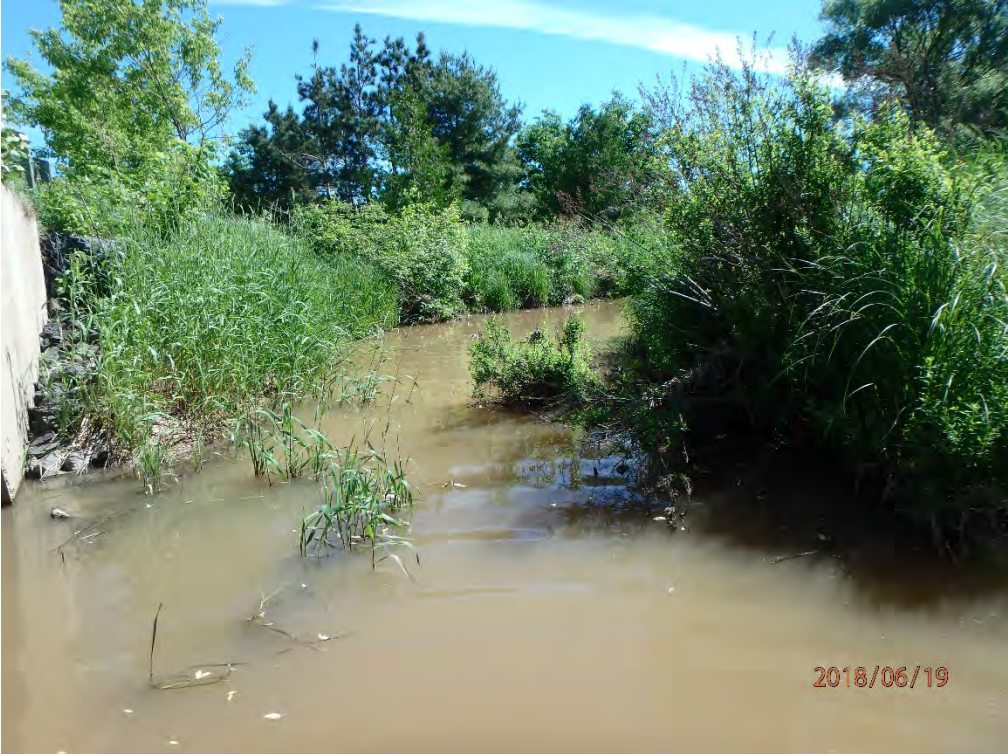
Downstream of Bridge

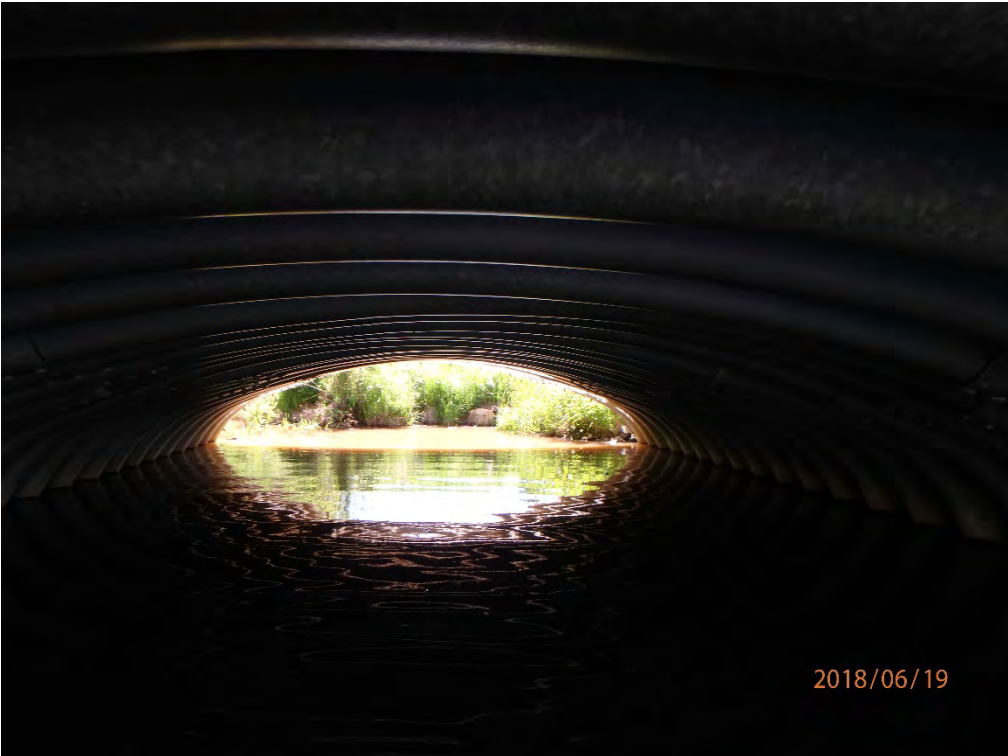
East through the Culvert

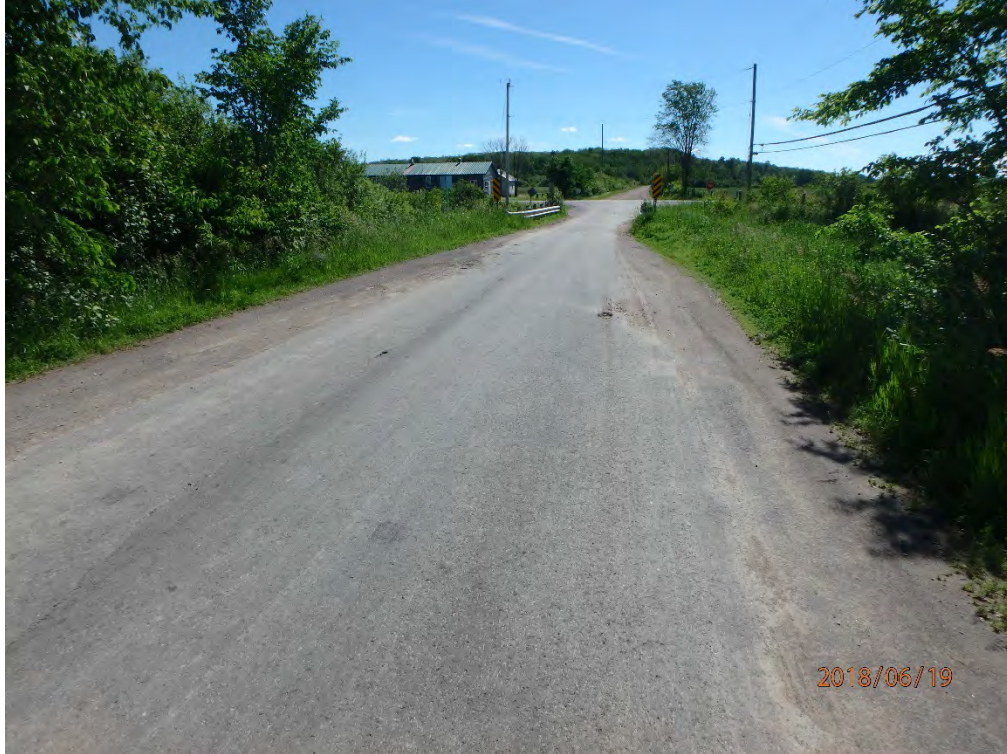
East across the bridge

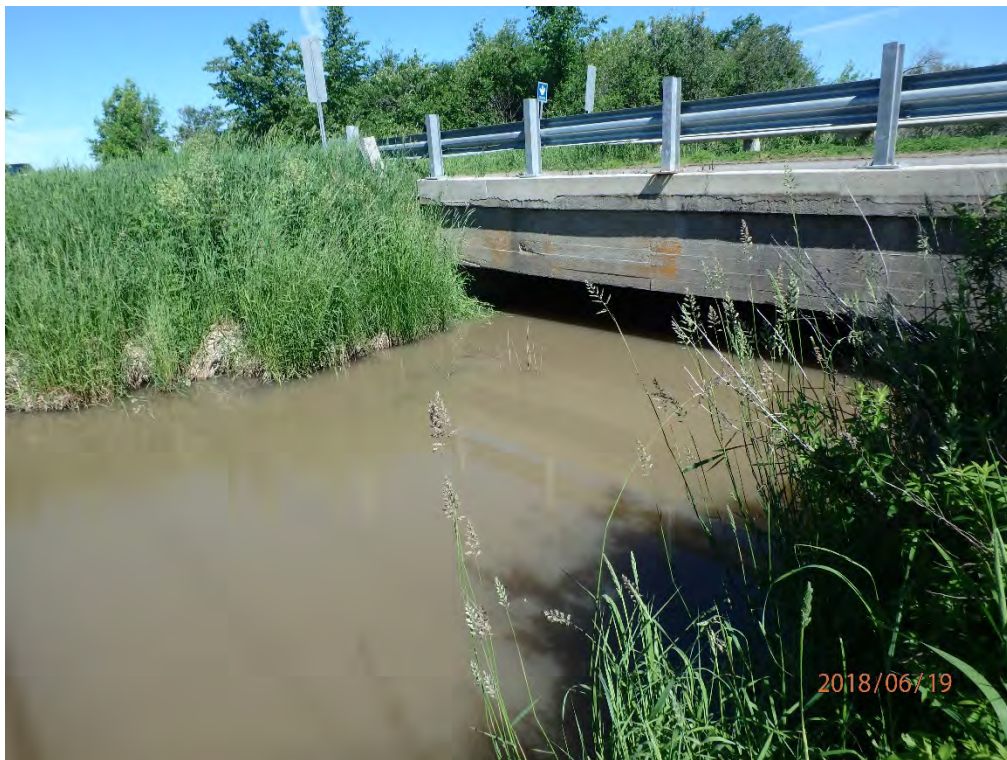
South Elevation of bridge

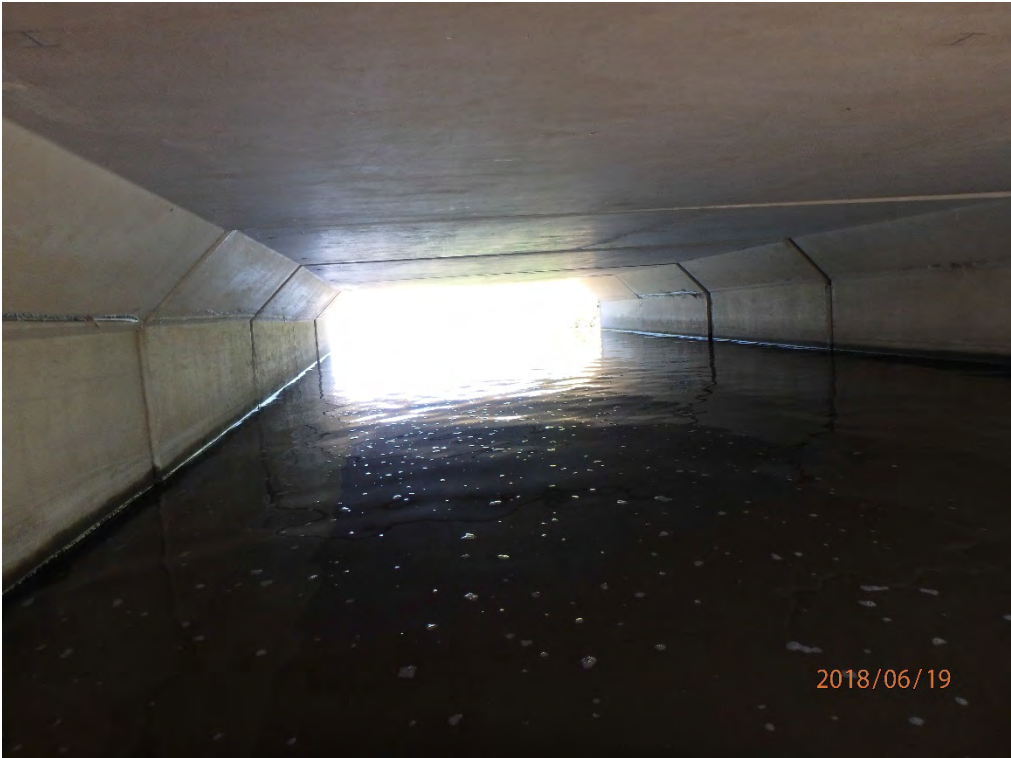
Looking west through barrel

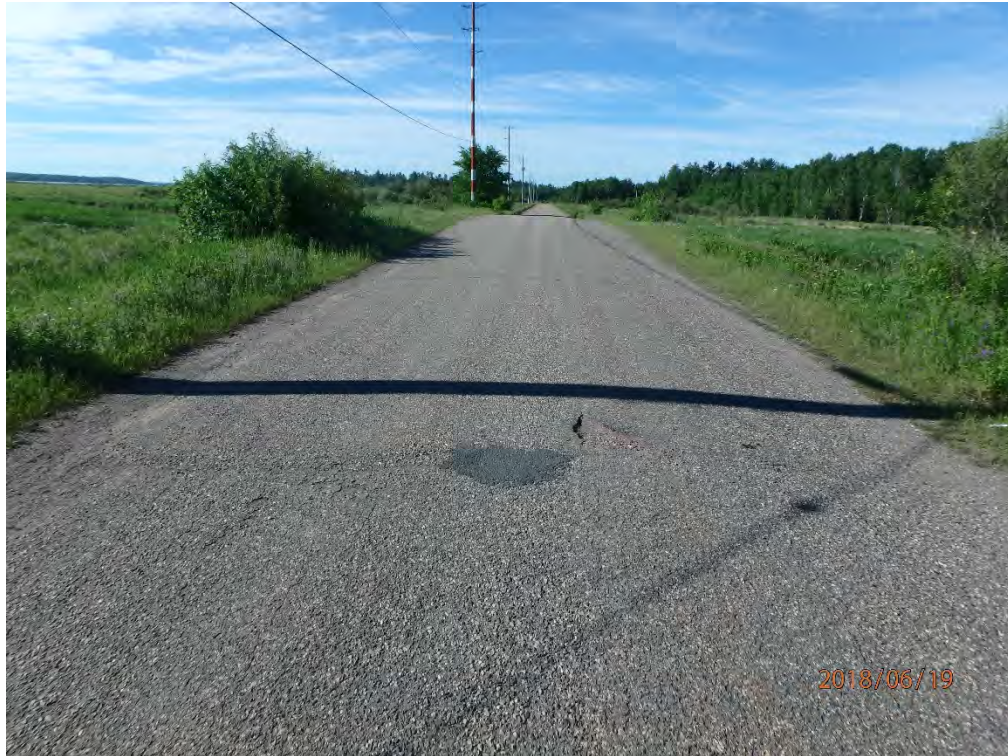
South across the culvert

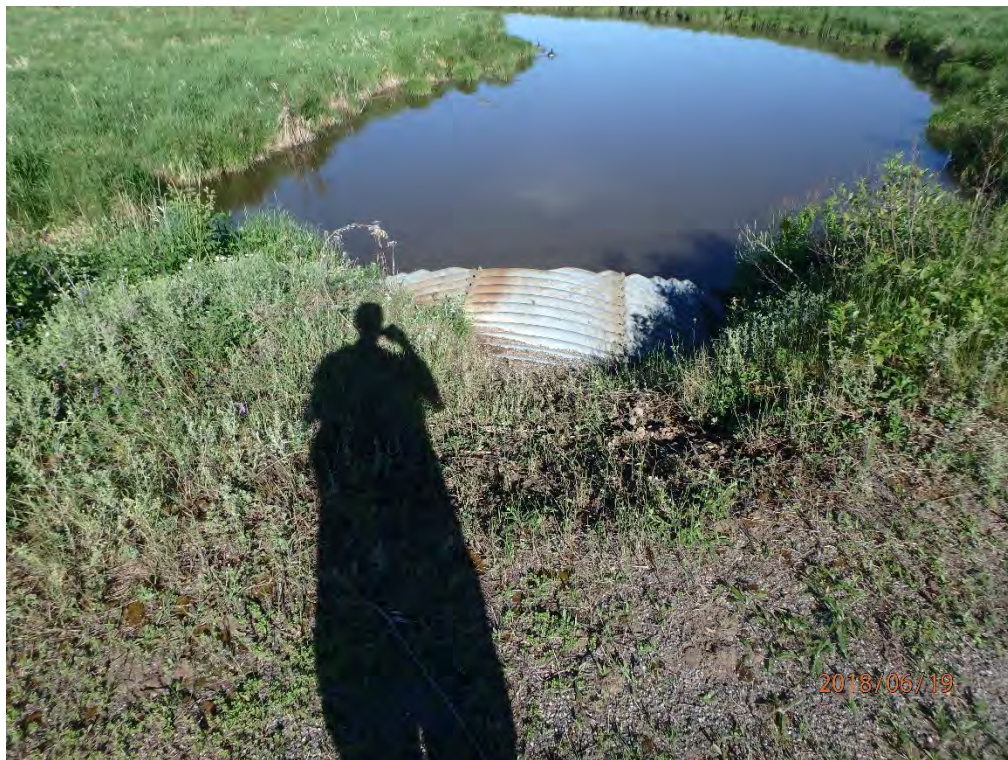
Looking west upstream of culvert

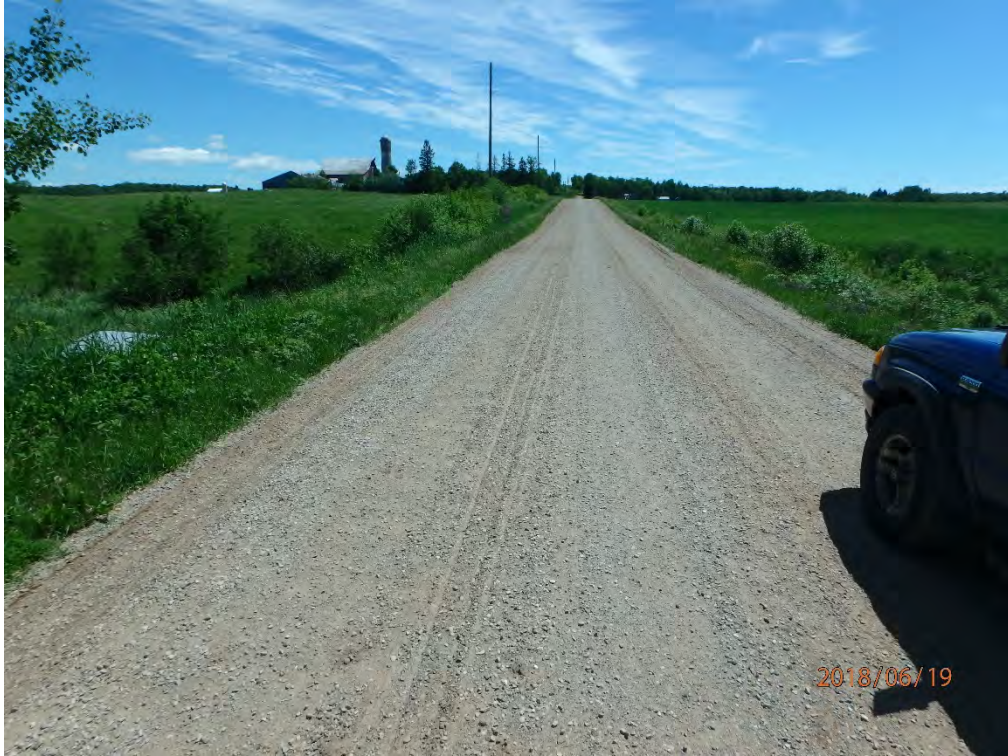
East Across culvert

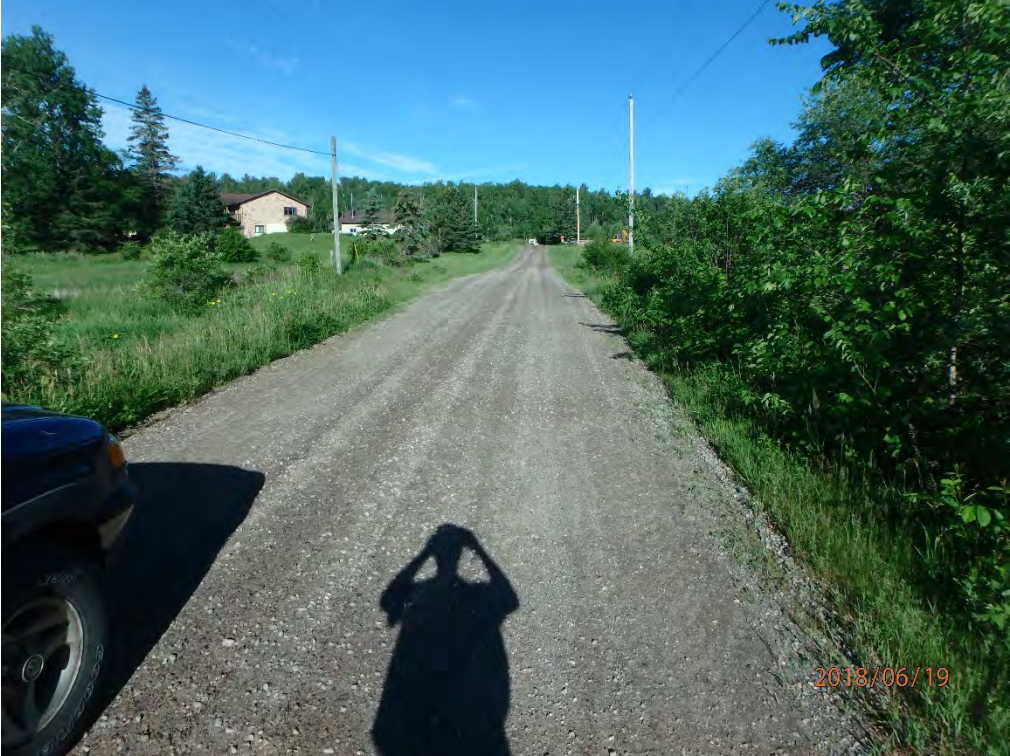
East across the culvert
