**2016 BIENNIAL MUNICIPAL BRIDGE
& CULVERT INSPECTIONS**

16-1055
August 3, 2016

Regarding: Township of Johnson - 2016 Biennial Bridge & Culvert Inspections

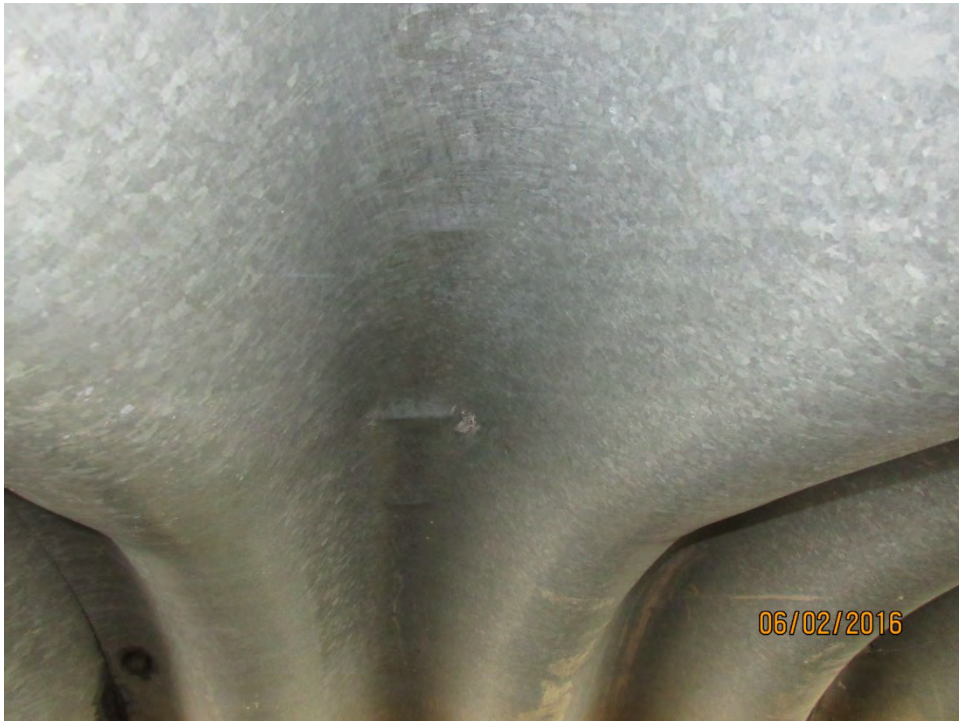
LOCALIZED INDENTATIONS IN THE RIBS OF THE CULVERT BARREL

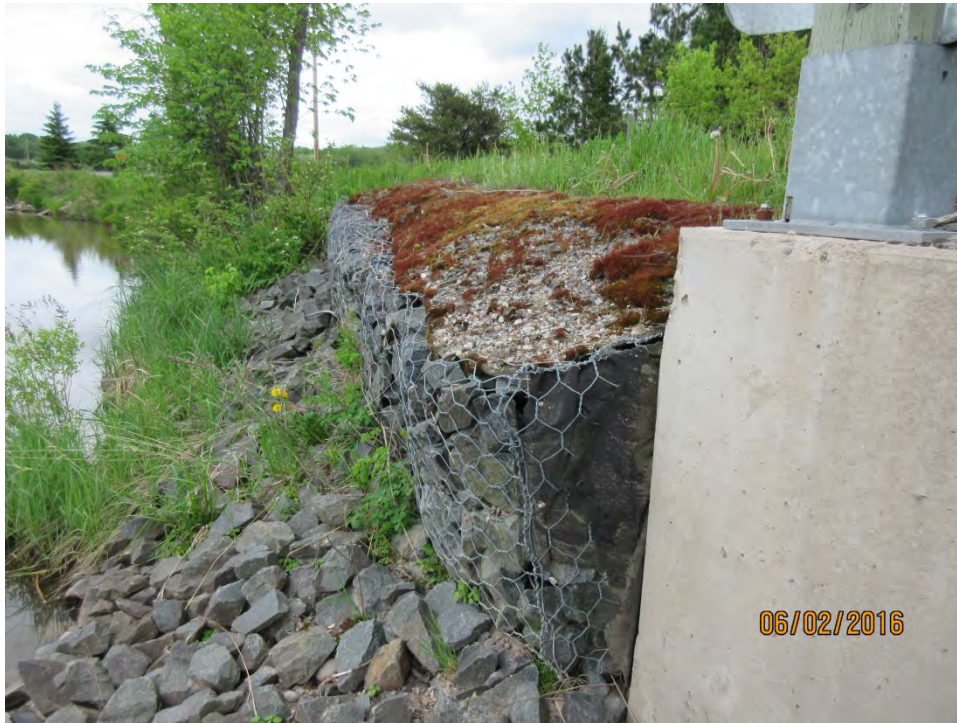
ROTATED GABION BASKET WINGWALL – NORTHWEST WINGWALL

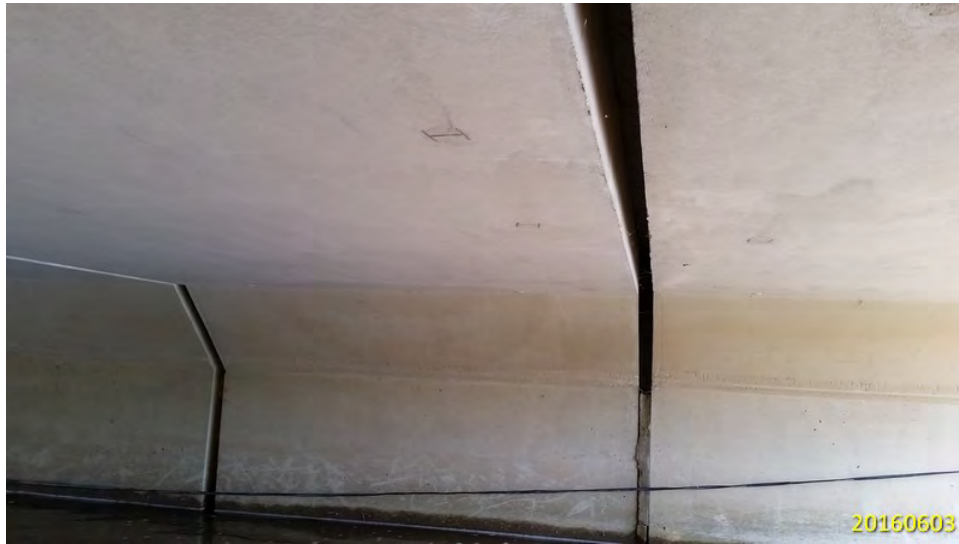
LOSS OF PARGING IN CULVERT BARREL JOINTS

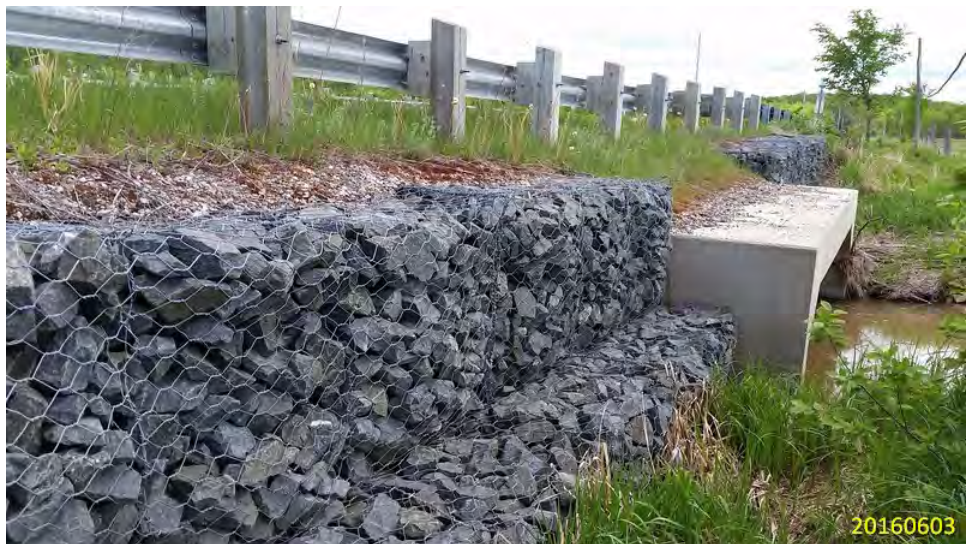
GABION BASKETS ALONG WEST ROADWAY EMBANKMENTS

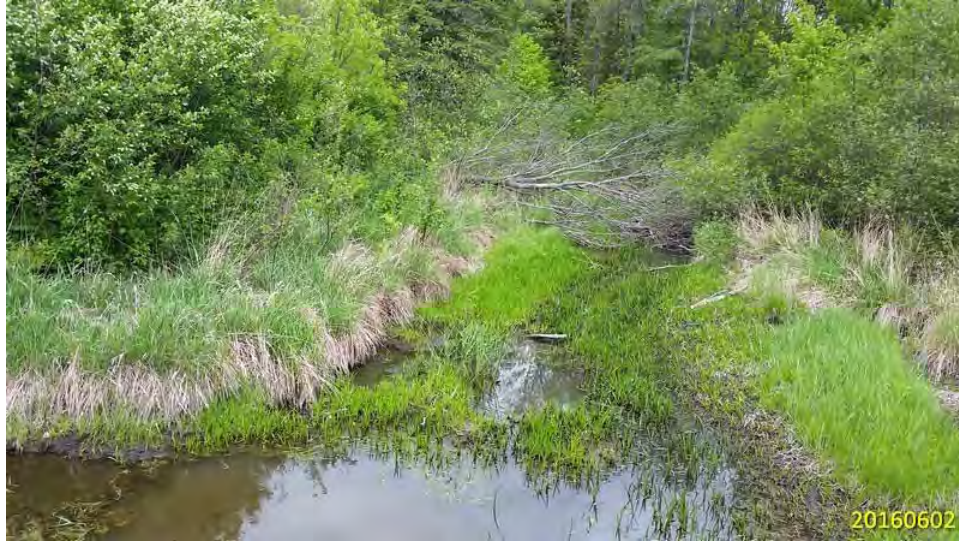
UPSTREAM FROM BRIDGE, TREE OBSTRUCTING WATERWAY

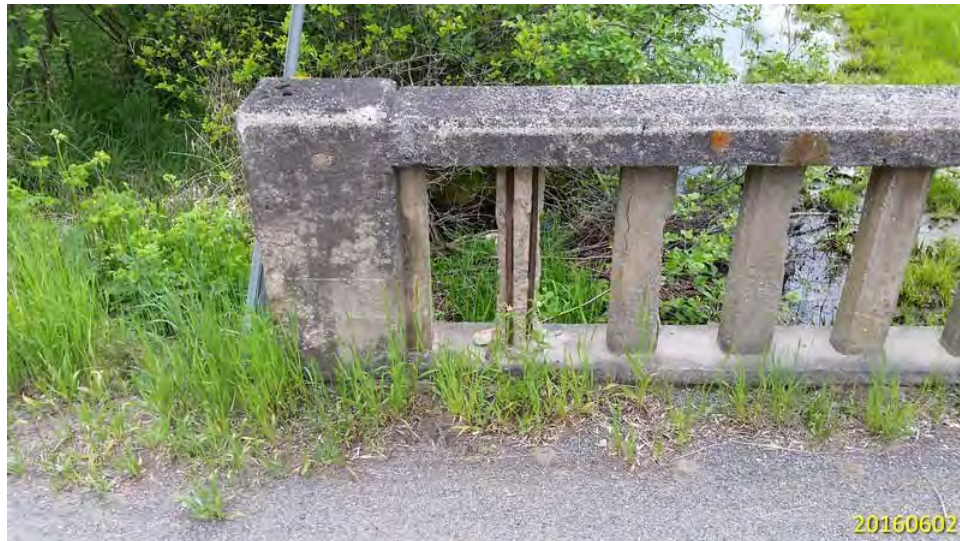
TYPICAL RAILING SYSTEM WITH EXPOSED REBAR
(SOUTHWEST QUADRANT)

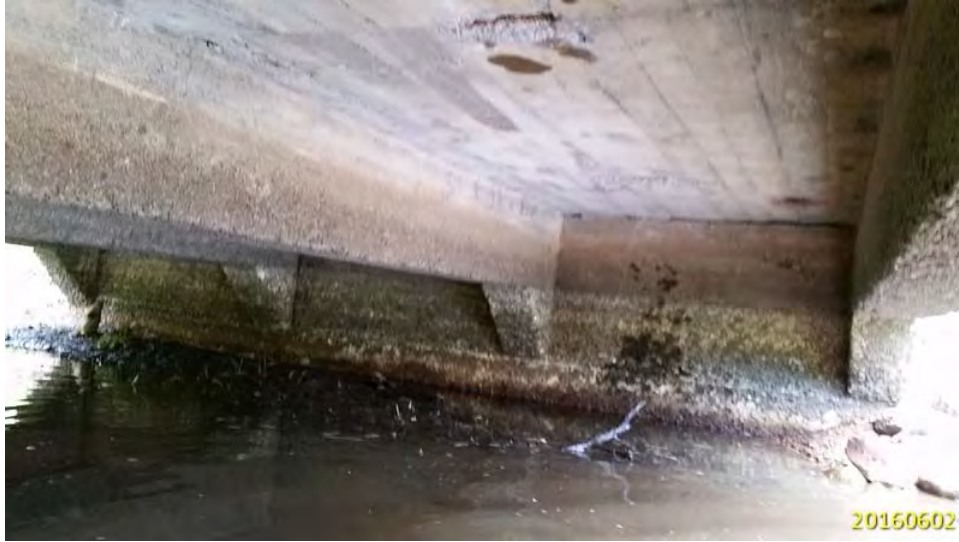
SOUTH ABUTMENT WITH MODERATE TO SEVERE EROSION

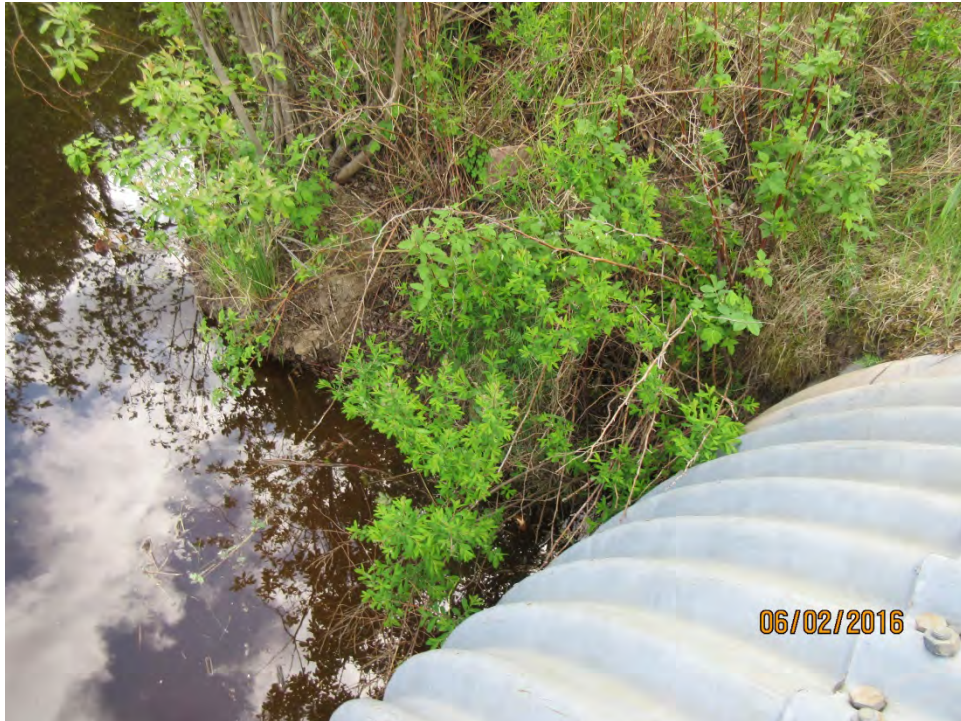
SEVERE EROSION AND SCOUR AT CULVERT INLET/NORTHEAST QUADRANT

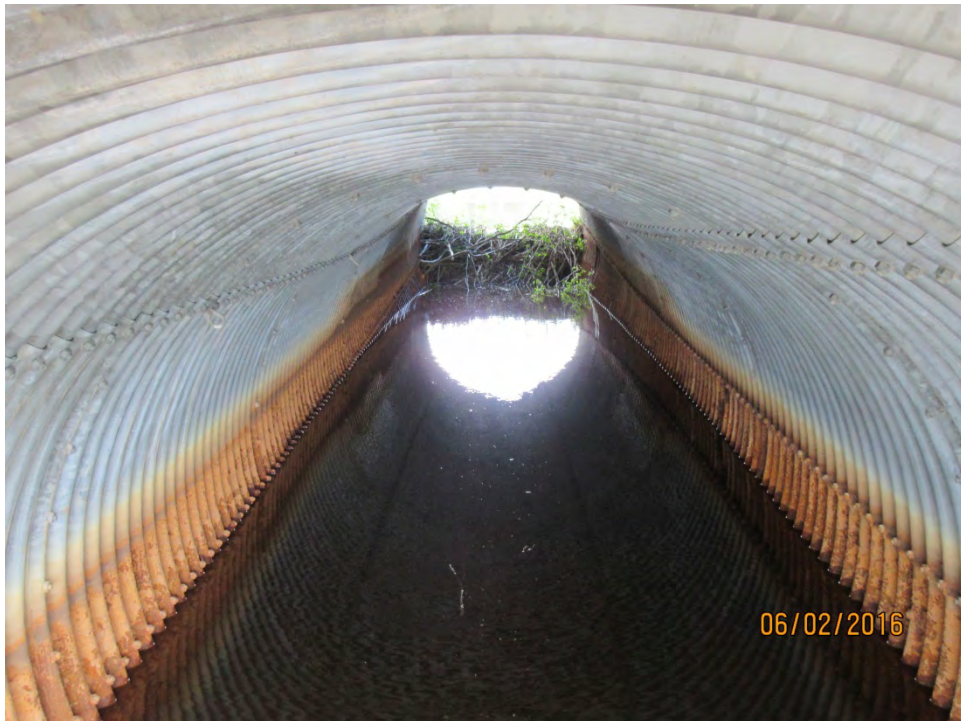
LOOKING NORTH THROUGH CULVERT BARREL – SIGNIFICANT SAG IN BARREL ALONG ITS LENGTH

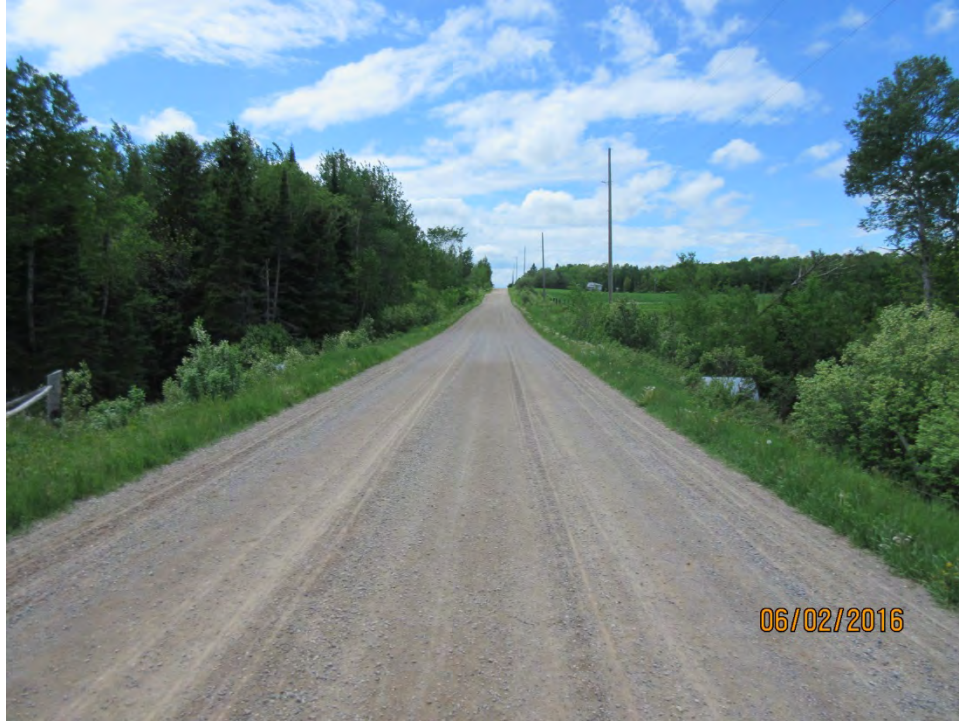
LOOKING WEST ACROSS STRUCTURE

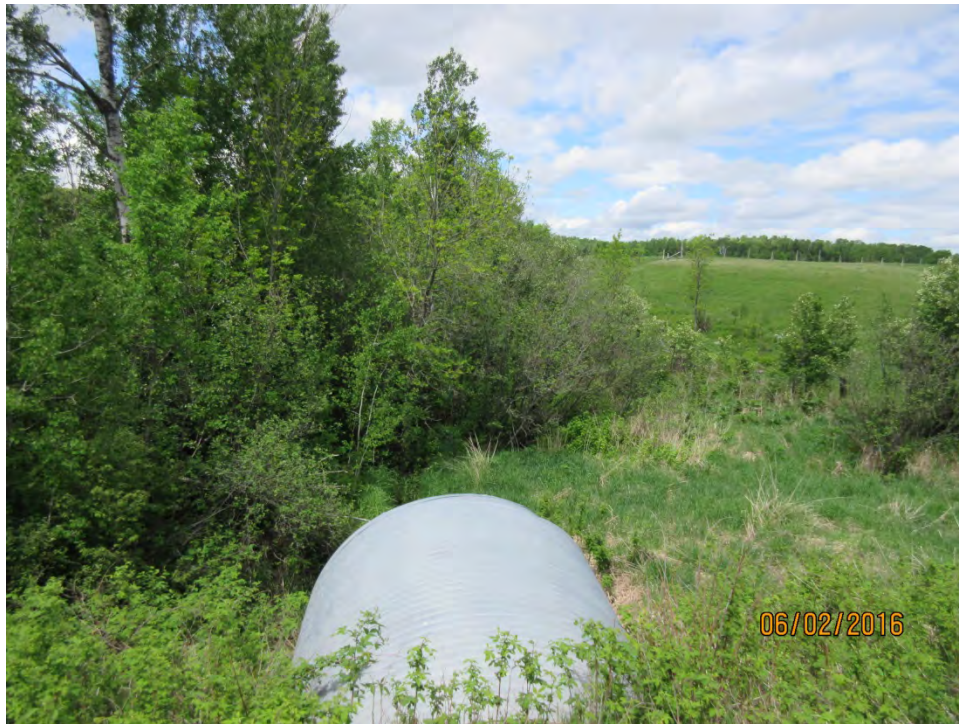
LOOKING UPSTREAM FROM CULVERT

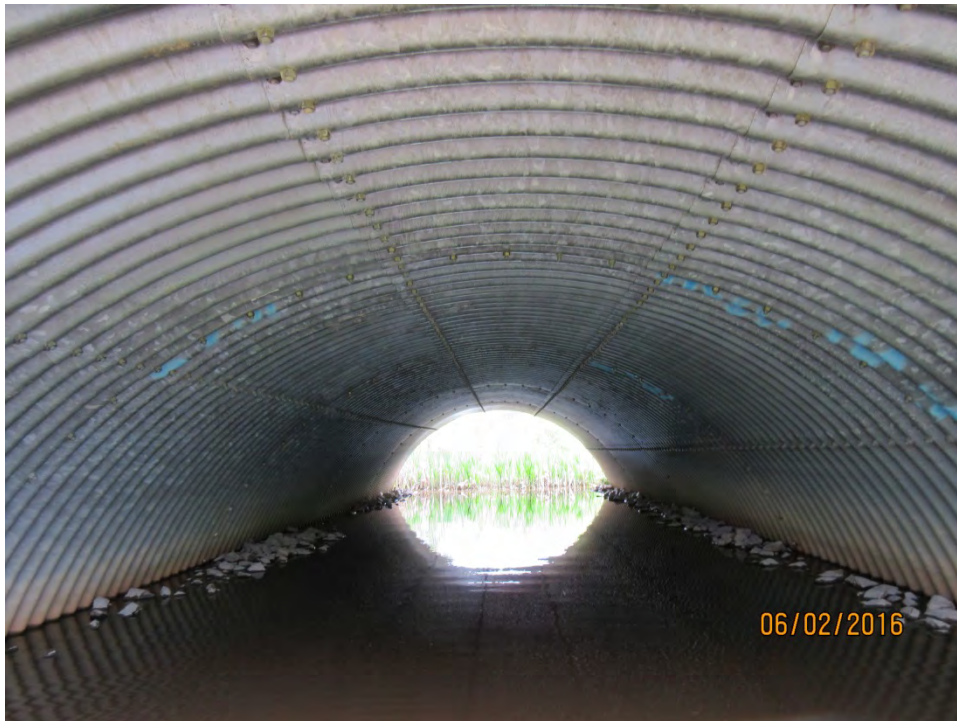
- Corrugated steel plate culvert is in good condition with light water staining of the culvert barrel at the water level..
- Water course is un-obstructed with no evidence of scour.

LOOKING EAST THROUGH CULVERT BARREL

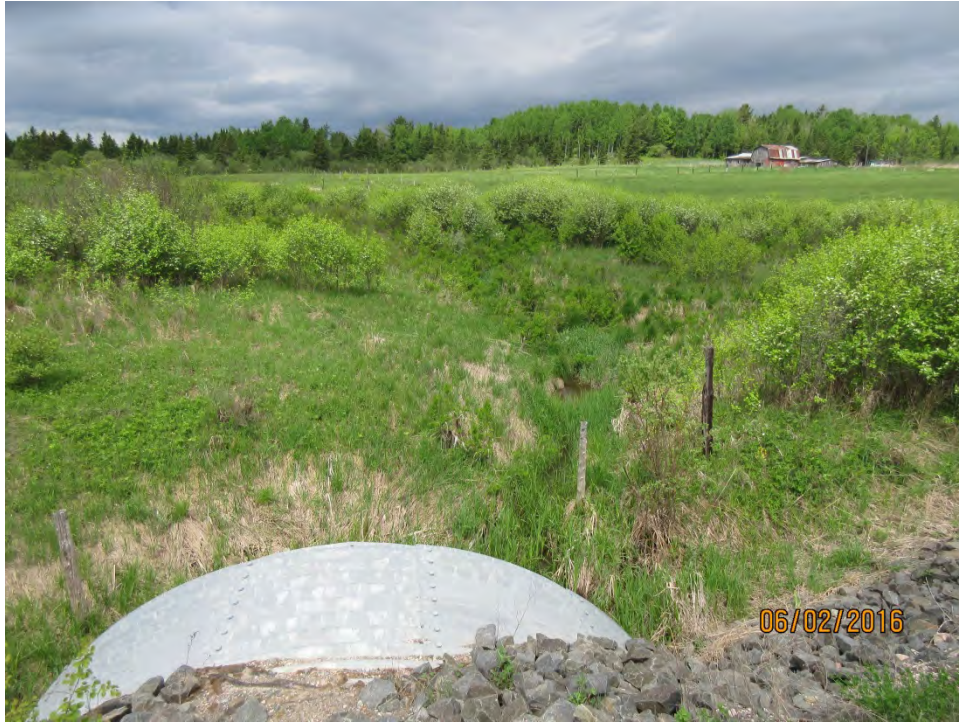
LOOKING WEST UPSTREAM FROM STRUCTURE

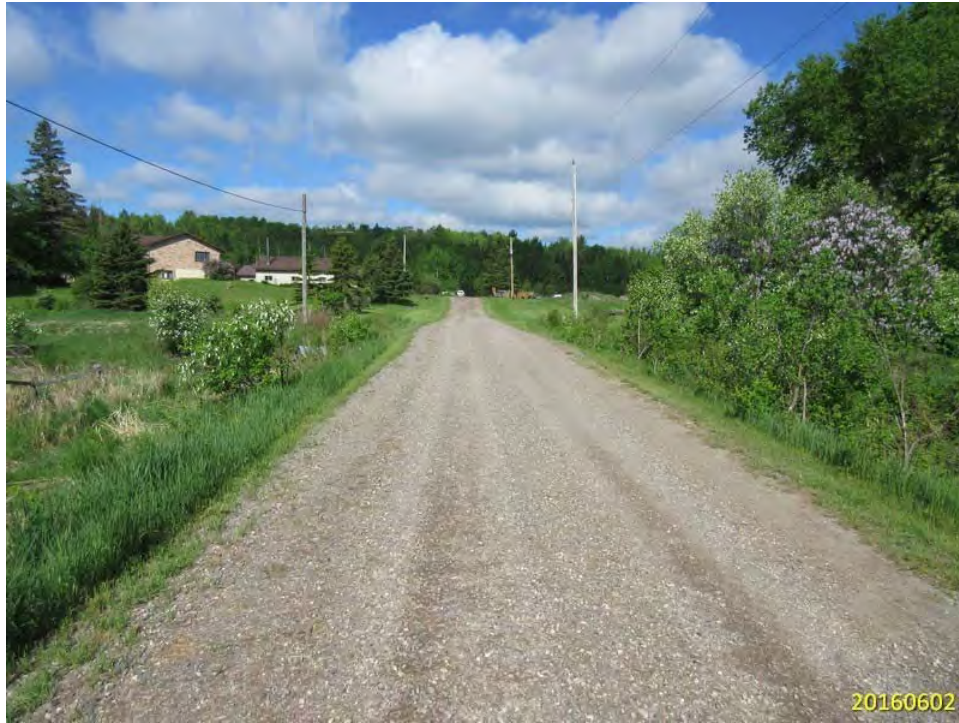
LOOKING WEST ACROSS STRUCTURE

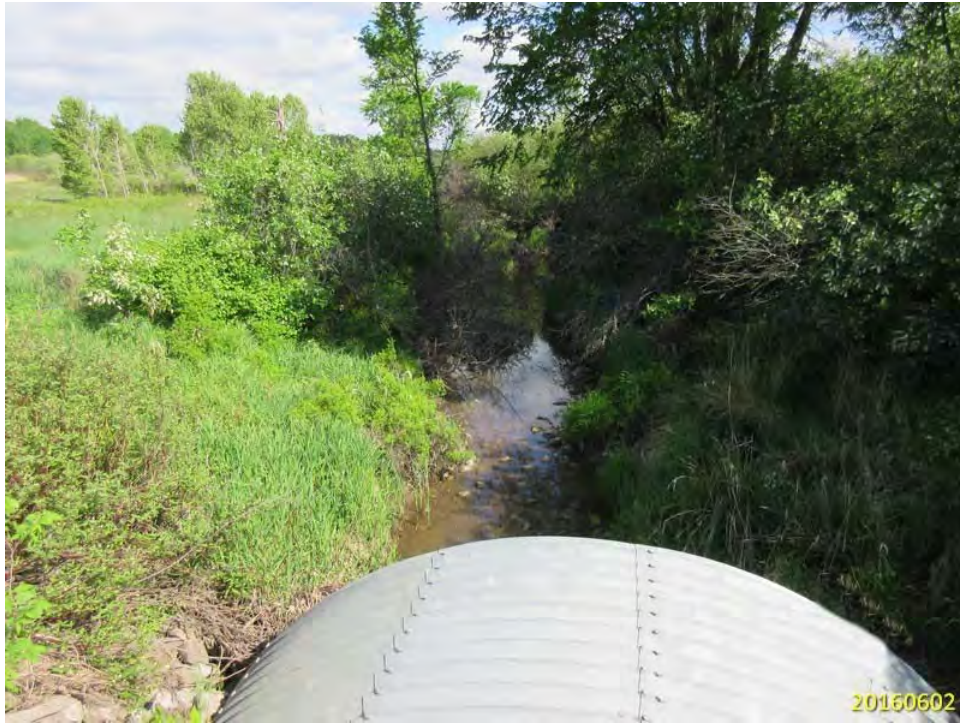
LOOKING NORTH UPSTREAM FROM STRUCTURE

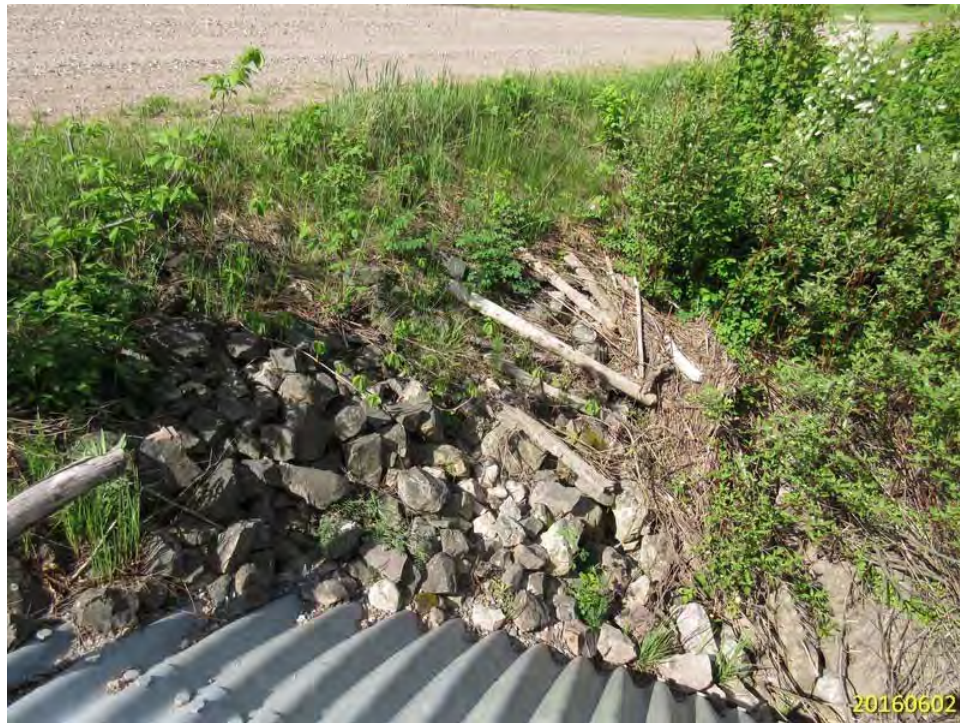
TYPICAL ROCK PROTECTION ON ROADWAY EMBANKMENT
