2018 Biennial Bridge and Culvert Inspection

Township of Johnson

STEM Engineering Group Inc.
875 Queen Street E. Suite 2
Sault Ste. Marie, ON
P6A 2B3

July 27, 2018

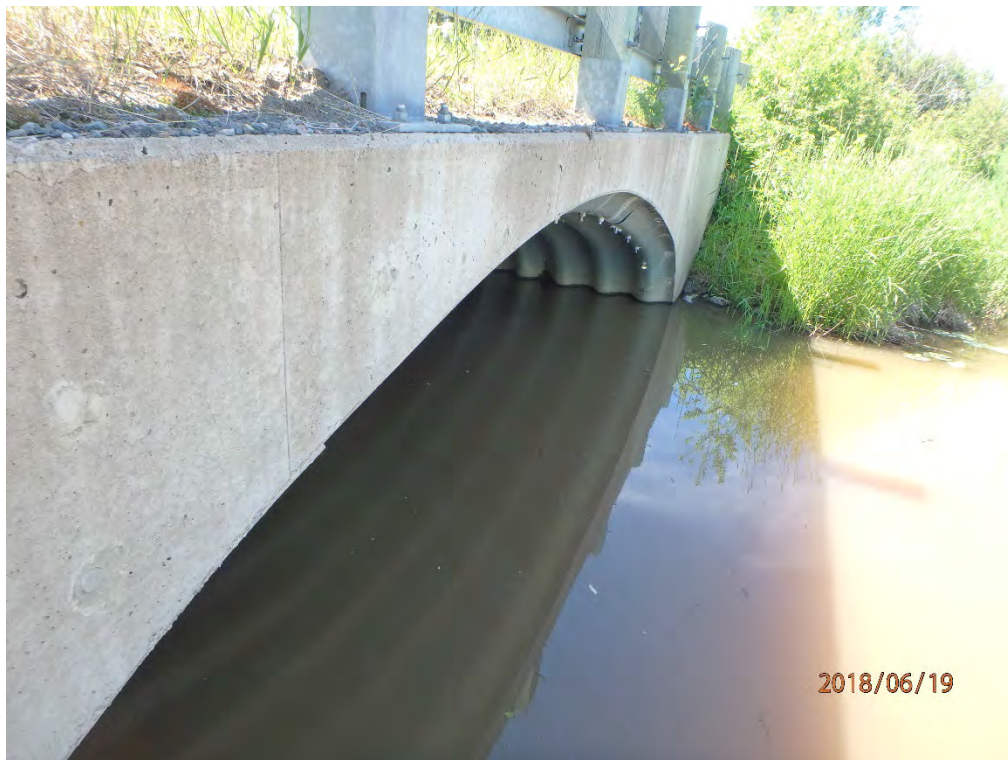
East Elevation

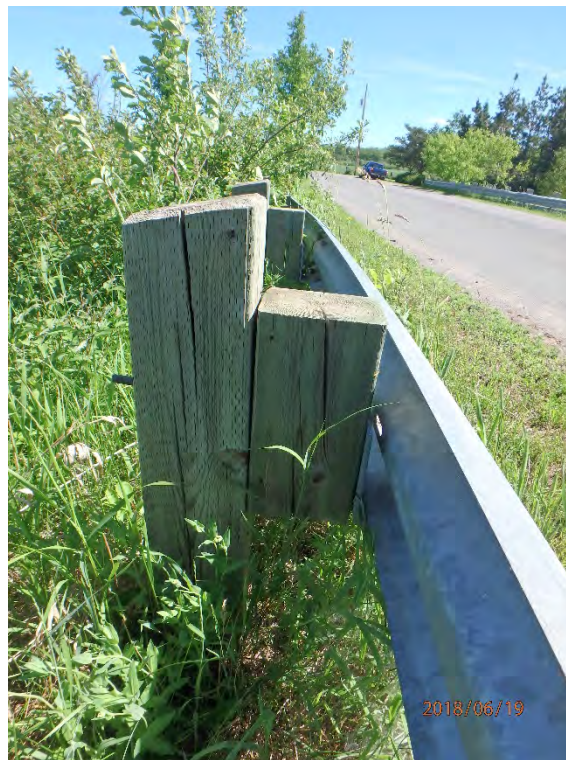
Splits and checks on posts

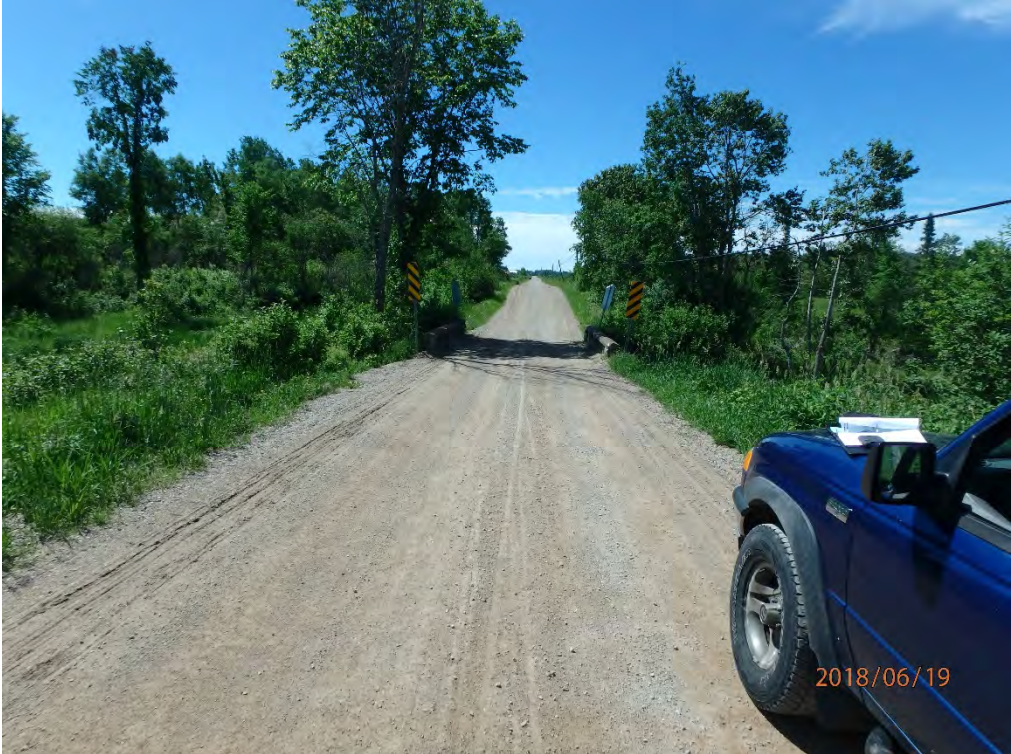
South across the bridge

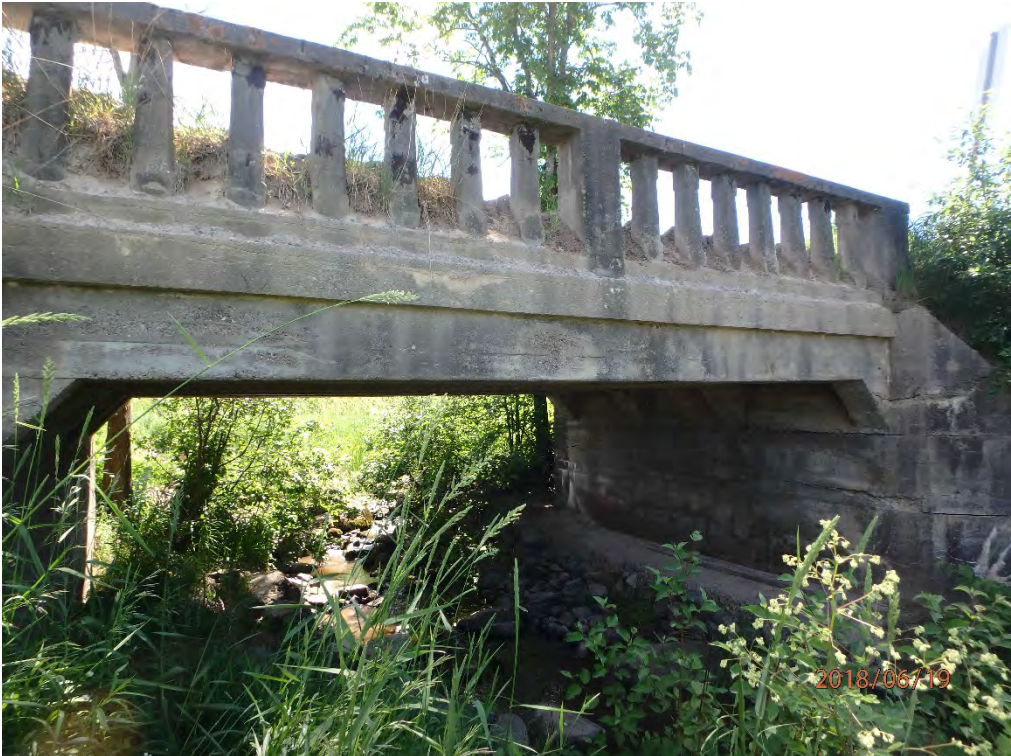
West Elevation

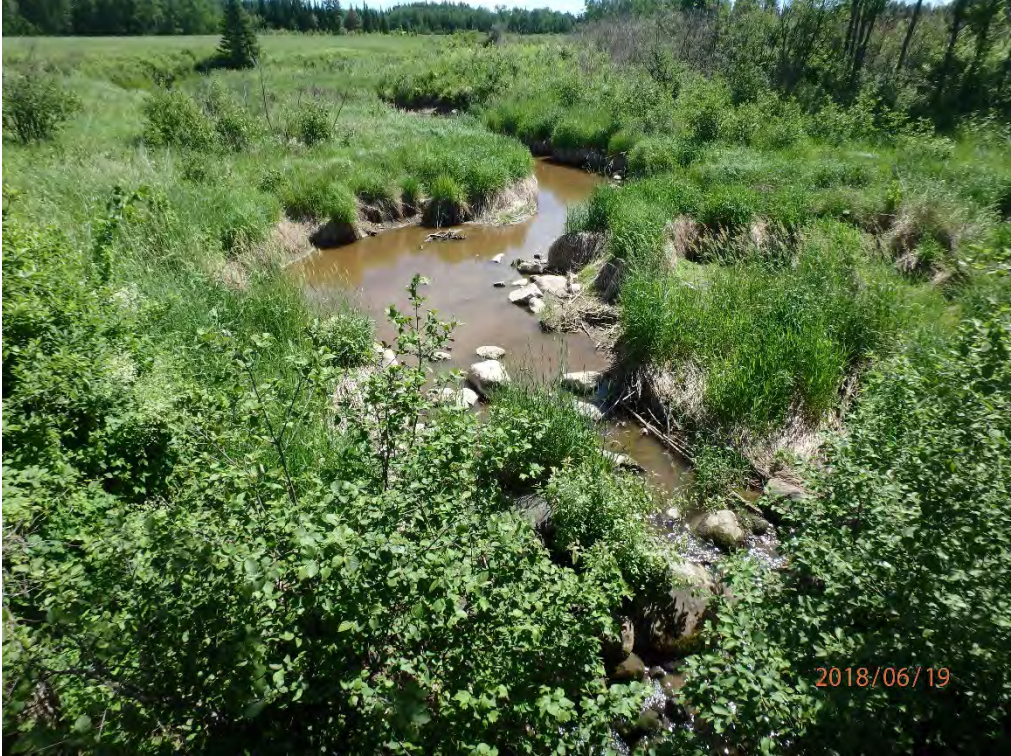
Unobstructed flow upstream

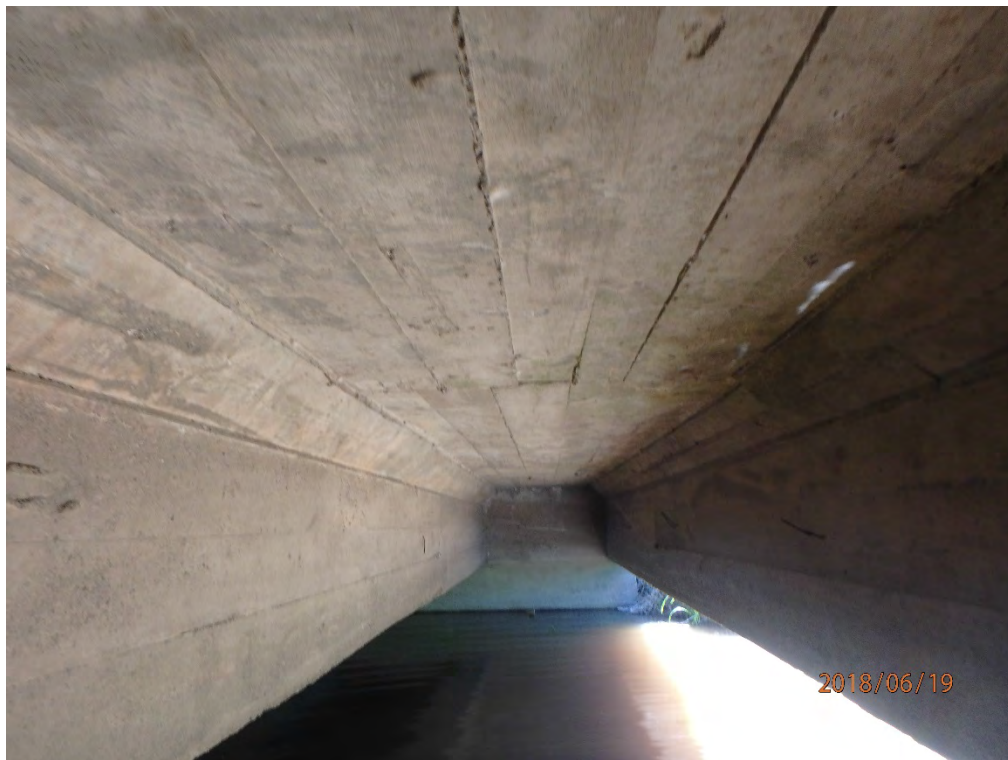
Typical T-beam arrangement

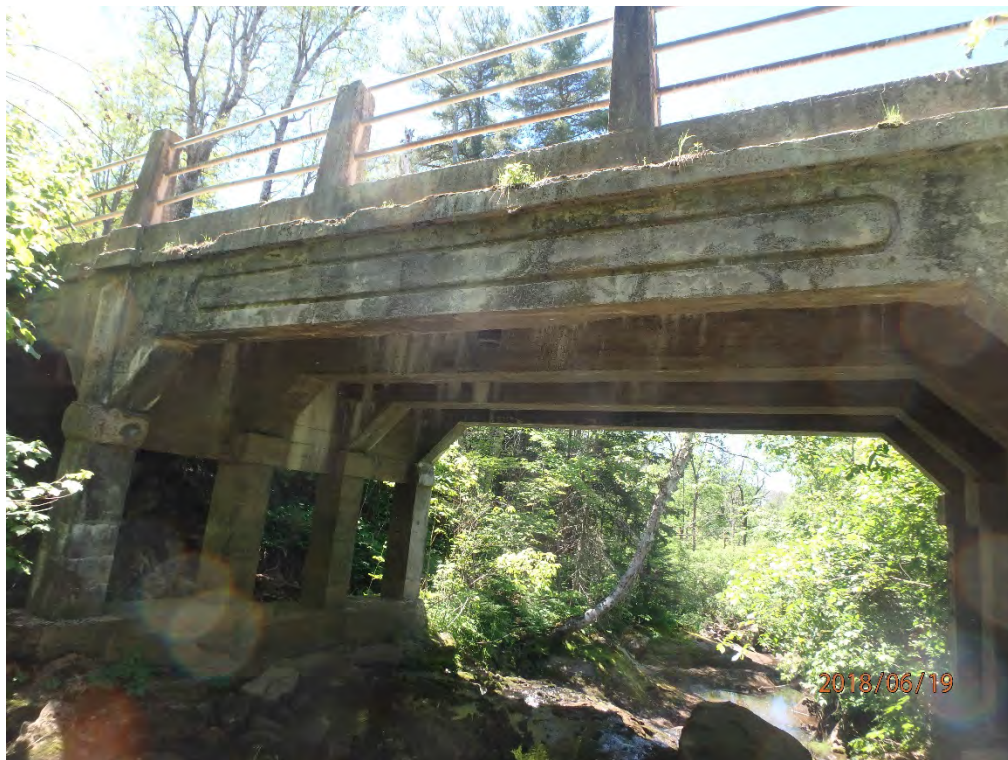
West Elevation

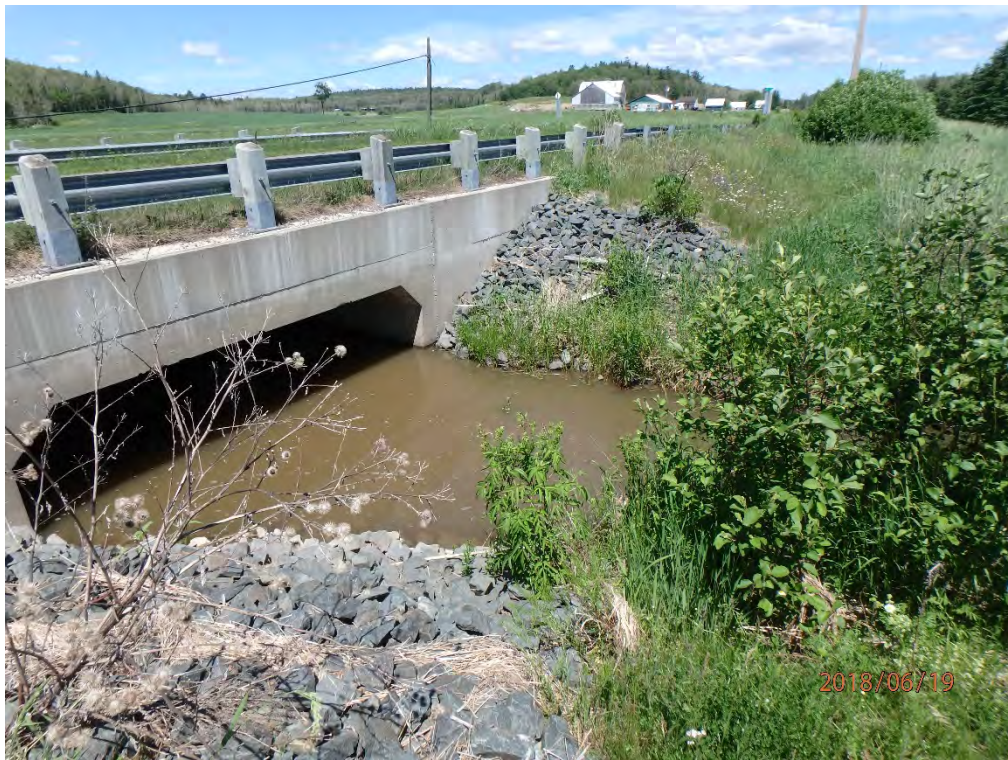
East Elevation

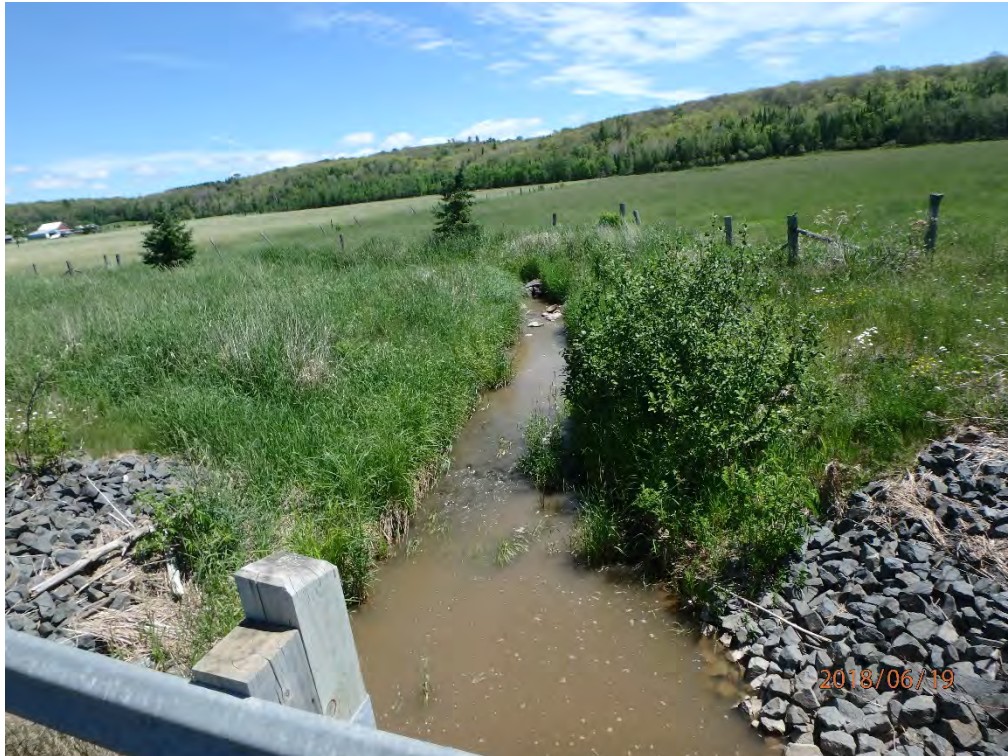
Looking downstream of the structure

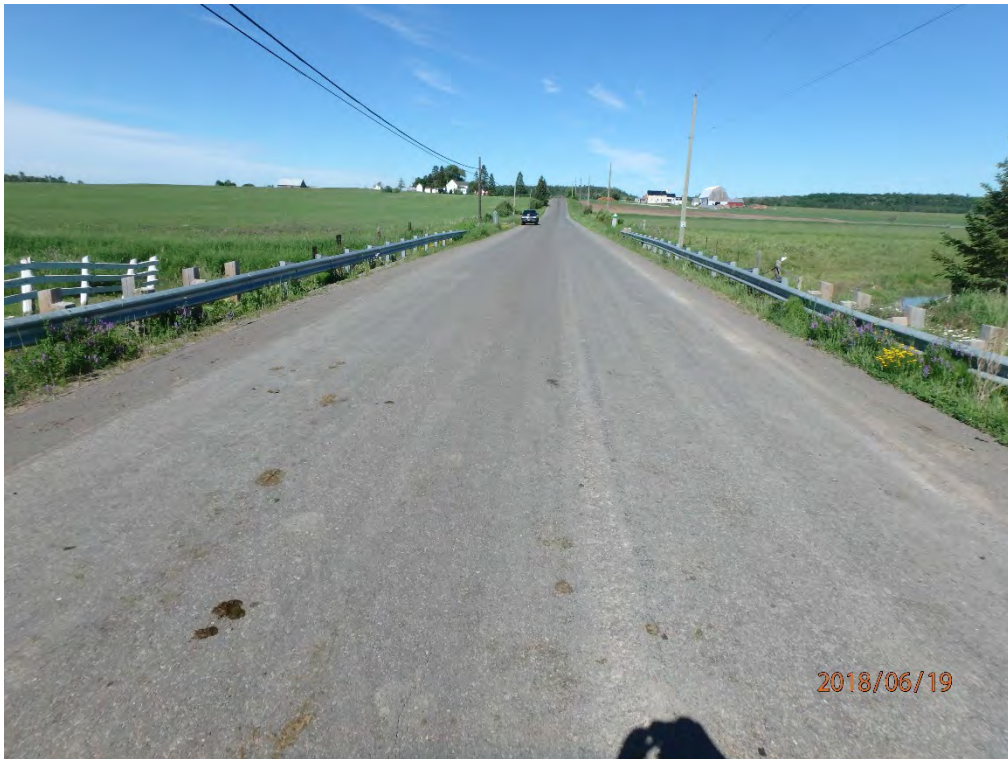
West across culvert

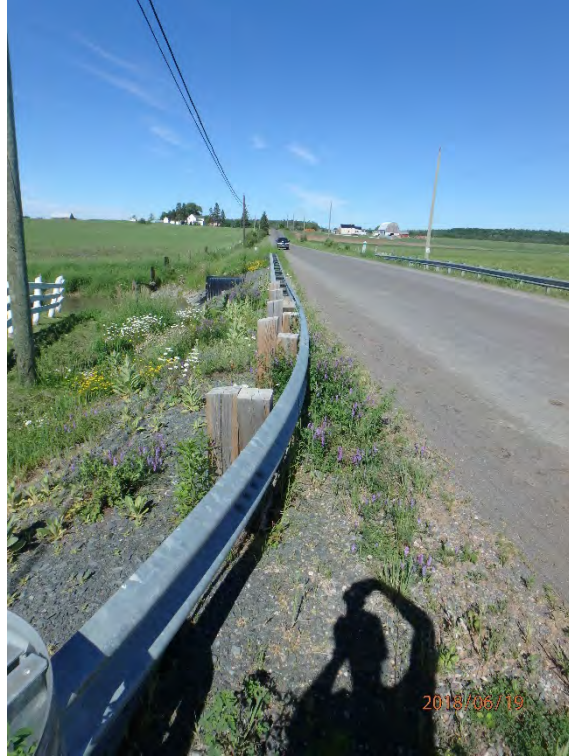
Typical Guiderail

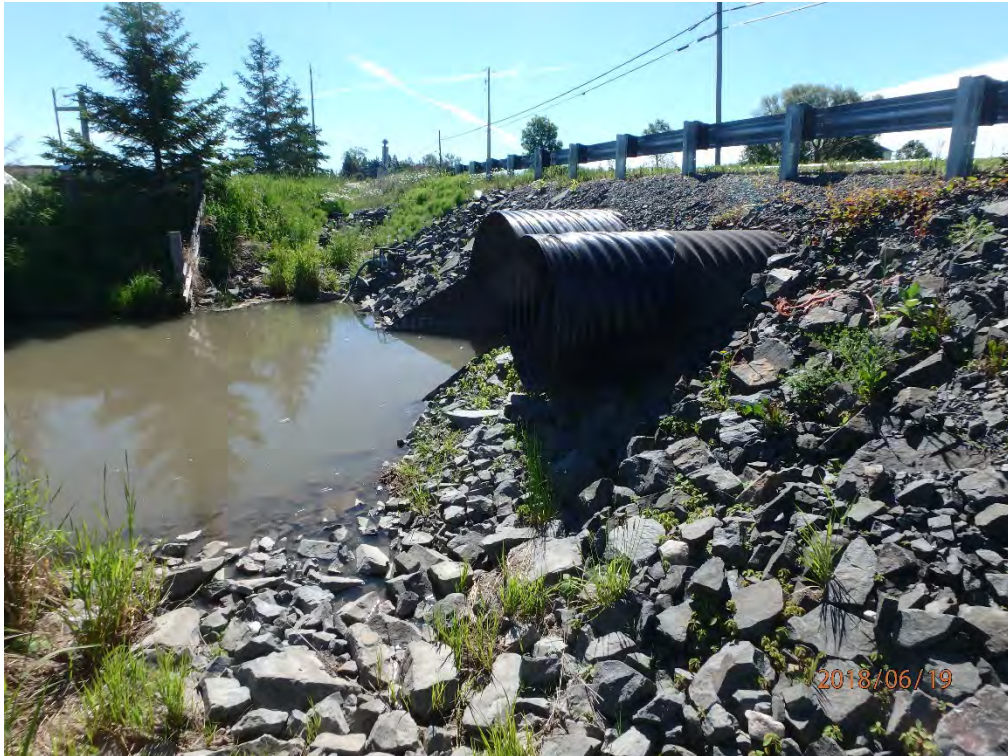
North side of Culvert, inlet. Banks protected by rock

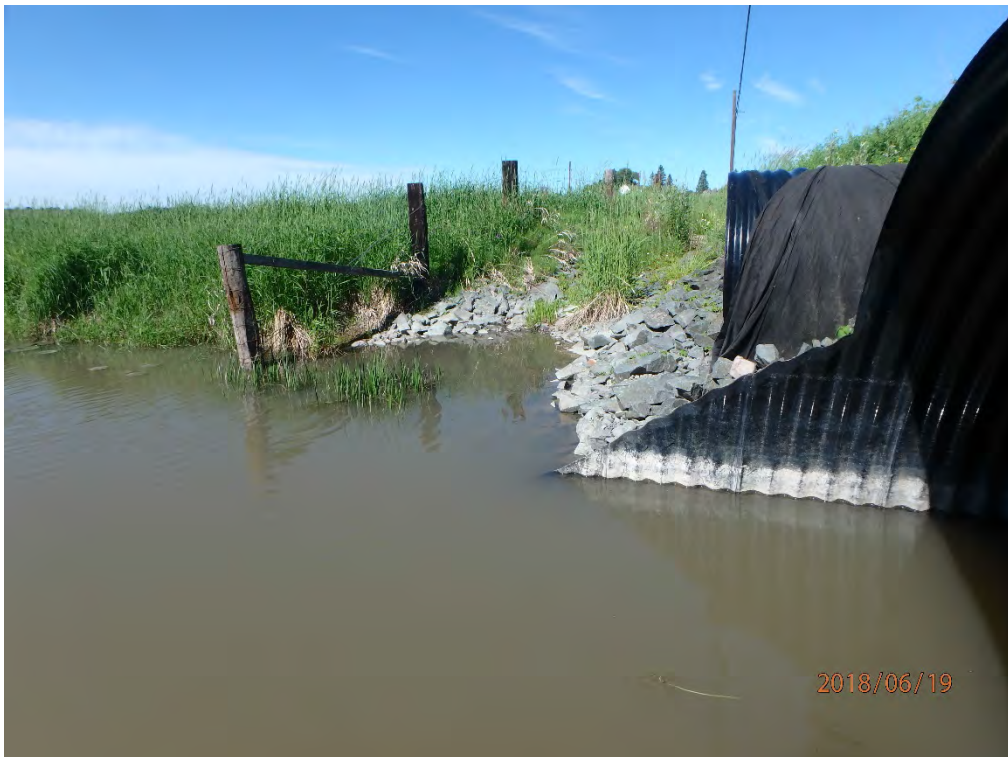
South outlet

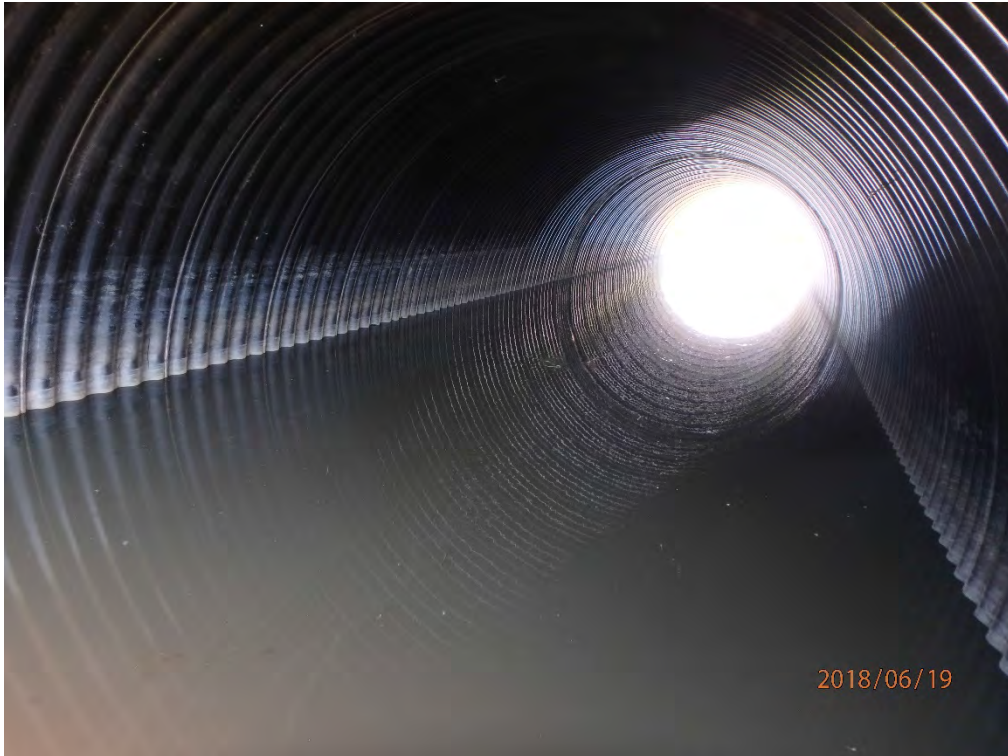
Looking north through the culvert.

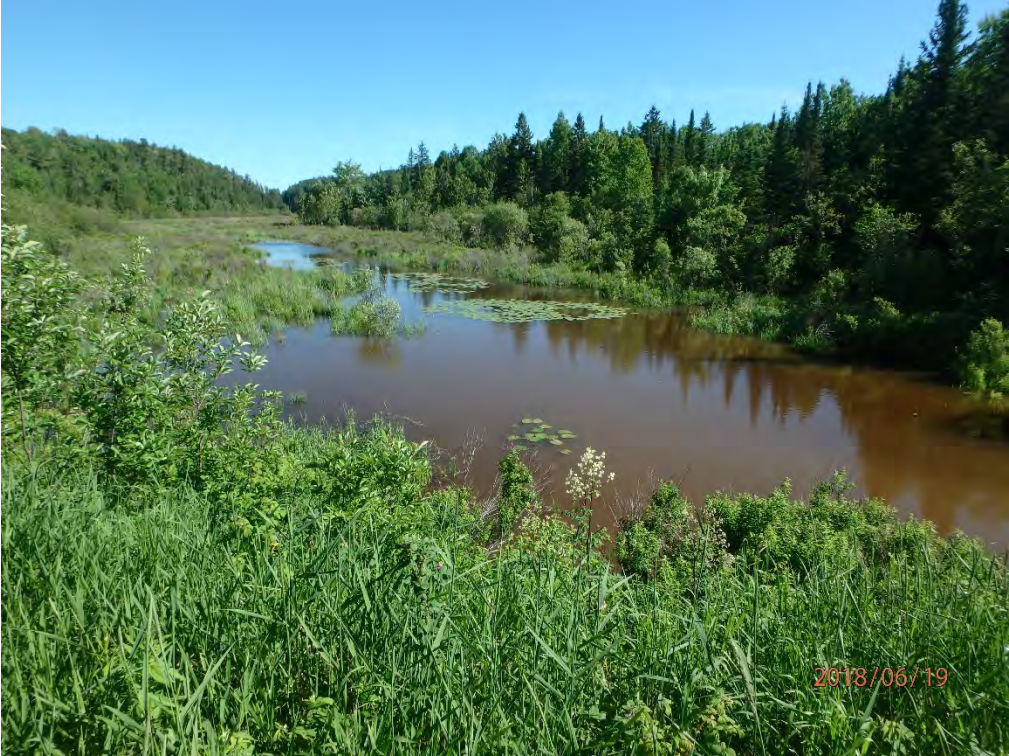
North upstream of culvert

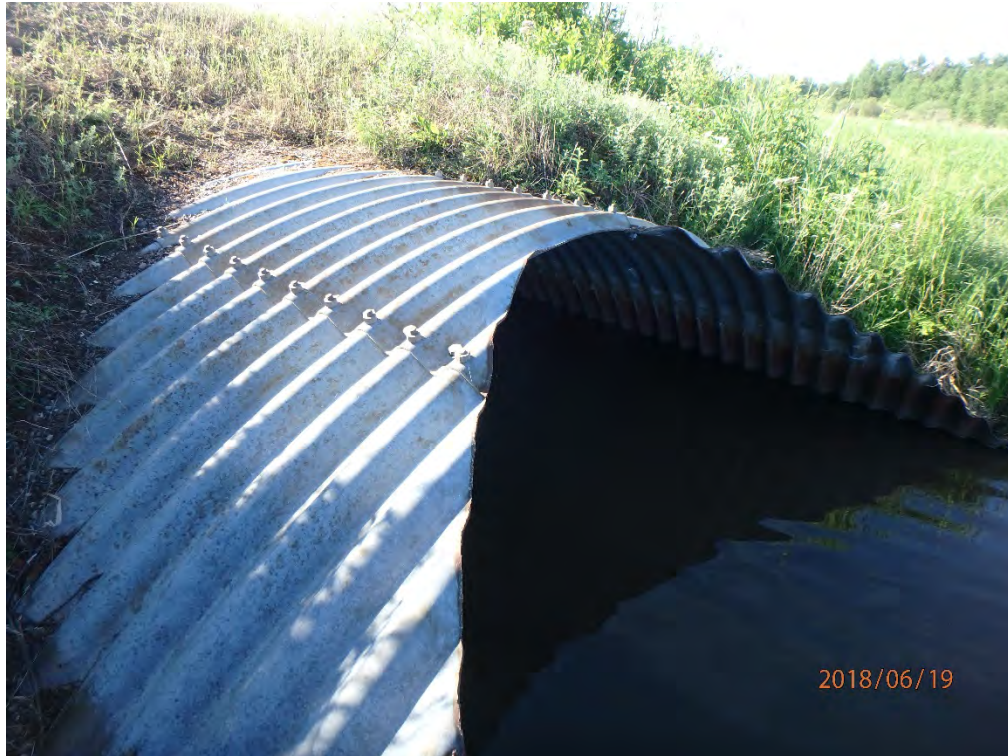
West elevation of culvert

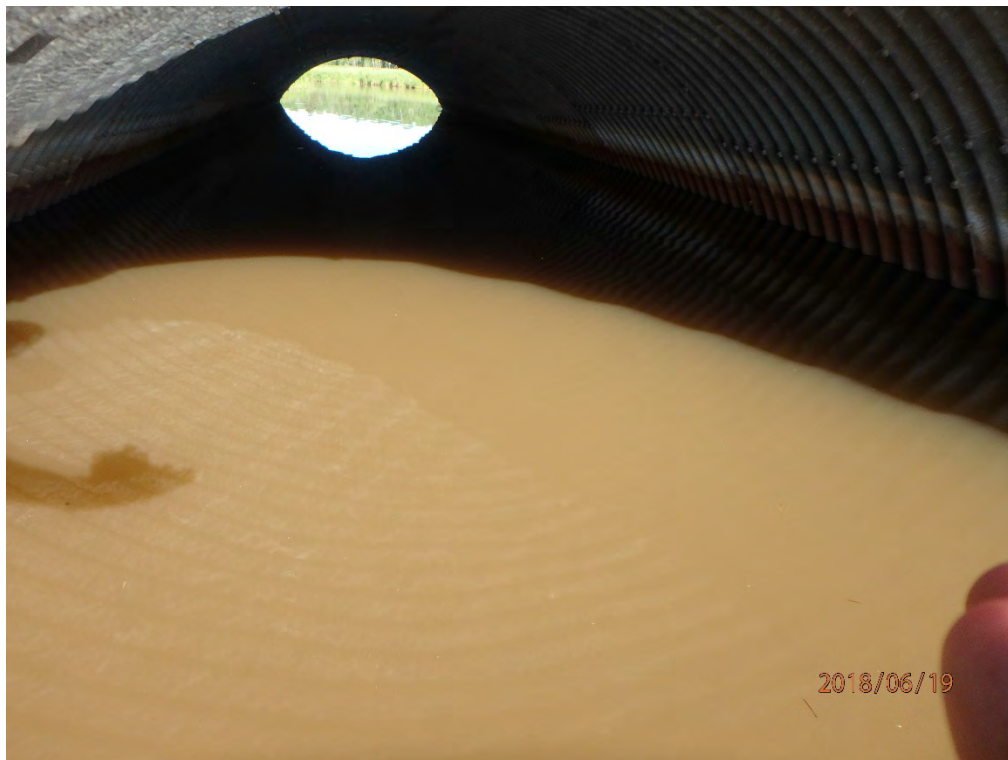
Looking upstream though the culvert

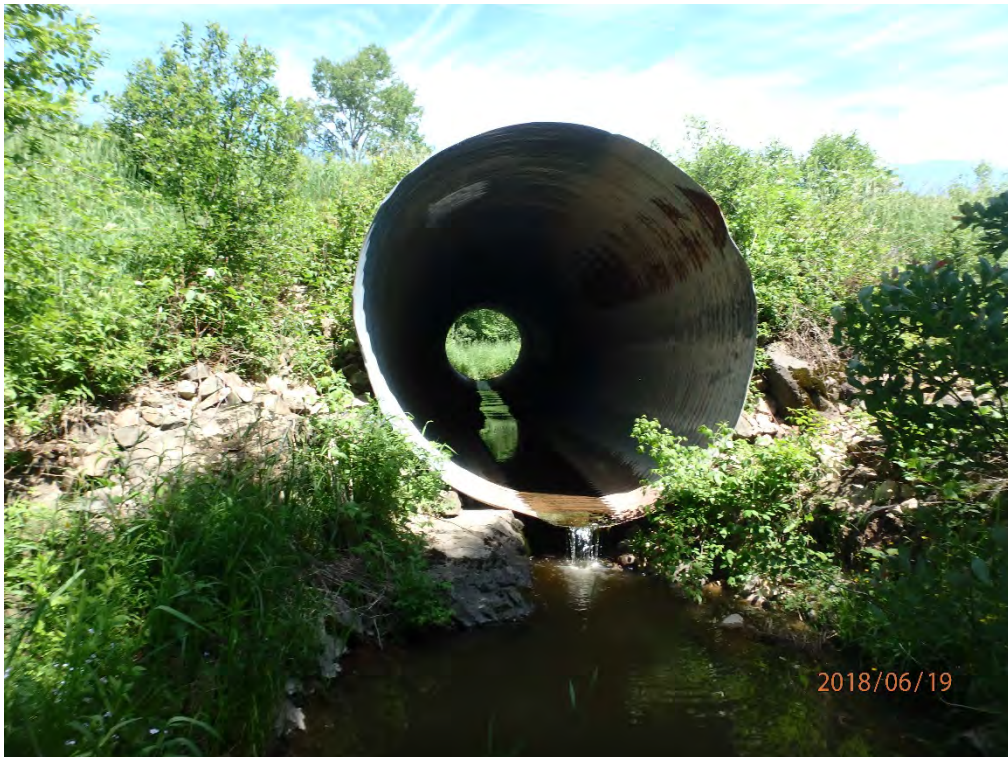
South end of culvert looking at the outlet

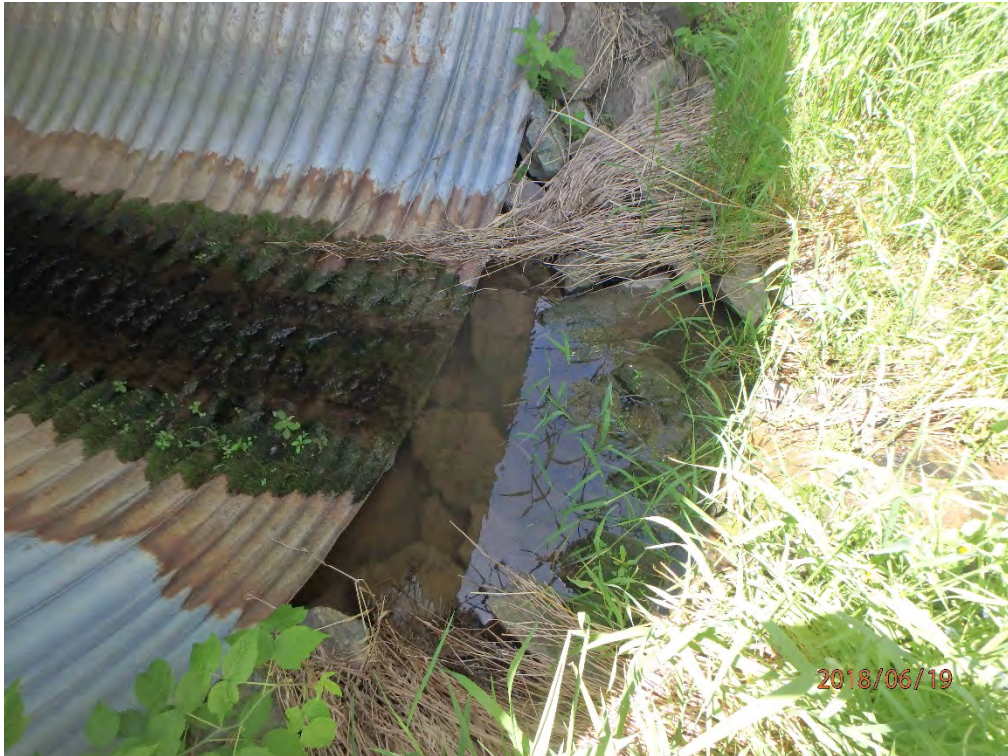
Inlet of culvert, moderate undermining.

- Structure does not require posting with a load limit.
- Traffic protection should be installed at the approaches and across the structure
- The missing parging and opened seams should be repaired and maintained to prevent water from travelling under the culvert, including repairs at each end of the culvert.
- Monitor indentation of culvert barrel at centerline of roadway/culvert barrel.
- Expected replacement of culvert should be budgeted for the next 6-10 years. Alternative option would be to install a liner in the culvert barrel. A culvert hydraulic study would be required to confirm suitability of installing a liner.

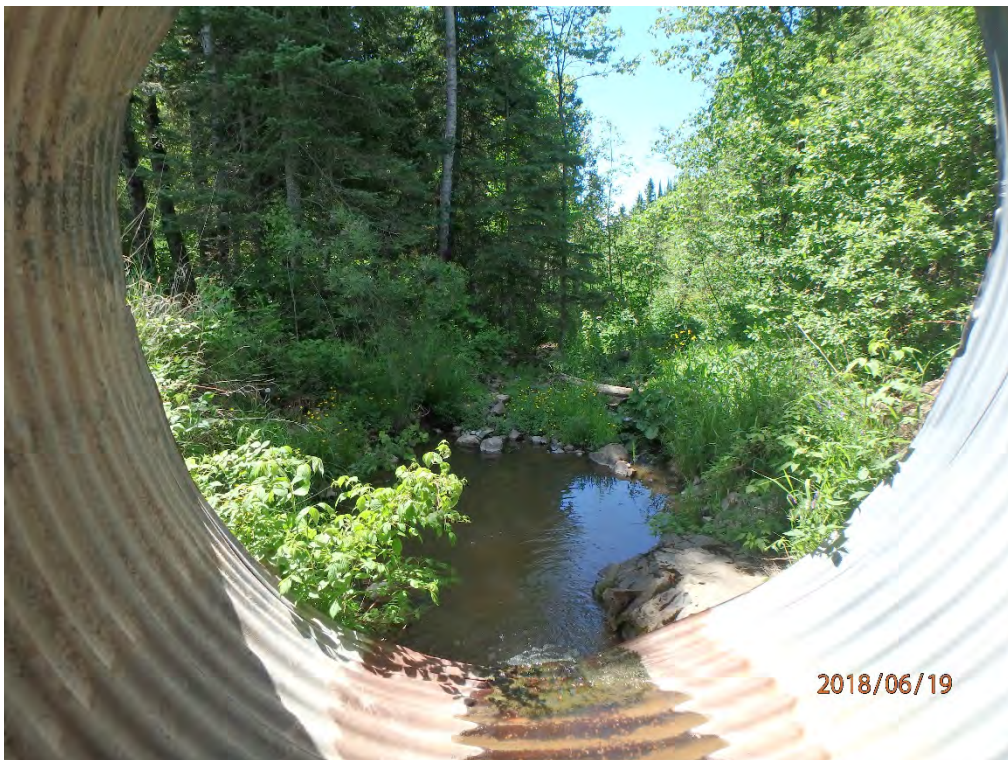
Outlet of culver, looking south downstream.

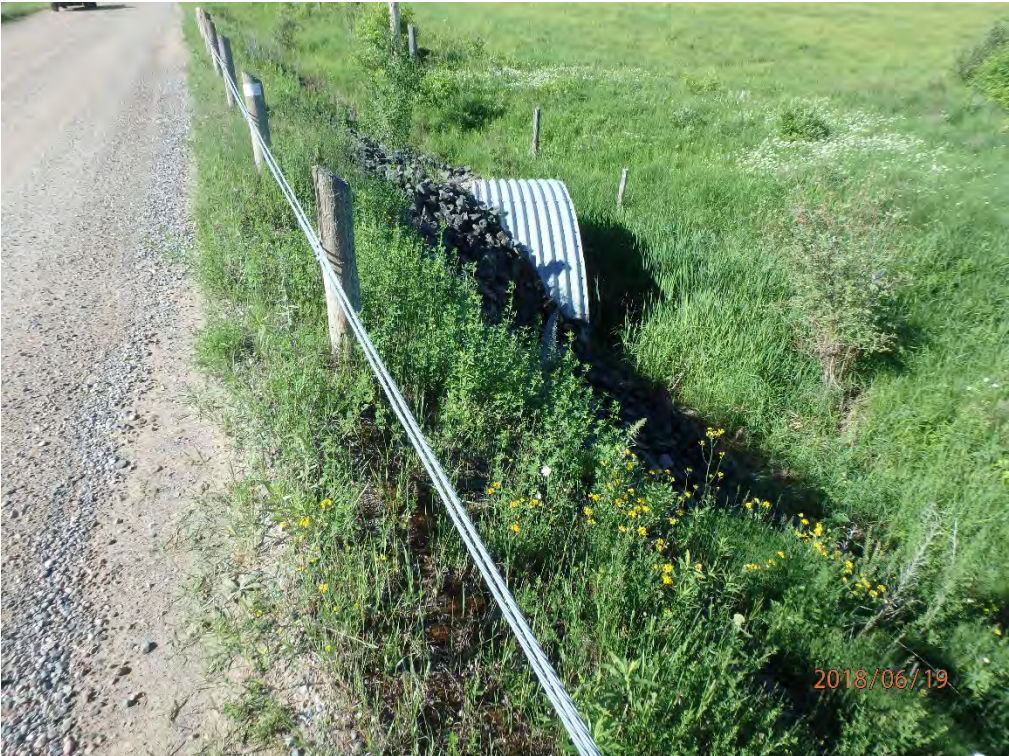
West end of the culvert, inlet

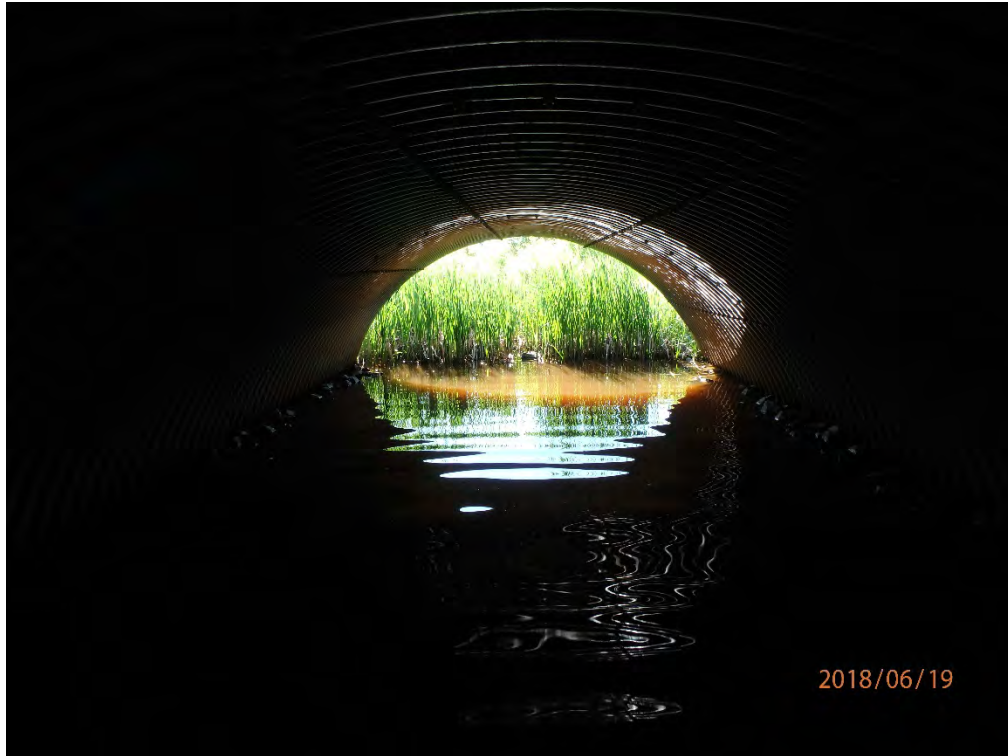
East through the culvert
