**2016 BIENNIAL MUNICIPAL BRIDGE
& CULVERT INSPECTIONS**

16-1055
August 3, 2016

Regarding: Township of Johnson - 2016 Biennial Bridge & Culvert Inspections

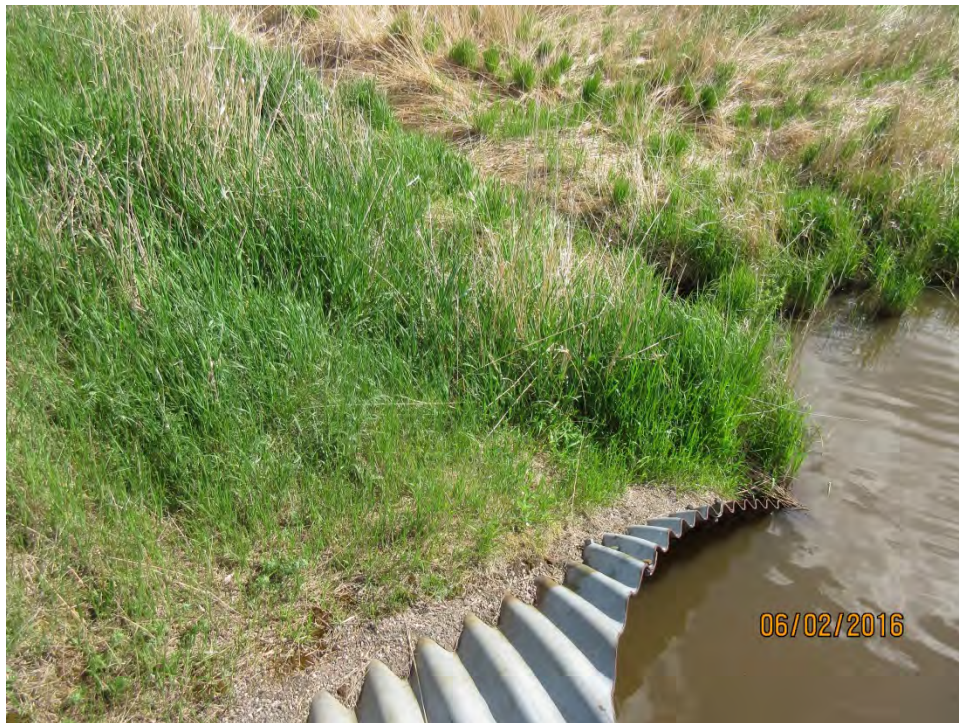
TYPICAL VEGETATED ROADWAY EMBANKMENT

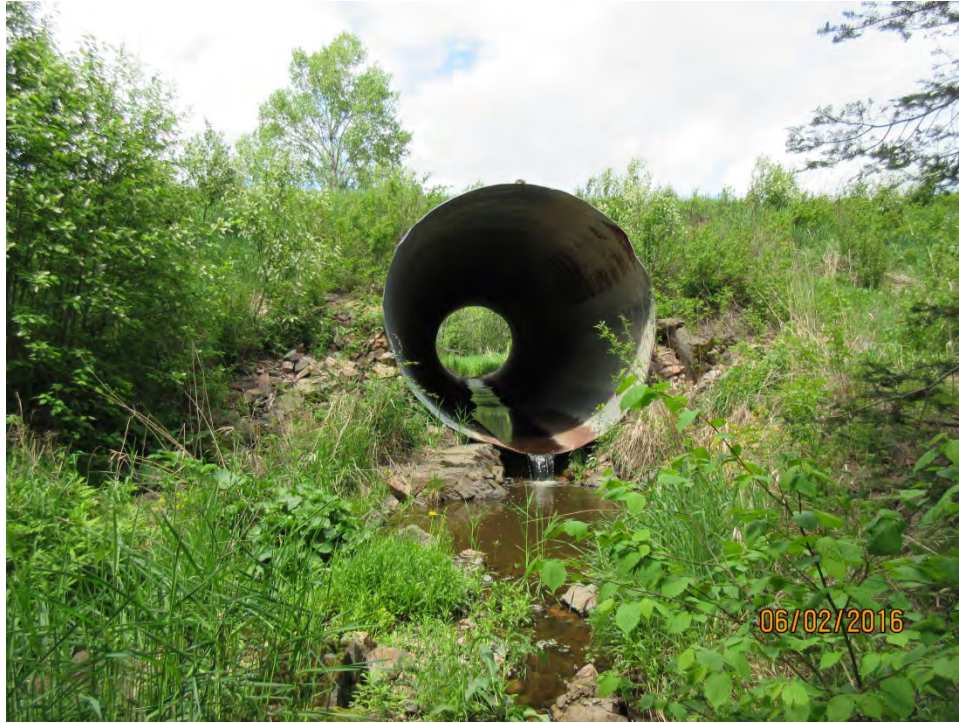
LOOKING NORTH THROUGH BARREL

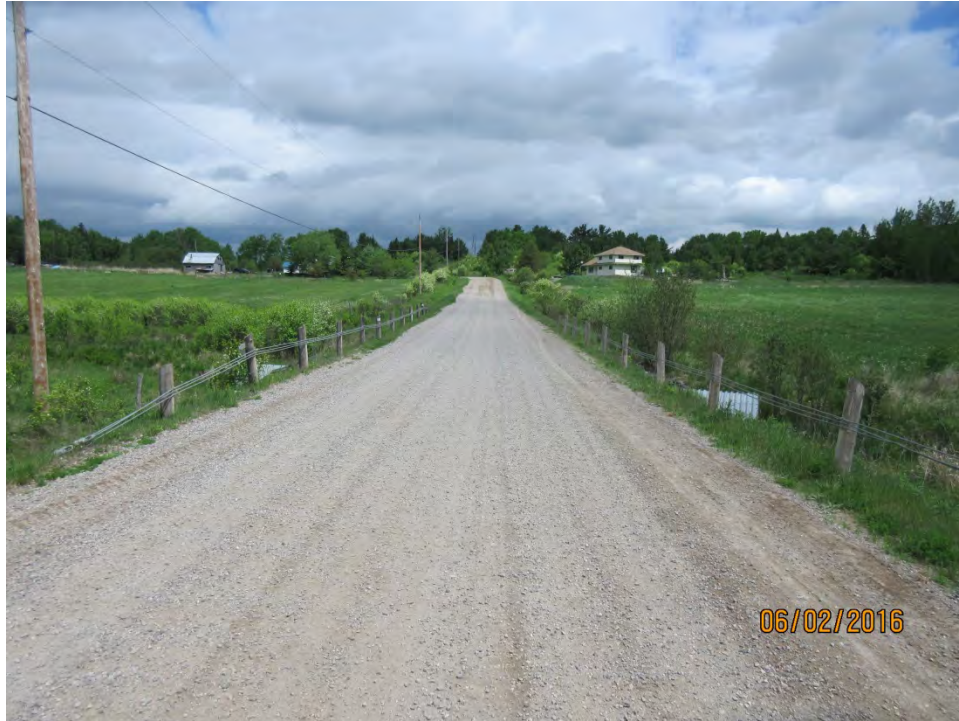
- Gravel roadway is in good condition with light washboard.
- Steel cable guiderail on timber posts is provided on the approaches and is in generally good condition. The cables were crossed at the southeast quadrant and a number of broken guiderail posts are causing the cables to be loose. The posts generally have wide splits and checks with minor decay. The approach 3 cable guiderail have buried end treatments.

LOOKING NORTH ACROSS STRUCTURE

- Structure does not require posting with a load limit.
- Should repair guiderail cables and replace broken posts as part of regular maintenance. The guiderail posts should be checked seasonally for broken or severely decayed posts.
- Lost armoring stone at the culvert inlet should be replaced to protect the walls of the structure.

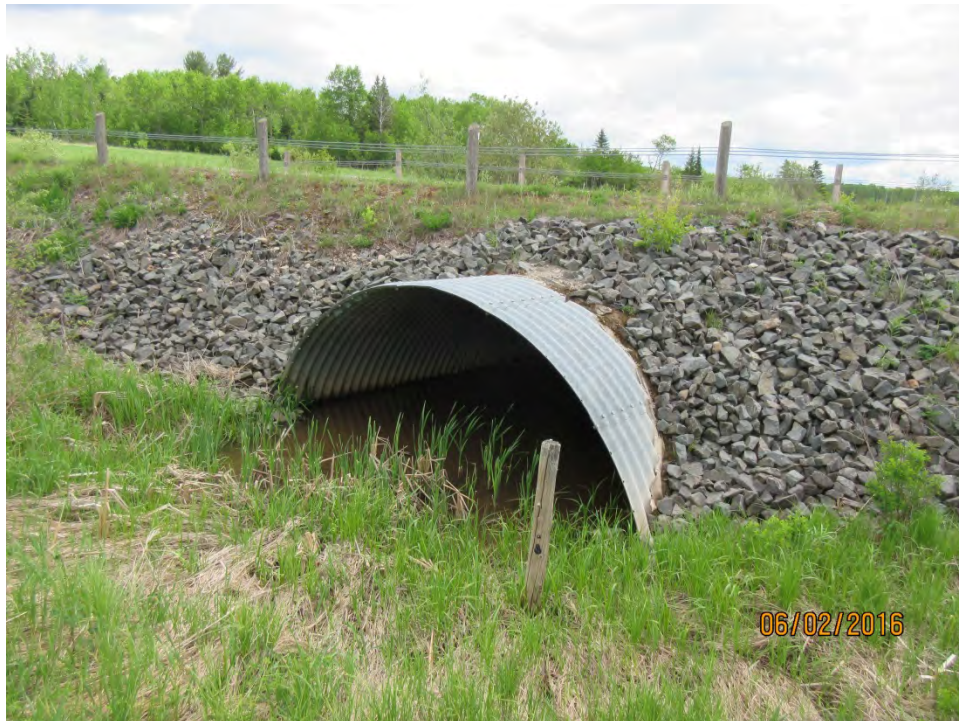
WEST ELEVATION

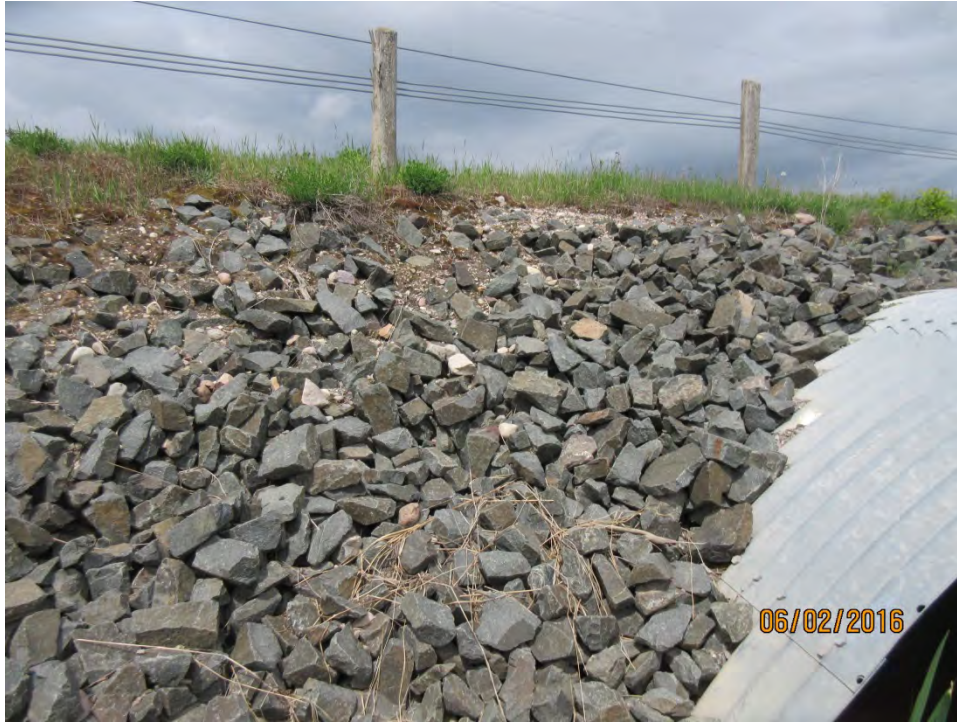
- Rock protection is provided on both roadway embankments and is in good condition with a loss of rock armoring near the inlet of the culvert which has been pushed further into structure.

TYPICAL ROCK PROTECTION AND EMBANKMENT

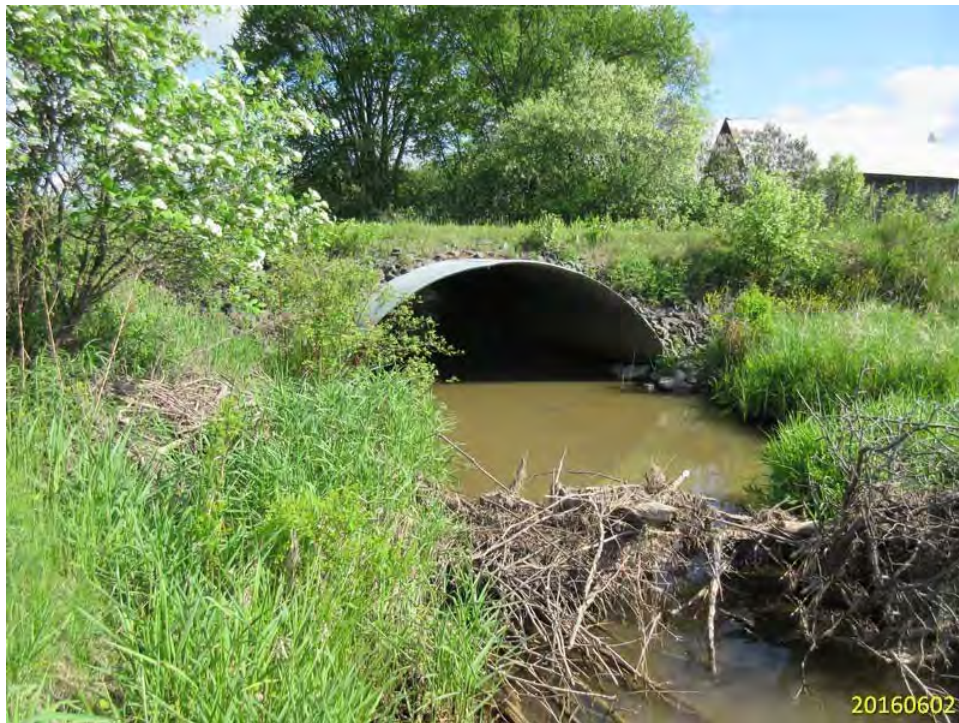
SOUTH ELEVATION

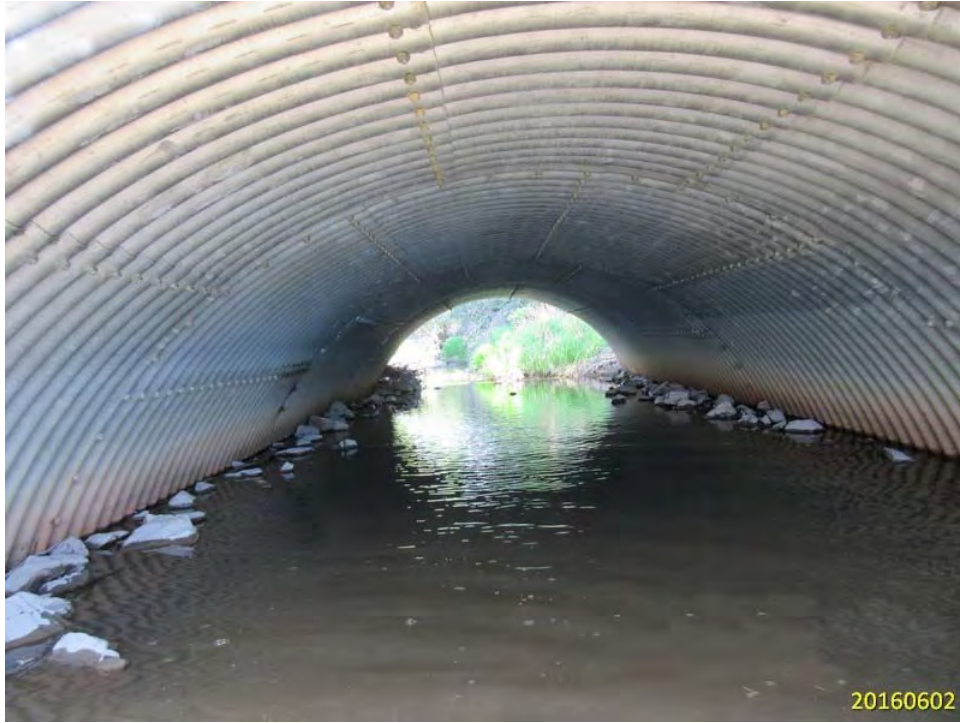
LOOKING NORTH THROUGH BARREL
